INSPECTION INFORMATION

[REDACTED]
St. Michaels, MD 21663

2 story, Small, Wood Frame, Colonial.

07/11/2005.

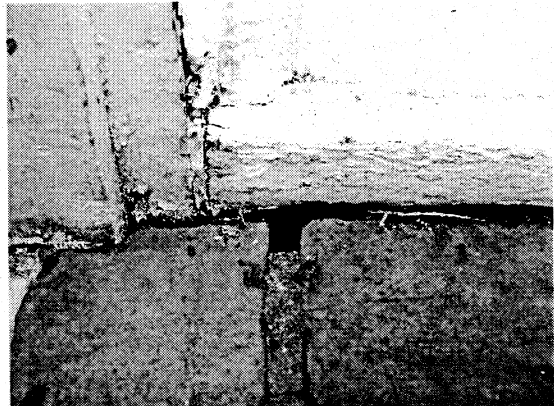
MAIN ENTRY

The gaps in the brick need to be repaired to keep water out of the framing. Framing damage has probably already occurred.

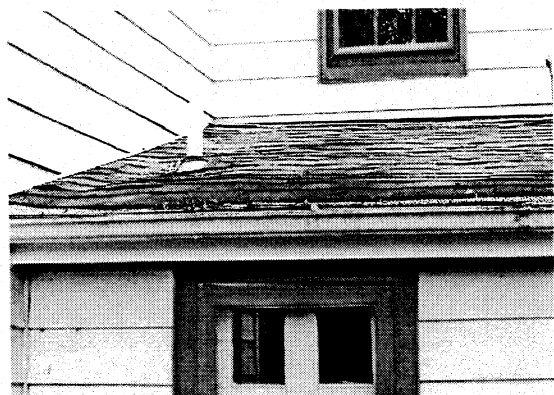
Marginal. Trouble with the roof is expected. Nails are popping, shingles are curling, flashing is loose, there are soft spots in the rear roof where water has gotten in and is starting to rot the sheathing.

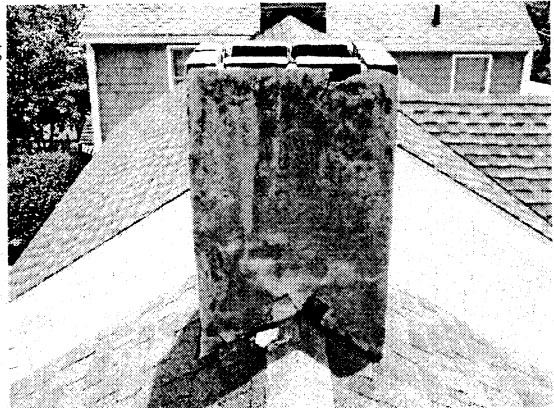
The chimney flashing is not done normally. It runs behind the stucco instead of over top of the stucco. The chimney flashing is also loose at the brick chimney. There is no flashing collar around the water heater vent so it is leaking. (see water heater also for additional comments on this vent).
