**EXTERIOR**

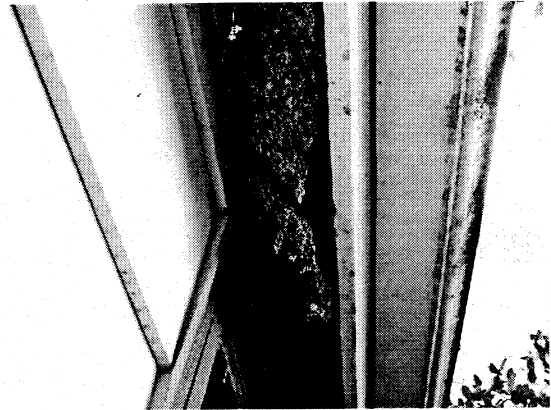
The soffit of the rear of the 1st floor bathroom is rotted and falling out due to roof leaks.

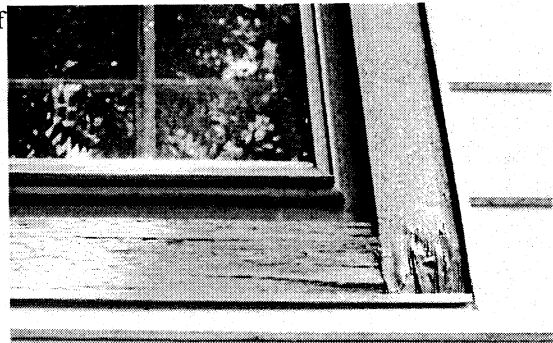
The rear upstairs window trim is rotted. Other smaller spots of rot were found also.

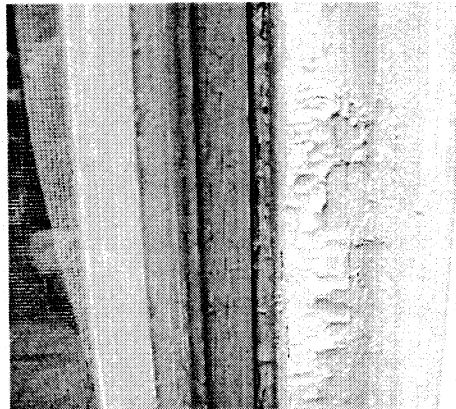
Major paint deterioration will require extensive preparation to restore it. The paint is cracked across the grain so it will have to be removed if you want new paint to stick. All of the wood work needs paint.
