Claxton Walker & Associates

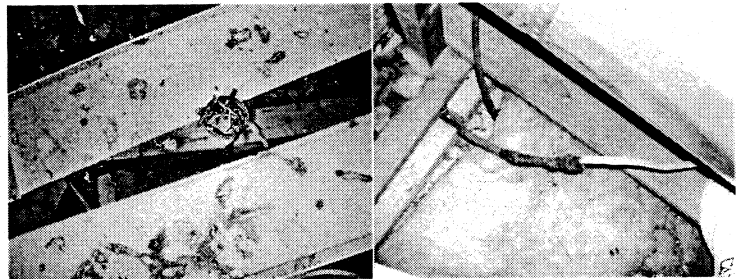
Exposed splices that need boxes in the attic and boxes that need covers in the attic were found. Have an electrician correct these defects.

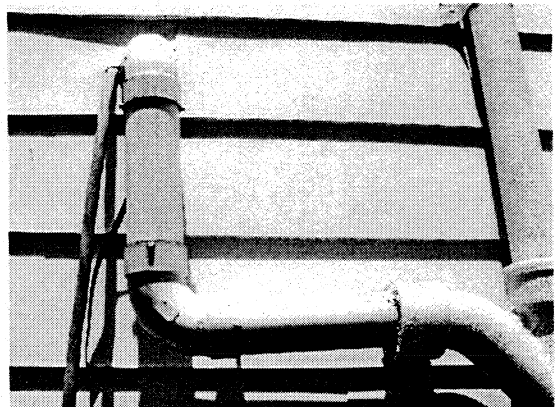
The pipe on the side of the house is a vent and drain. The vent doesn't go above the roof line so you may get whiff of sewer gas from time to time. It also runs slightly uphill which it is not supposed to do. The hole where it goes in the house needs to be sealed. The pipe is slightly melted where someone has inappropriately applied heat. There has been a leak in it at a coupling back inside over the laundry. That will have to be monitored to see if it reoccurs.

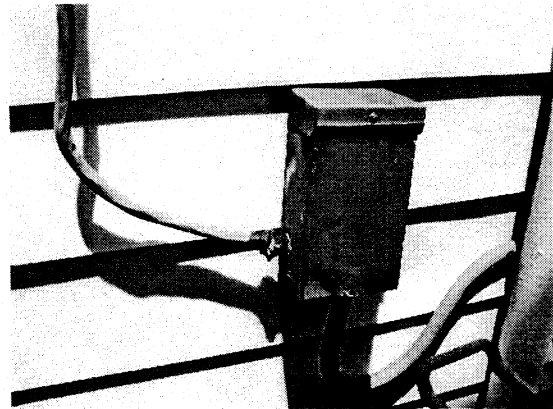
The electric disconnect box outside is not water tight and water has been running through it. Repair or replace.
