**APPLICATION FOR HISTORIC AREA  
WORK PERMIT**

**3914 Baltimore St.  
Kensington, MD 21770**

Re: Fire Damaged Home Evaluation  
3914 Baltimore Street  
Kensington, MD  
SCI No: 2009.017

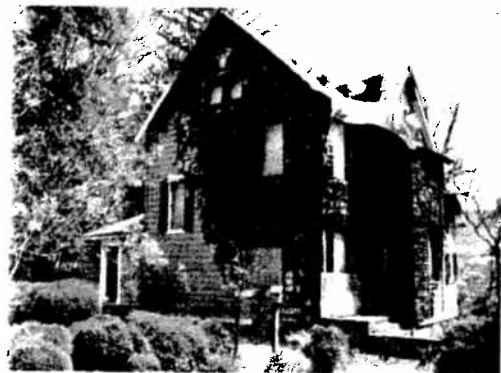
On April 28, 2009 and April 15, 2010 a representative of Structural Concepts, Inc. visited the above referenced project to evaluate the structural damage of the home that resulted from a fire. The home is a two story home with a full basement and attic space that was constructed in the later half of the 1800's. The fire started in the first floor kitchen located in the North West corner of the home and spread to the upper level, the roof and adjacent rooms.

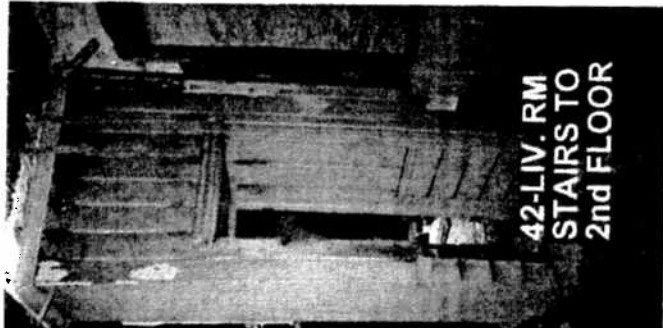
42-LIV. RM  
STAIRS TO  
2nd FLOOR

FRAMING IN THE AREA WELL  
TOTALLY DESTROYED-ALL OF  
IT NEEDS TO BE REPLACED

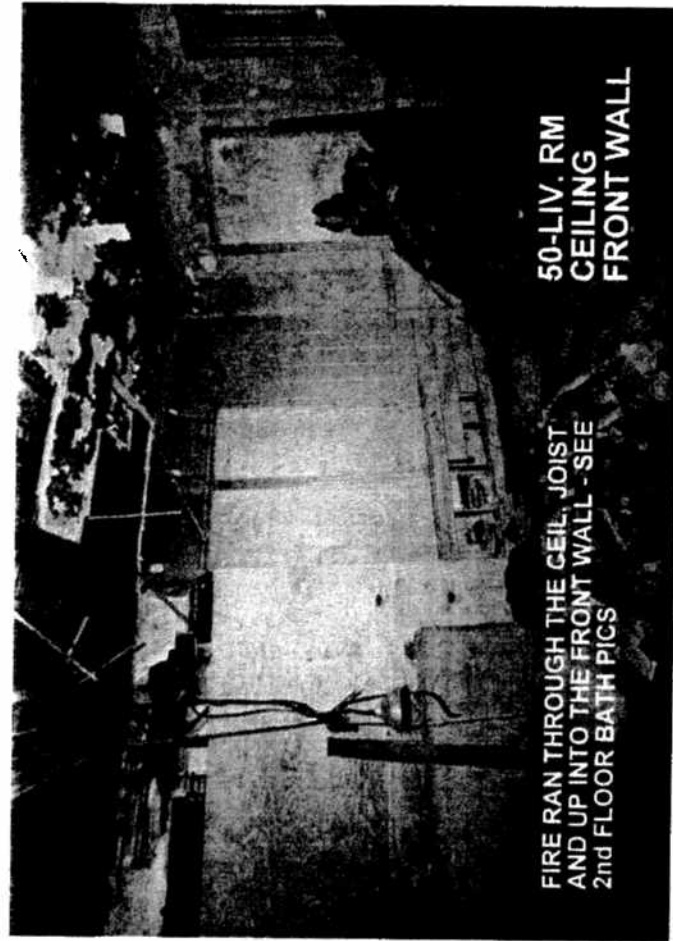
50-LIV. RM  
CEILING  
FRONT WALL

FIRE RAN THROUGH THE CEIL. JOIST  
AND UP INTO THE FRONT WALL - SEE  
2nd FLOOR BATH PICS

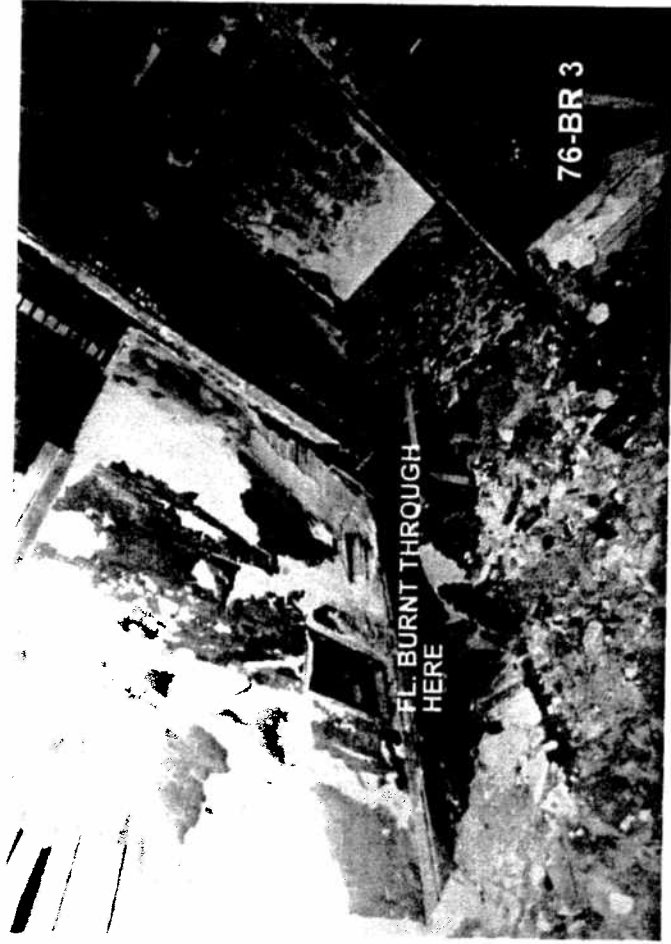
76-BR 3

FL. BURNT THROUGH  
HERE

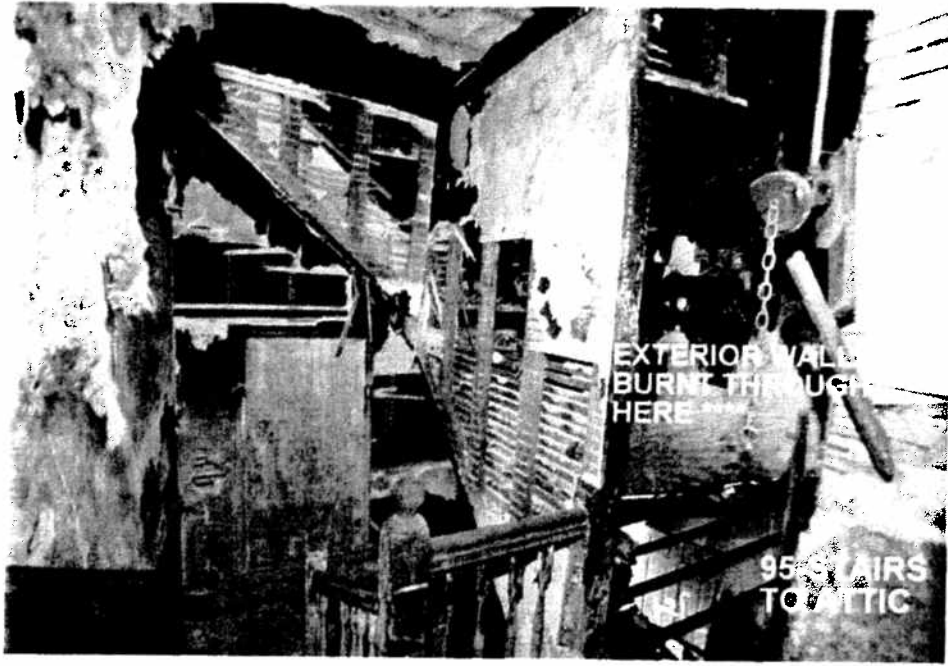
95 STAIRS  
TO ATTIC

EXTERIOR WALL  
BURNT THROUGH  
HERE

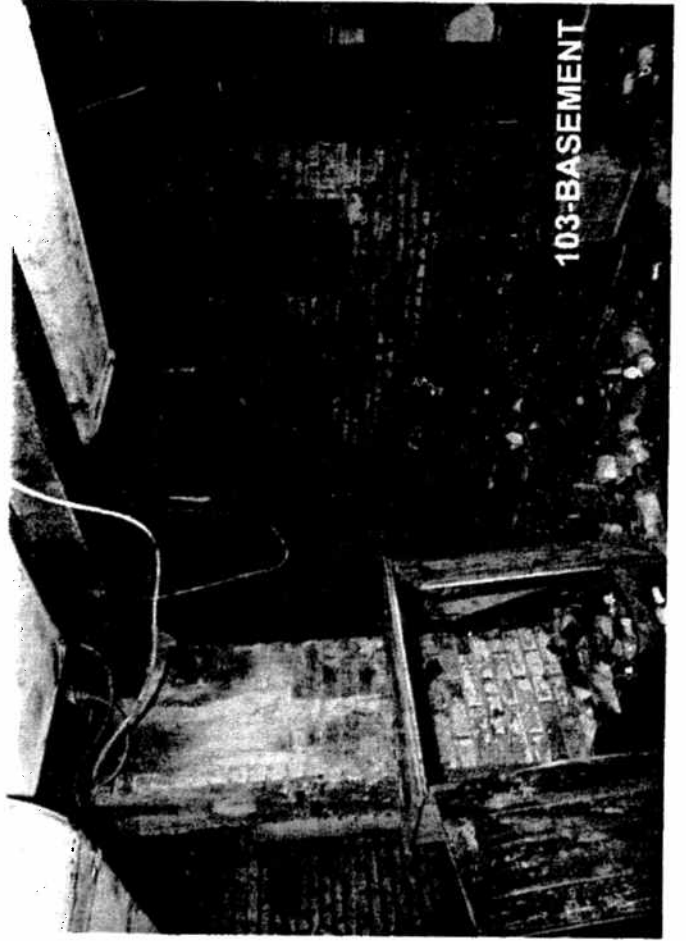
103-BASEMENT

BASEMENT  
FRAMING NOT  
TO CODE

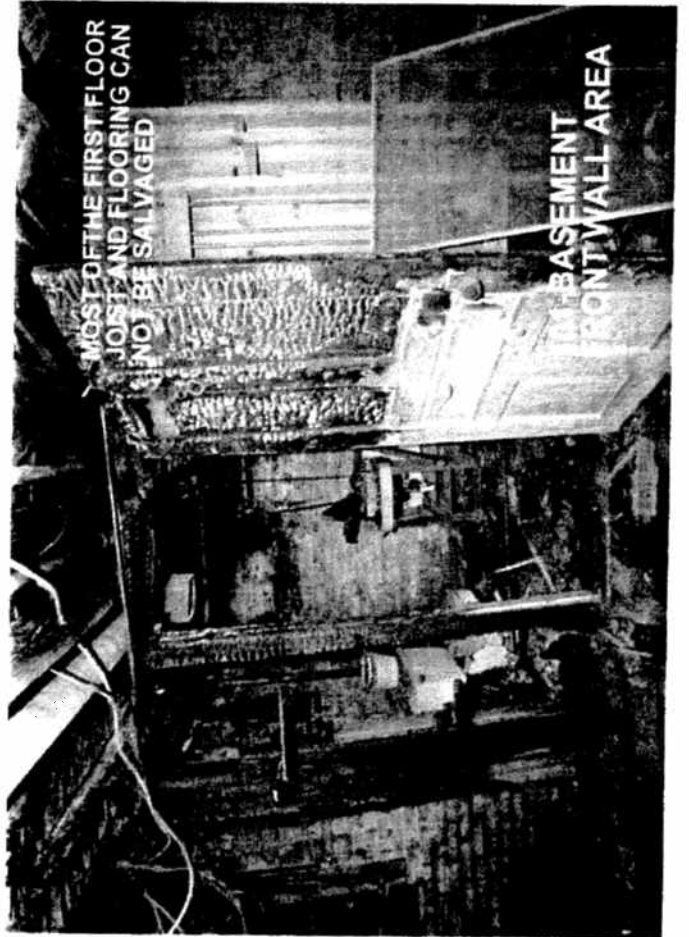
101-BASEMENT  
FRONT WALL AREA

MOST OF THE FIRST FLOOR  
JOIST AND FLOORING CAN  
BE SALVAGED
