## NB-1: Environmental Stewardship Stream Restoration Site Corridor 1 and Corridor 2

## NB-2C: Environmental Stewardship Stream Restoration Site Corridor 1 and Corridor 2

## NB-3: Environmental Stewardship Stream Restoration Site Corridor 1 and Corridor 2

## NB-16: Environmental Stewardship Stormwater Management Retrofit Site Corridor 1 and Corridor 2

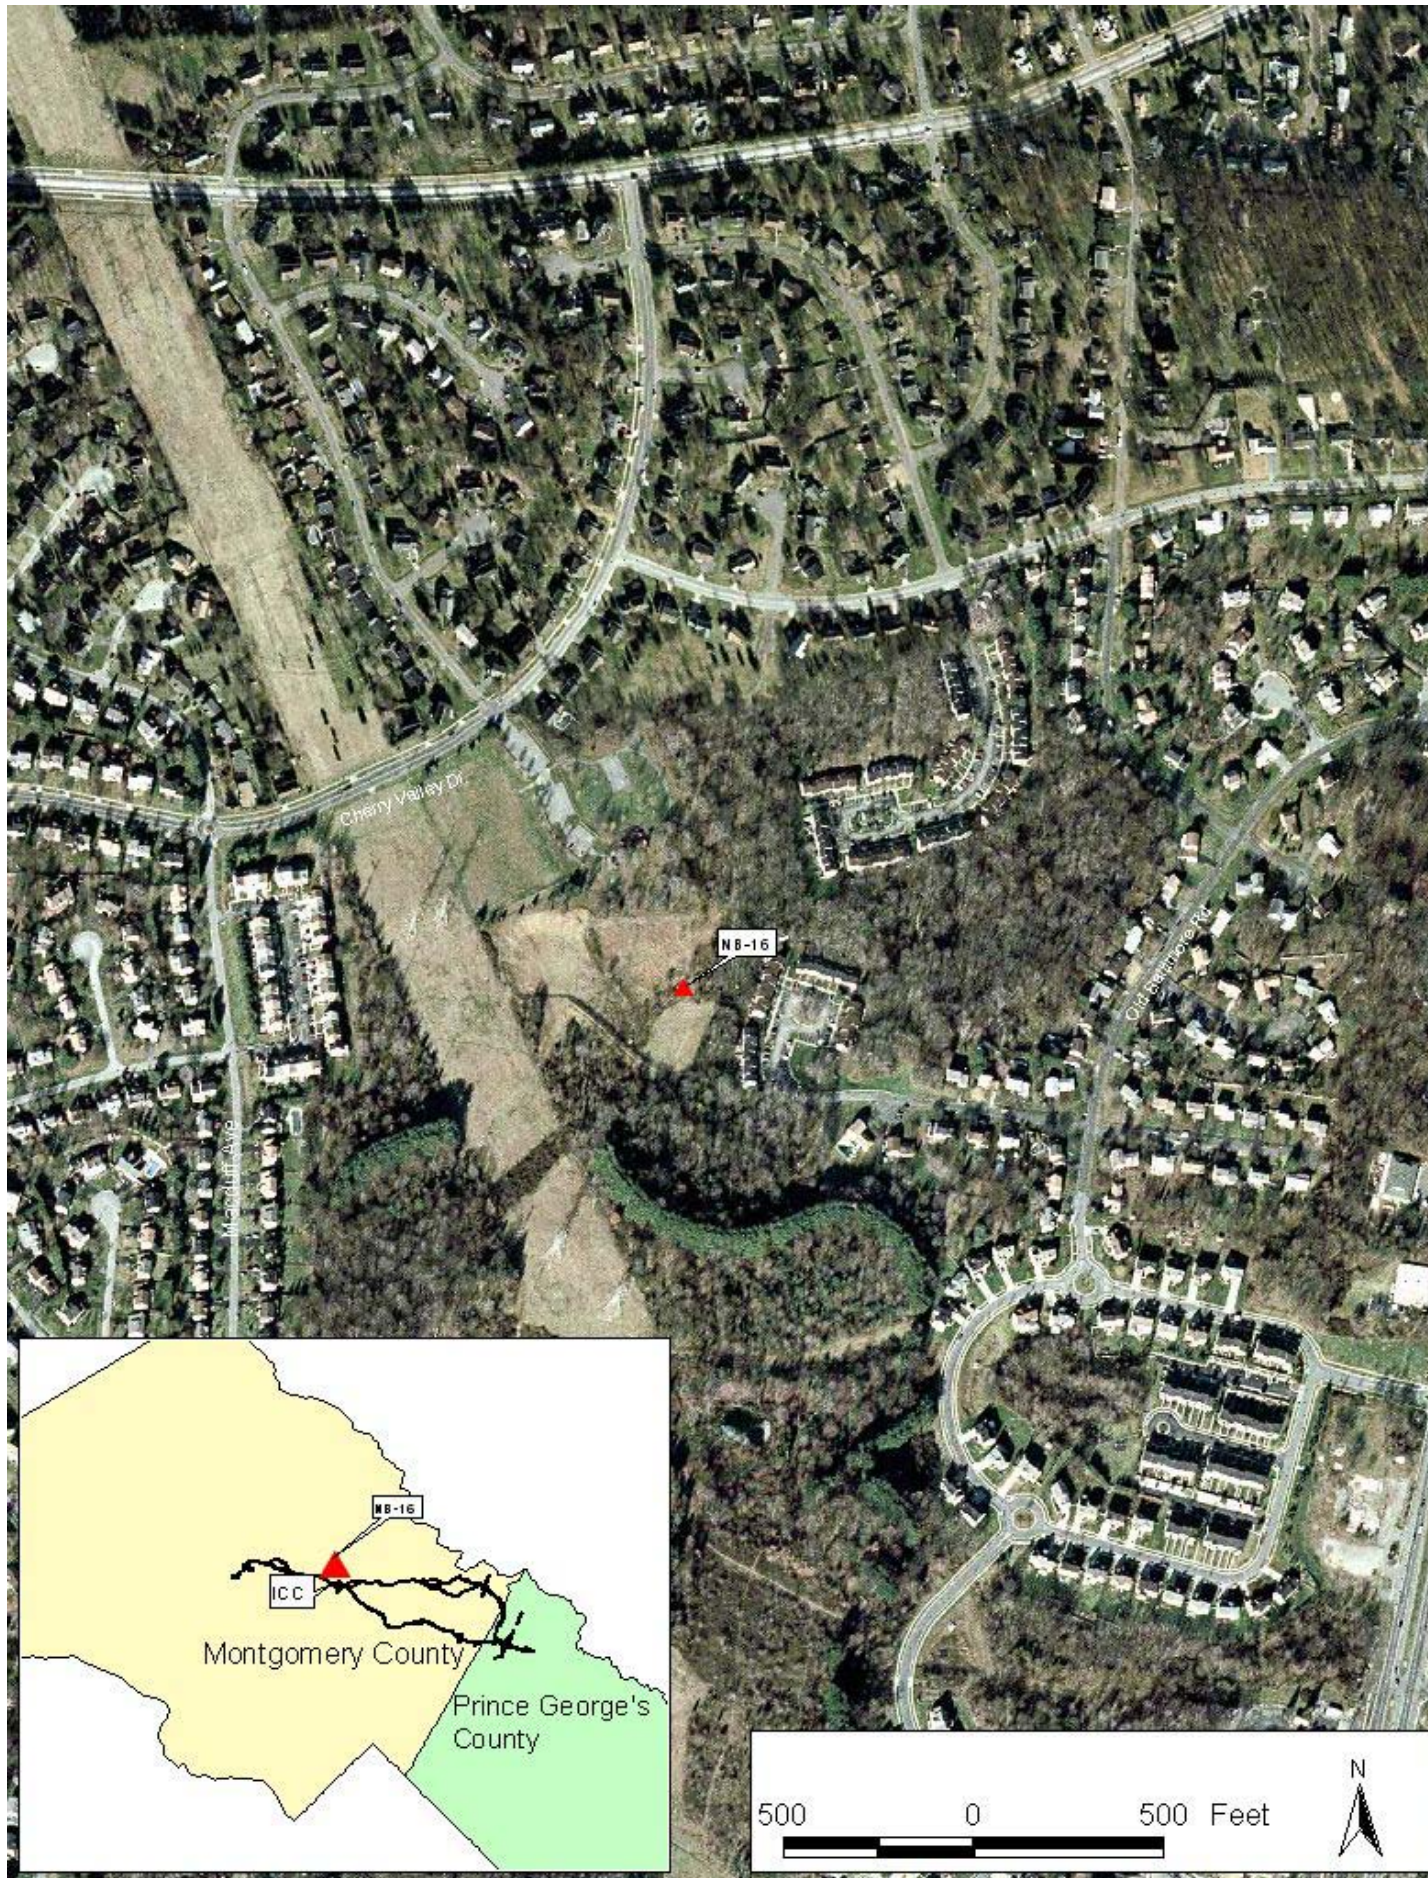
**CONCEPT PLAN**  
**Stormwater Management**  
**Retrofit Site NB-16**

- Retrofitted to provide 1 year extended detention
- Expansion of existing wetlands

Scale: 1" = 600'  
Topography: 5-foot contours

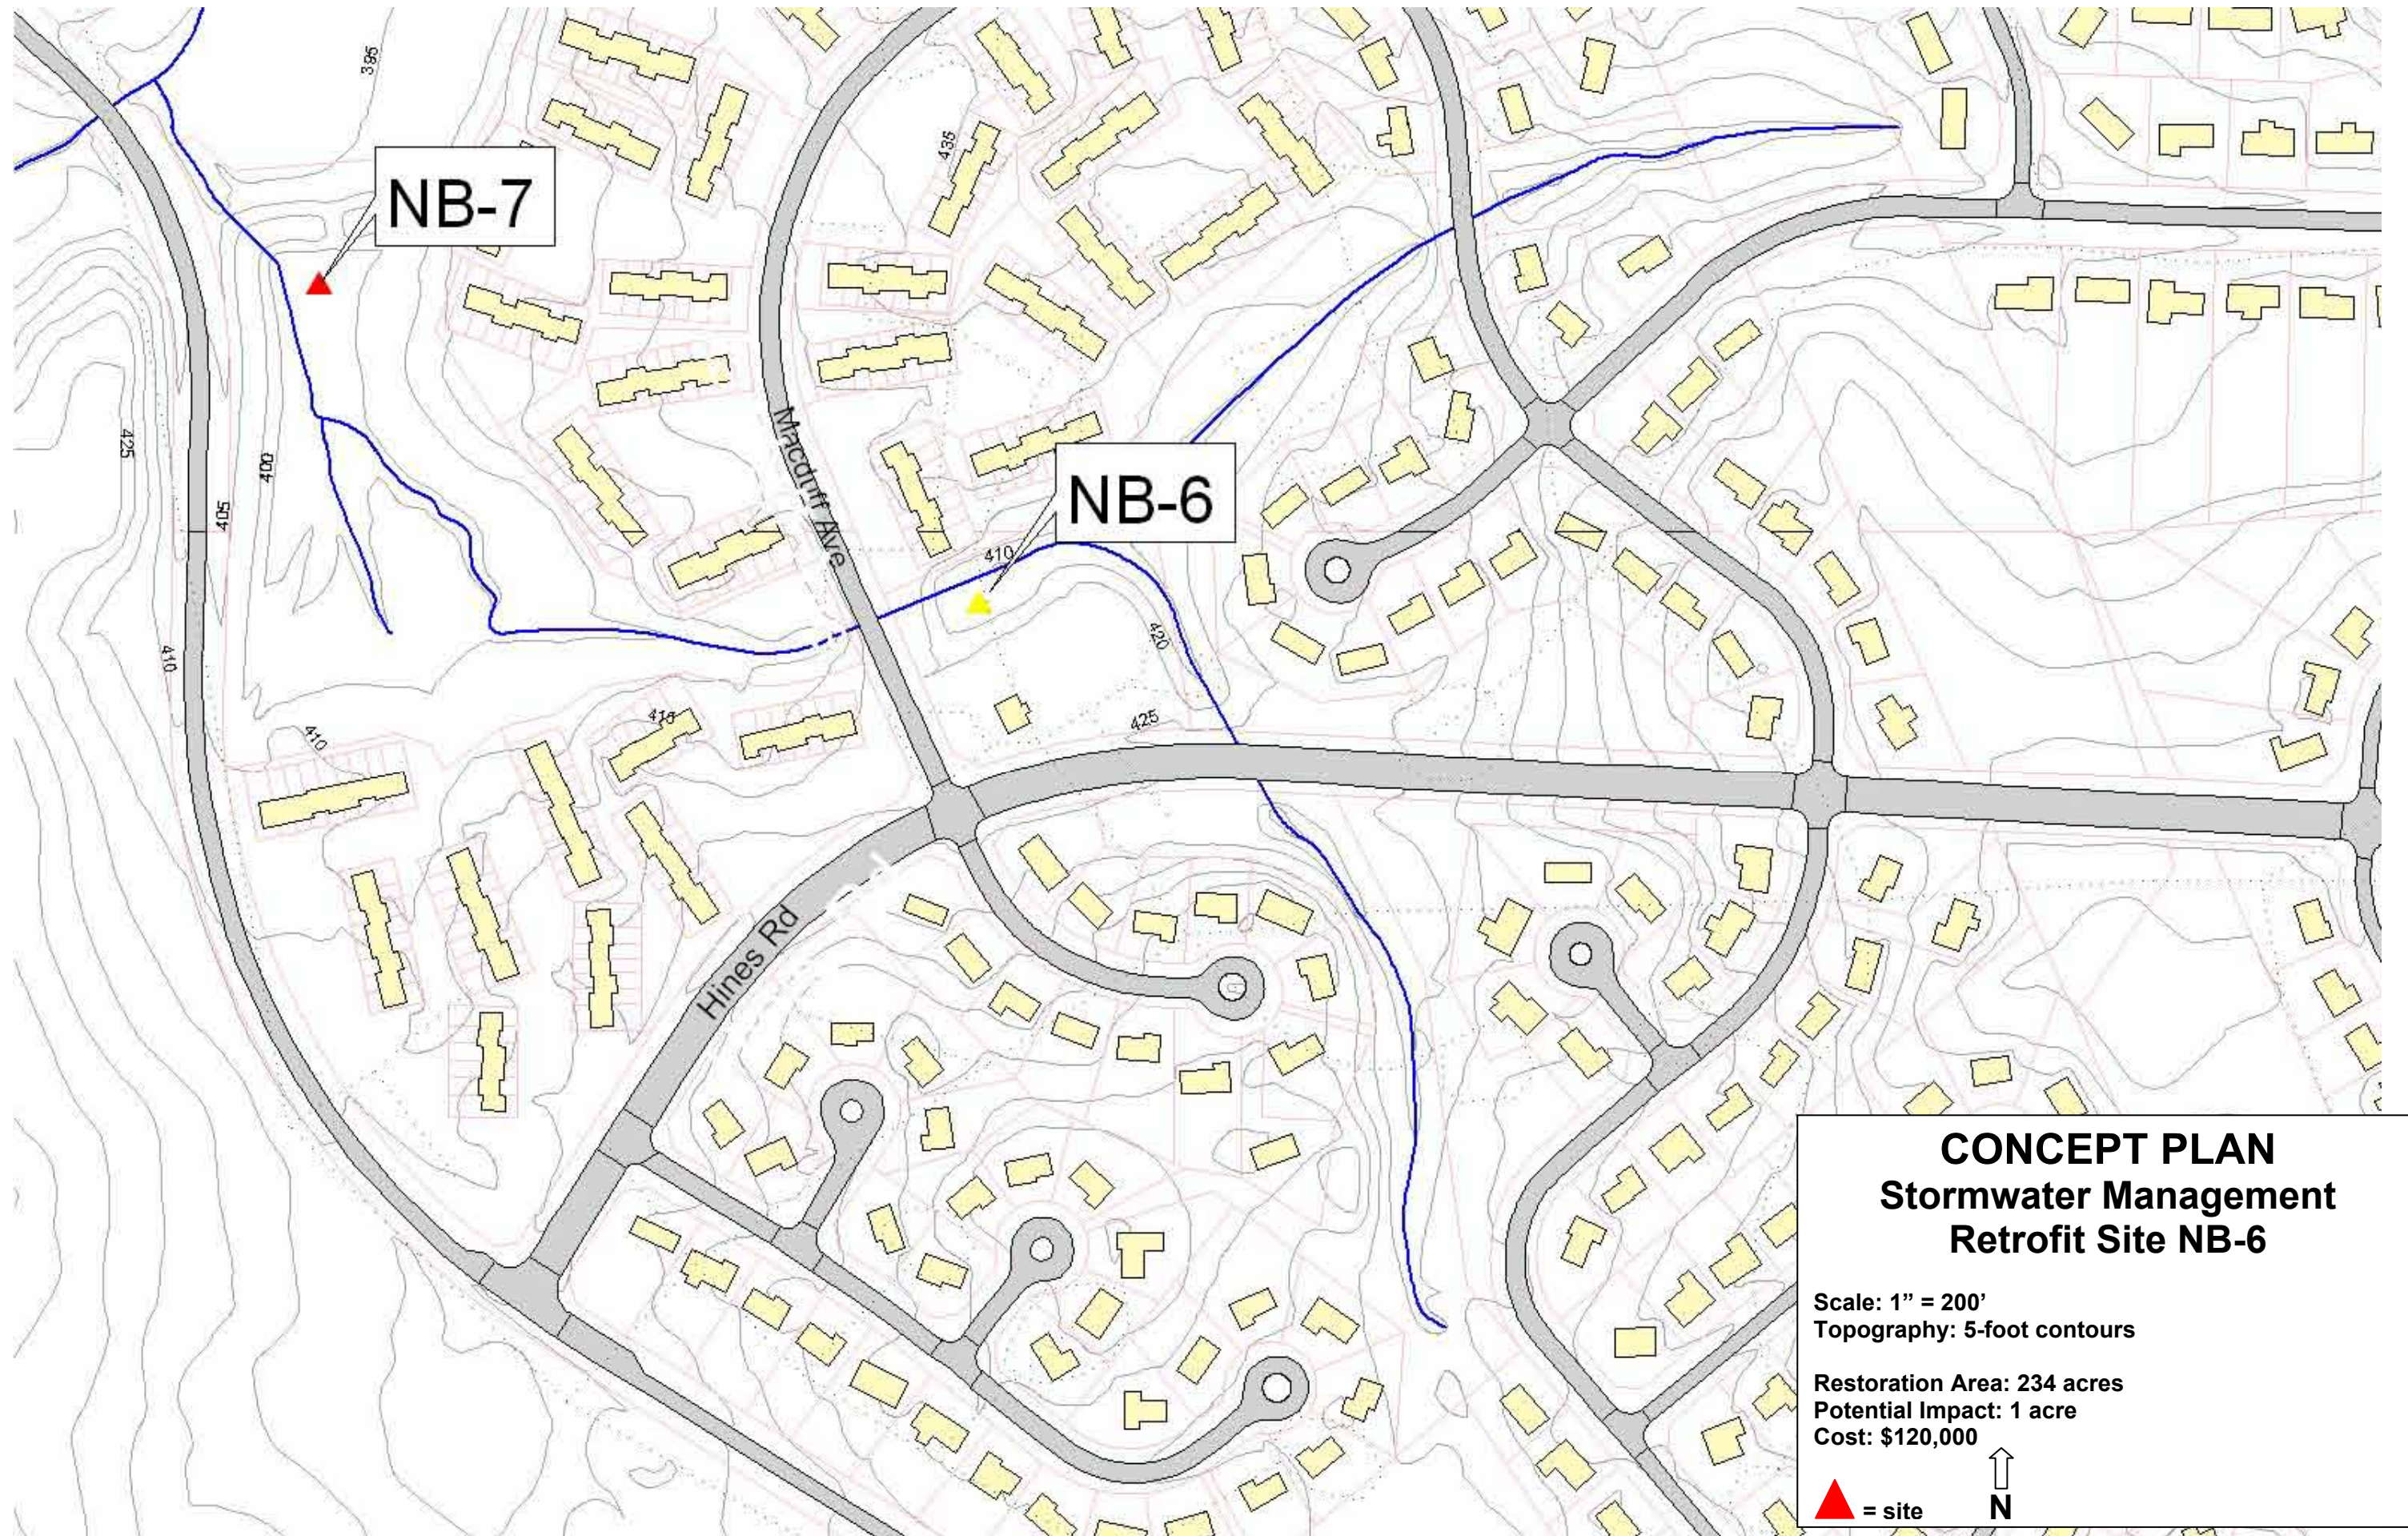
- Convert the existing dry pond to provide extended detention with micropools.
