Appendix – Q
Environmental Stewardship Design Plates

**PB-133: Environmental Stewardship
Special Protection Area Best Management Practice Site
Corridor 1 and Corridor 2**

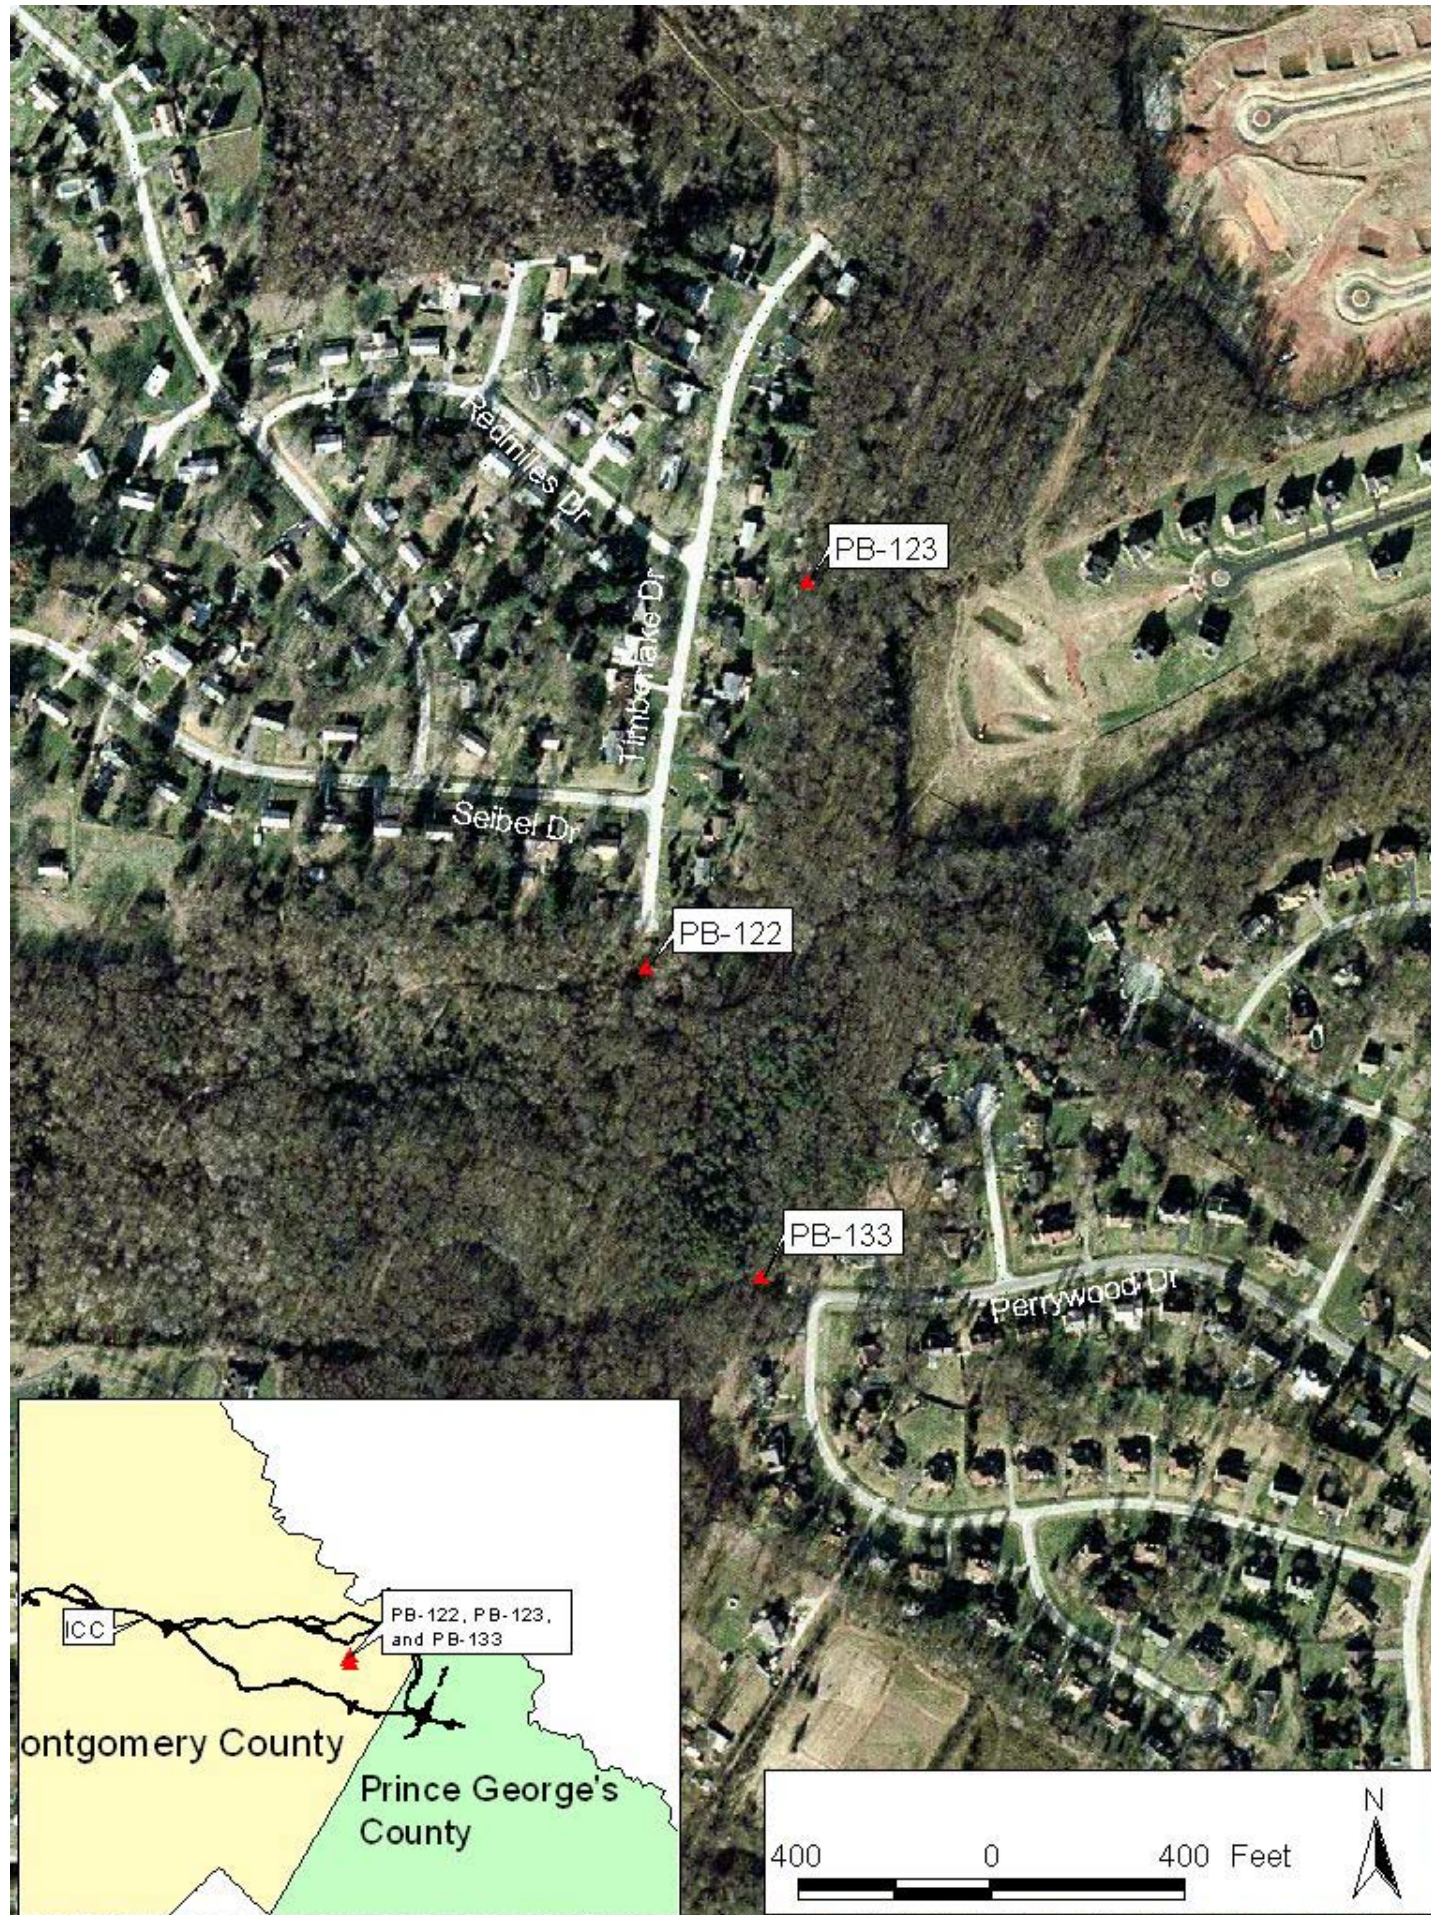
The concept for PB-133 consists of reconstructing existing grassy swales to provide bioretention areas.

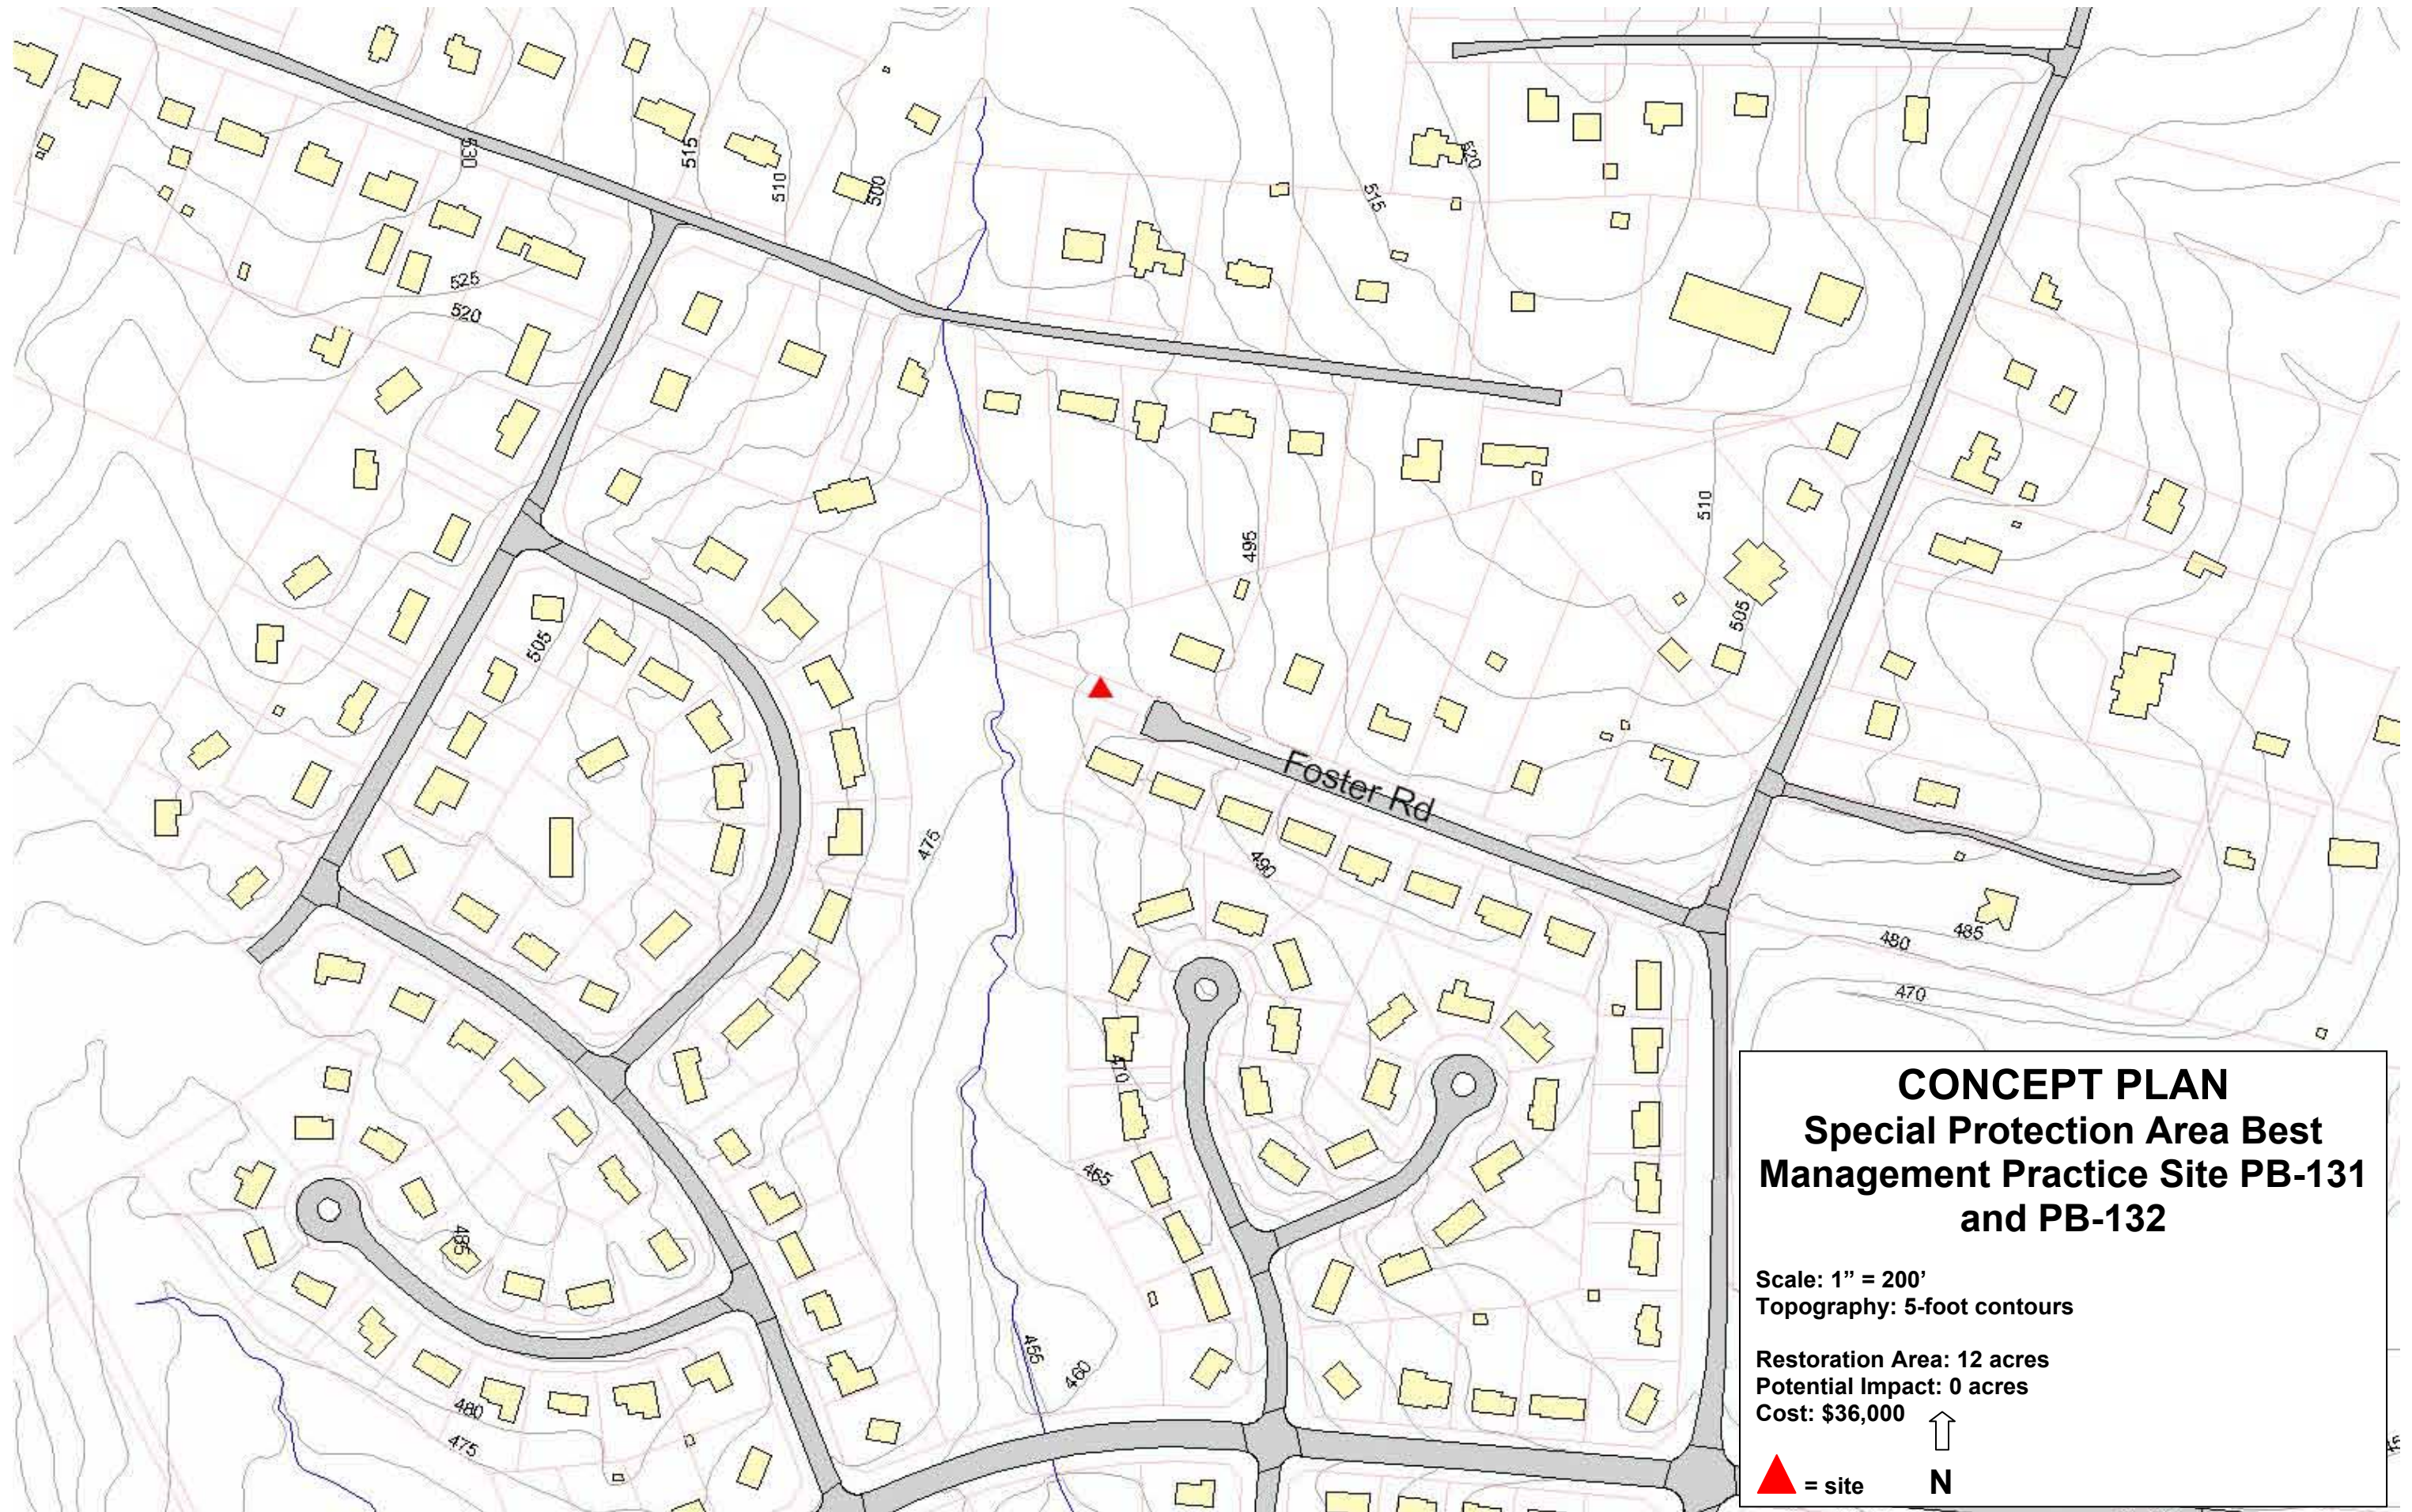
It is anticipated that the construction of PB-131 and PB-132 would not impact streams. Restoration of PB-131 and PB-132 would cost approximately \$36,000.

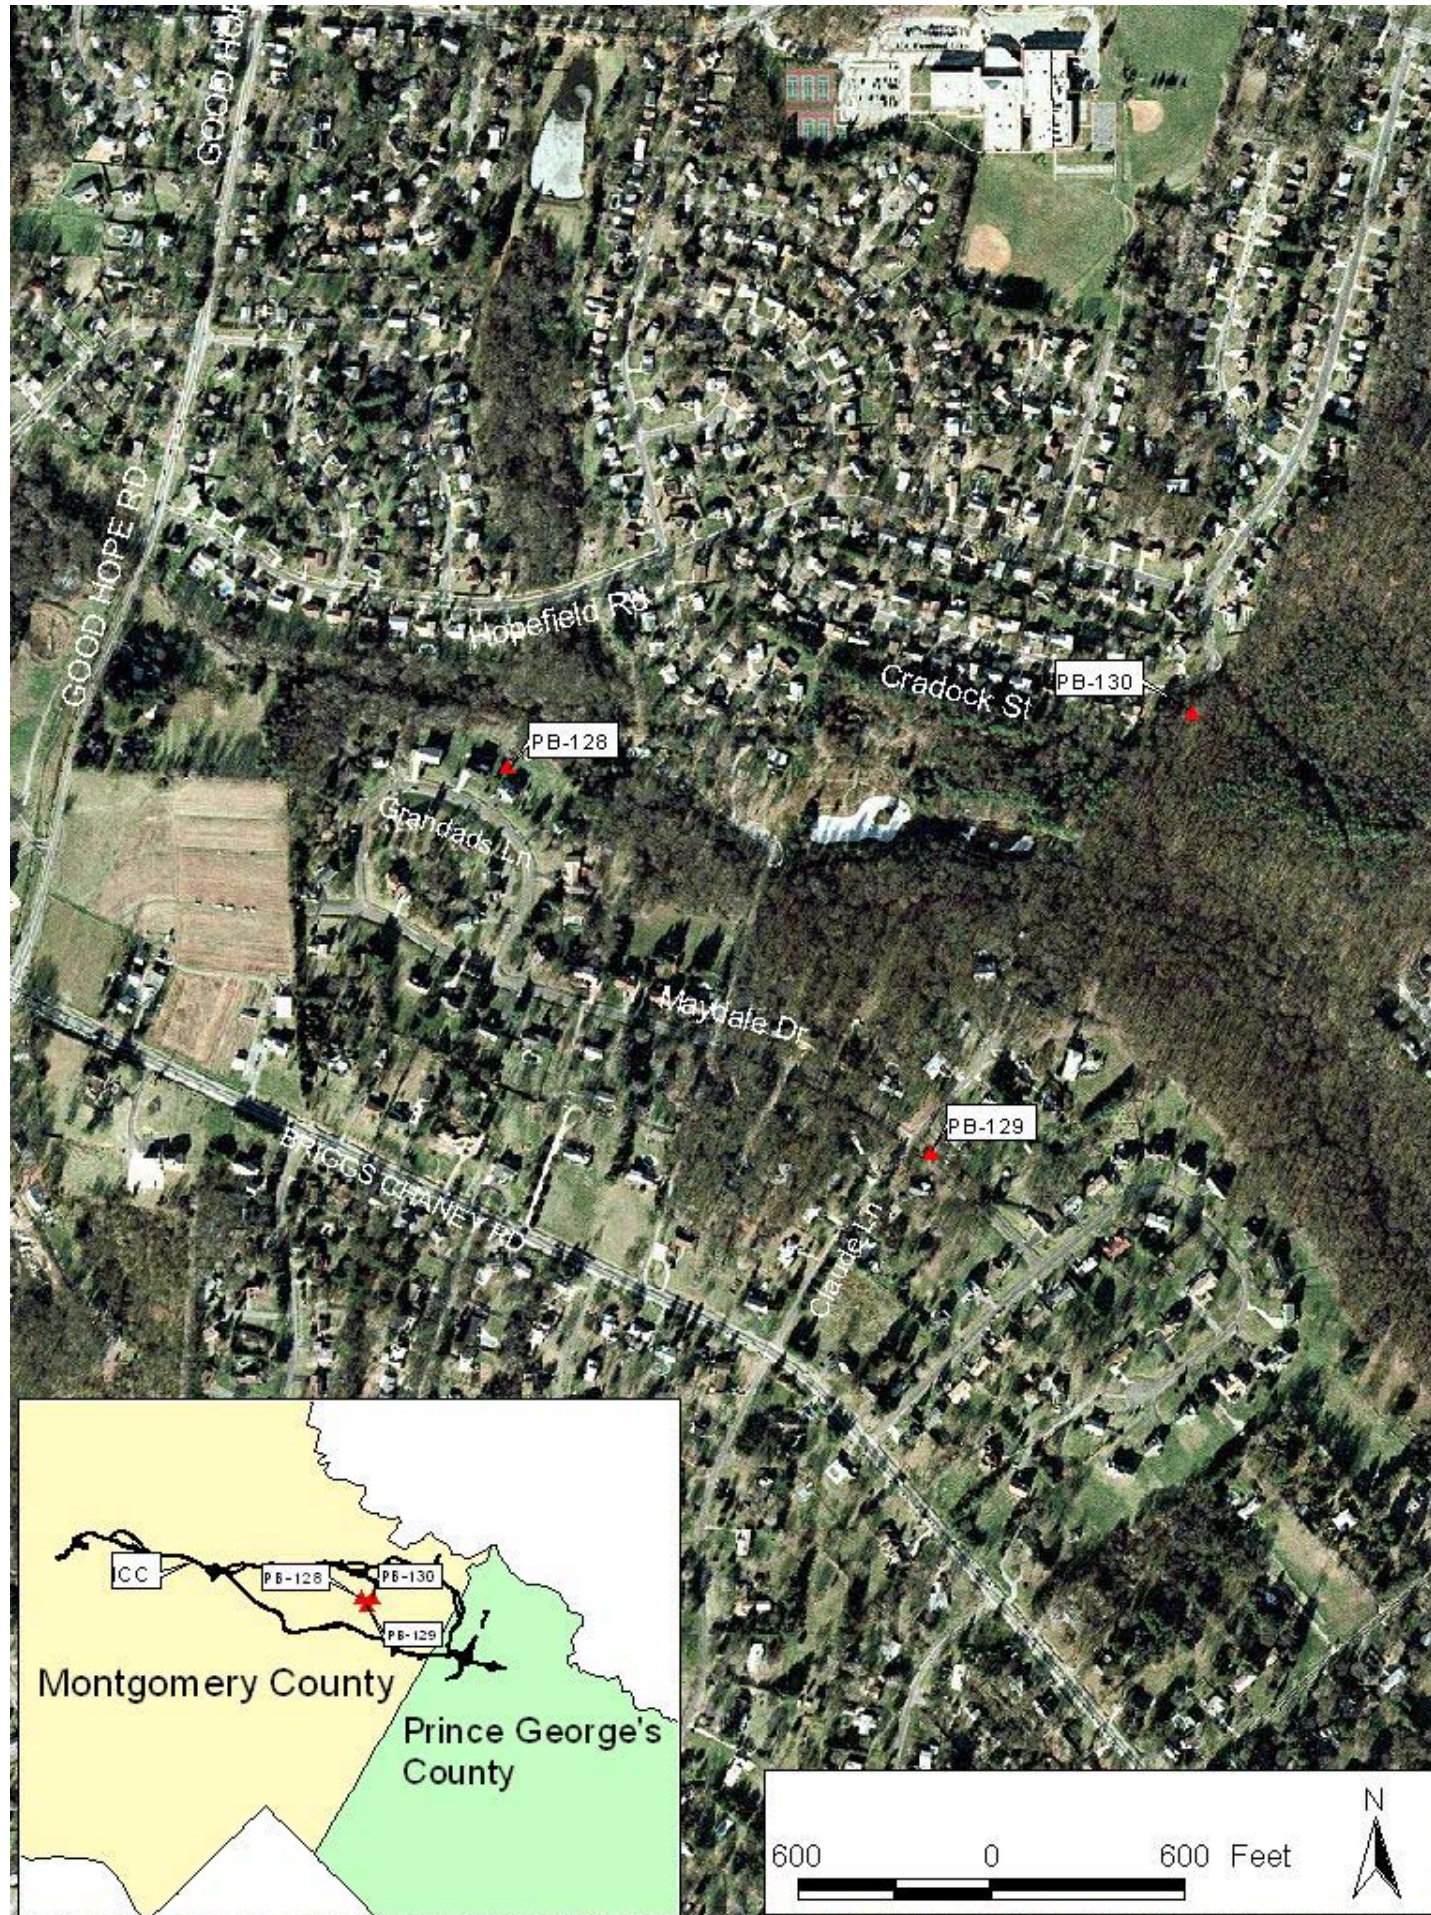
The project concept would be to construct an inline bioretention area below the existing outlet structure.

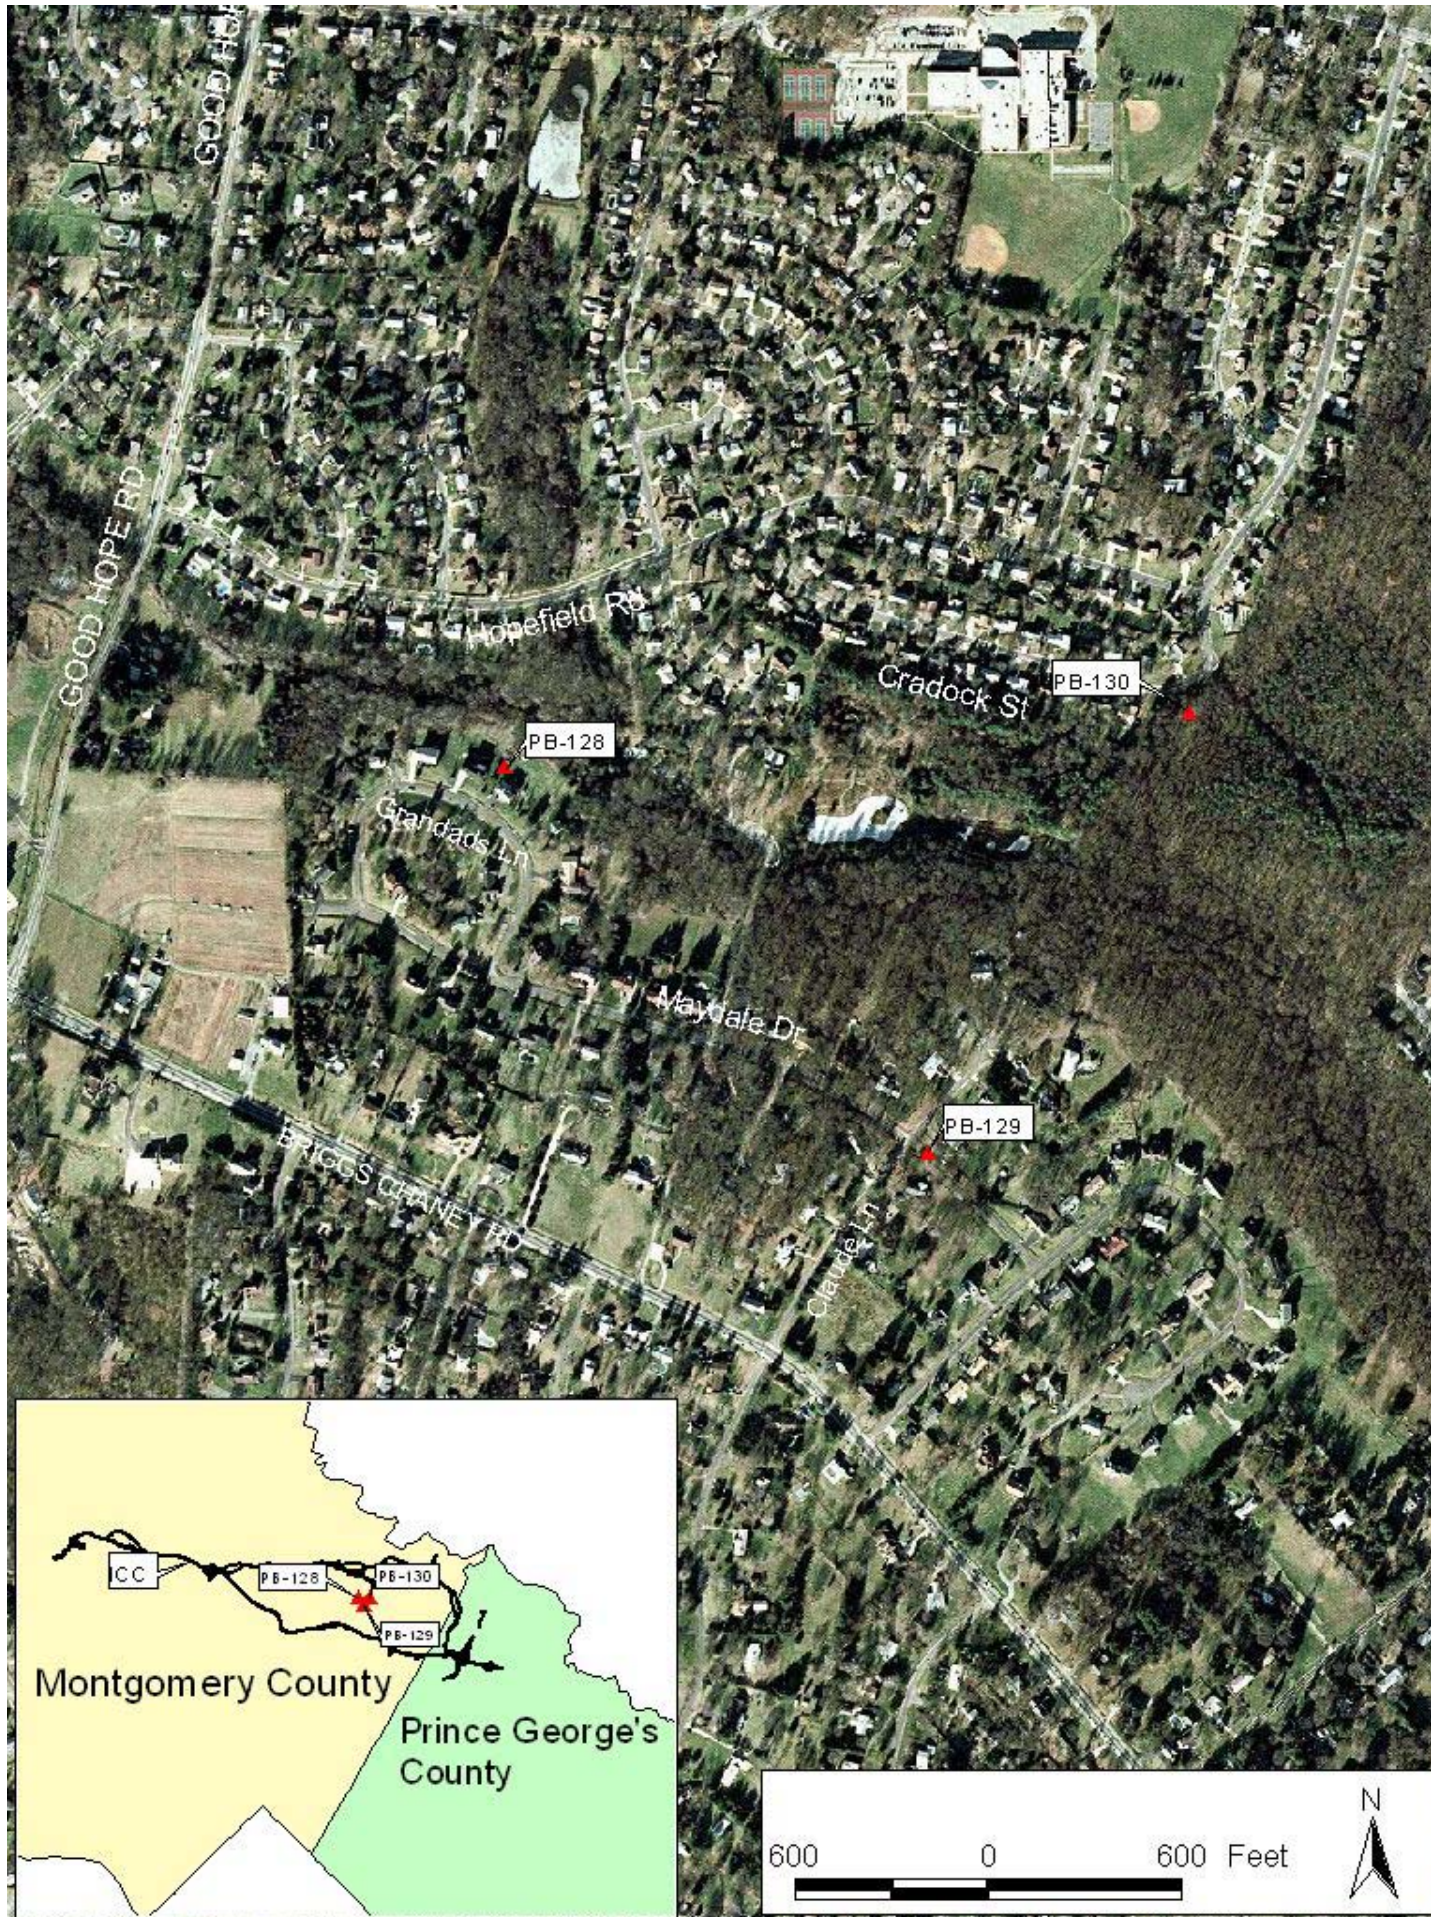
The concept for PB-128 and PB-129 consists of reconstructing existing grassy swales to provide bioretention areas.

It is anticipated that the construction of PB-128 and PB-129 would not impact streams. Restoration of PB-128 and PB-129 would cost approximately \$64,800.

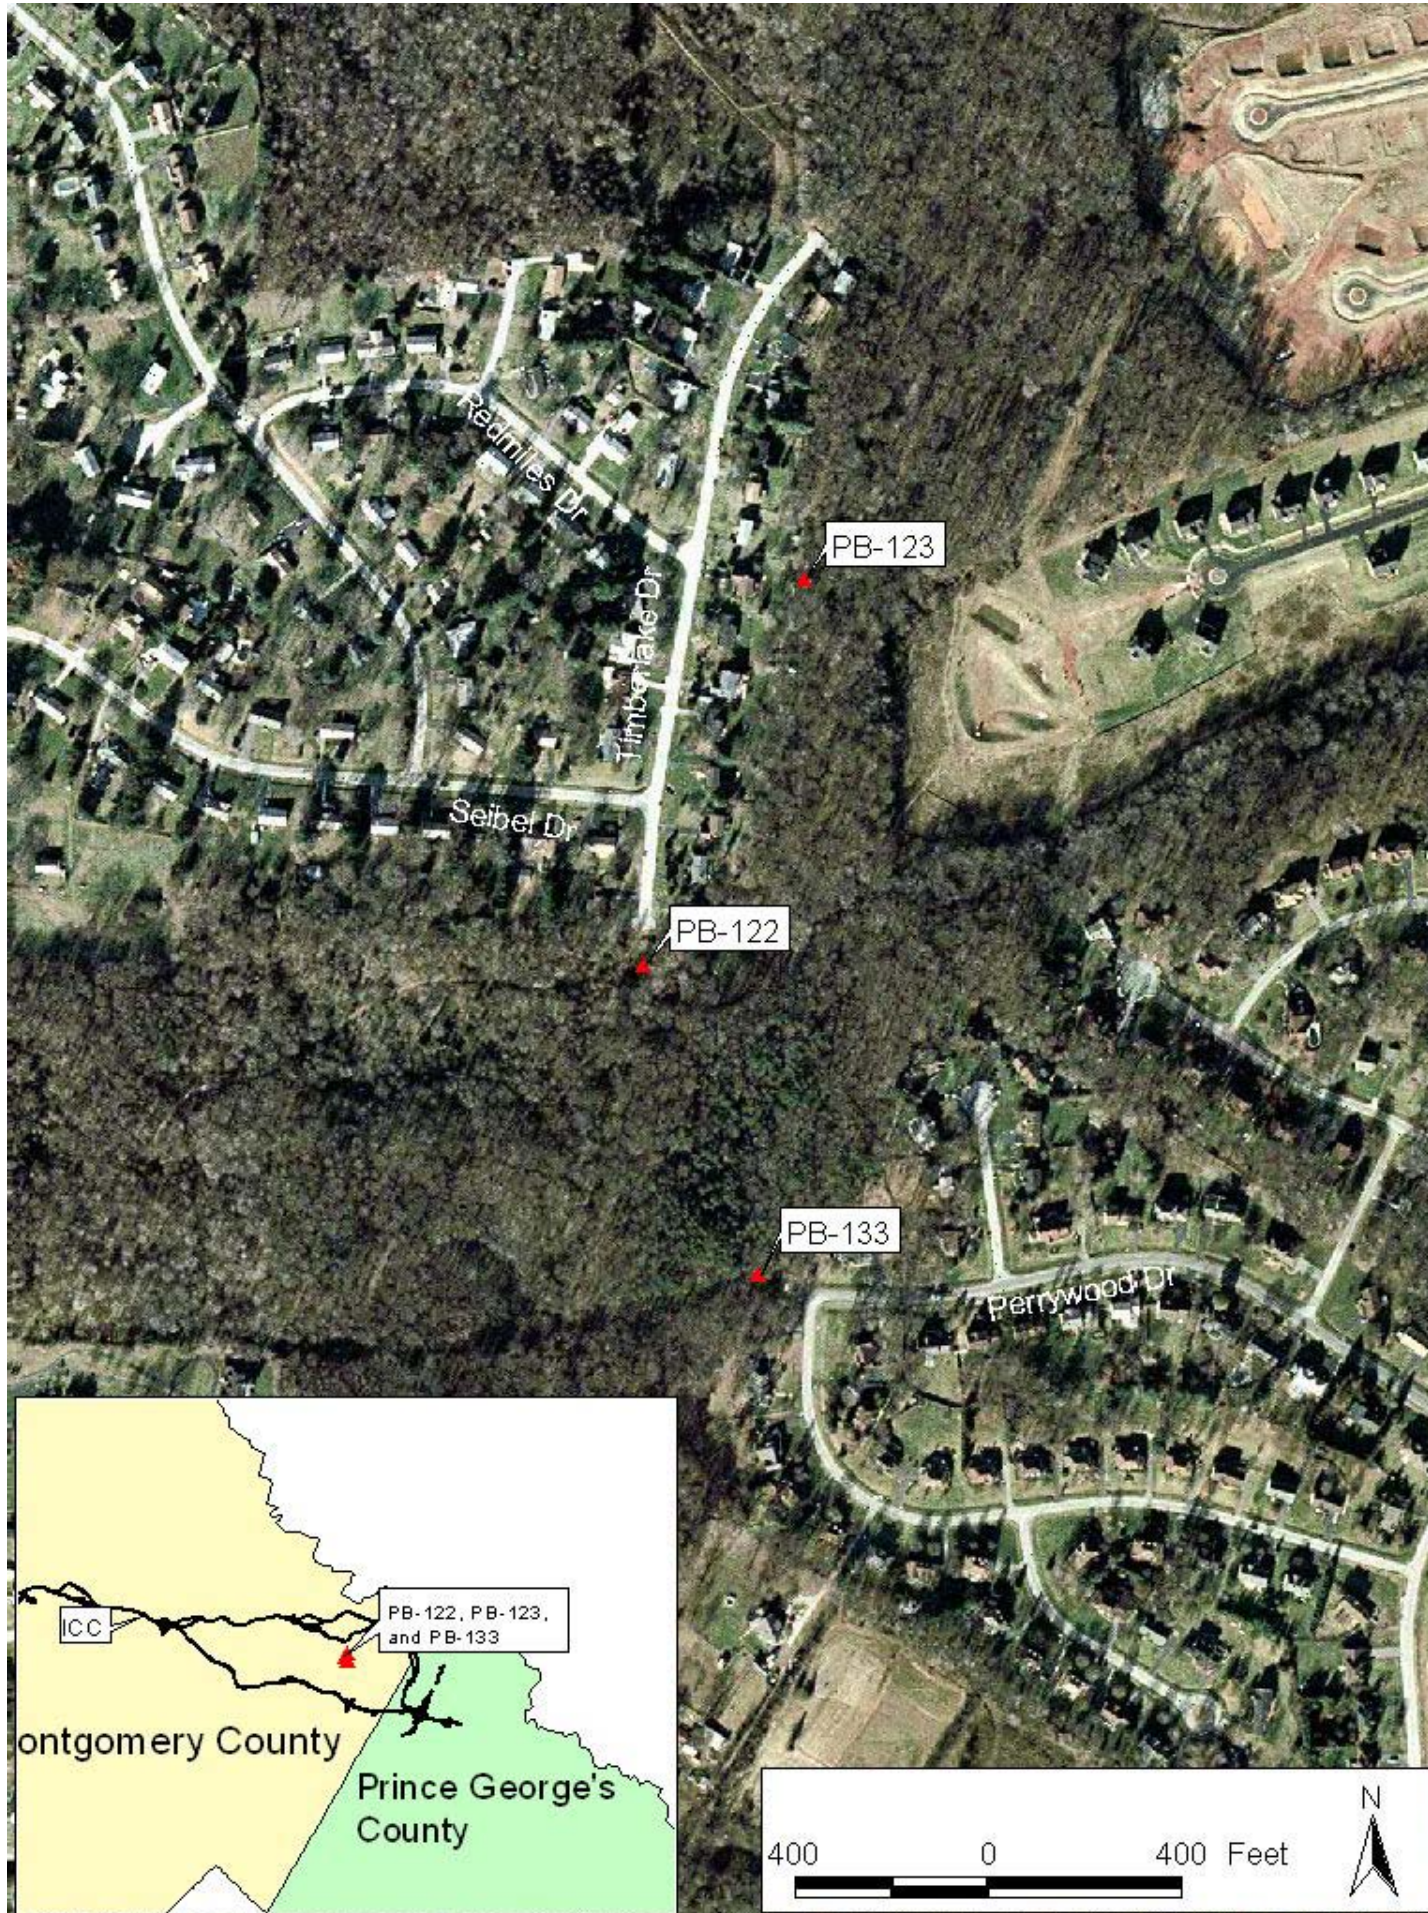
The concept for PB-122 and PB-123 consists of reconstructing existing grassy swales to provide bioretention areas.

It is anticipated that the construction of PB-122 and PB-123 would not impact streams. Restoration of PB-122 and PB-123 would cost approximately \$100,000.

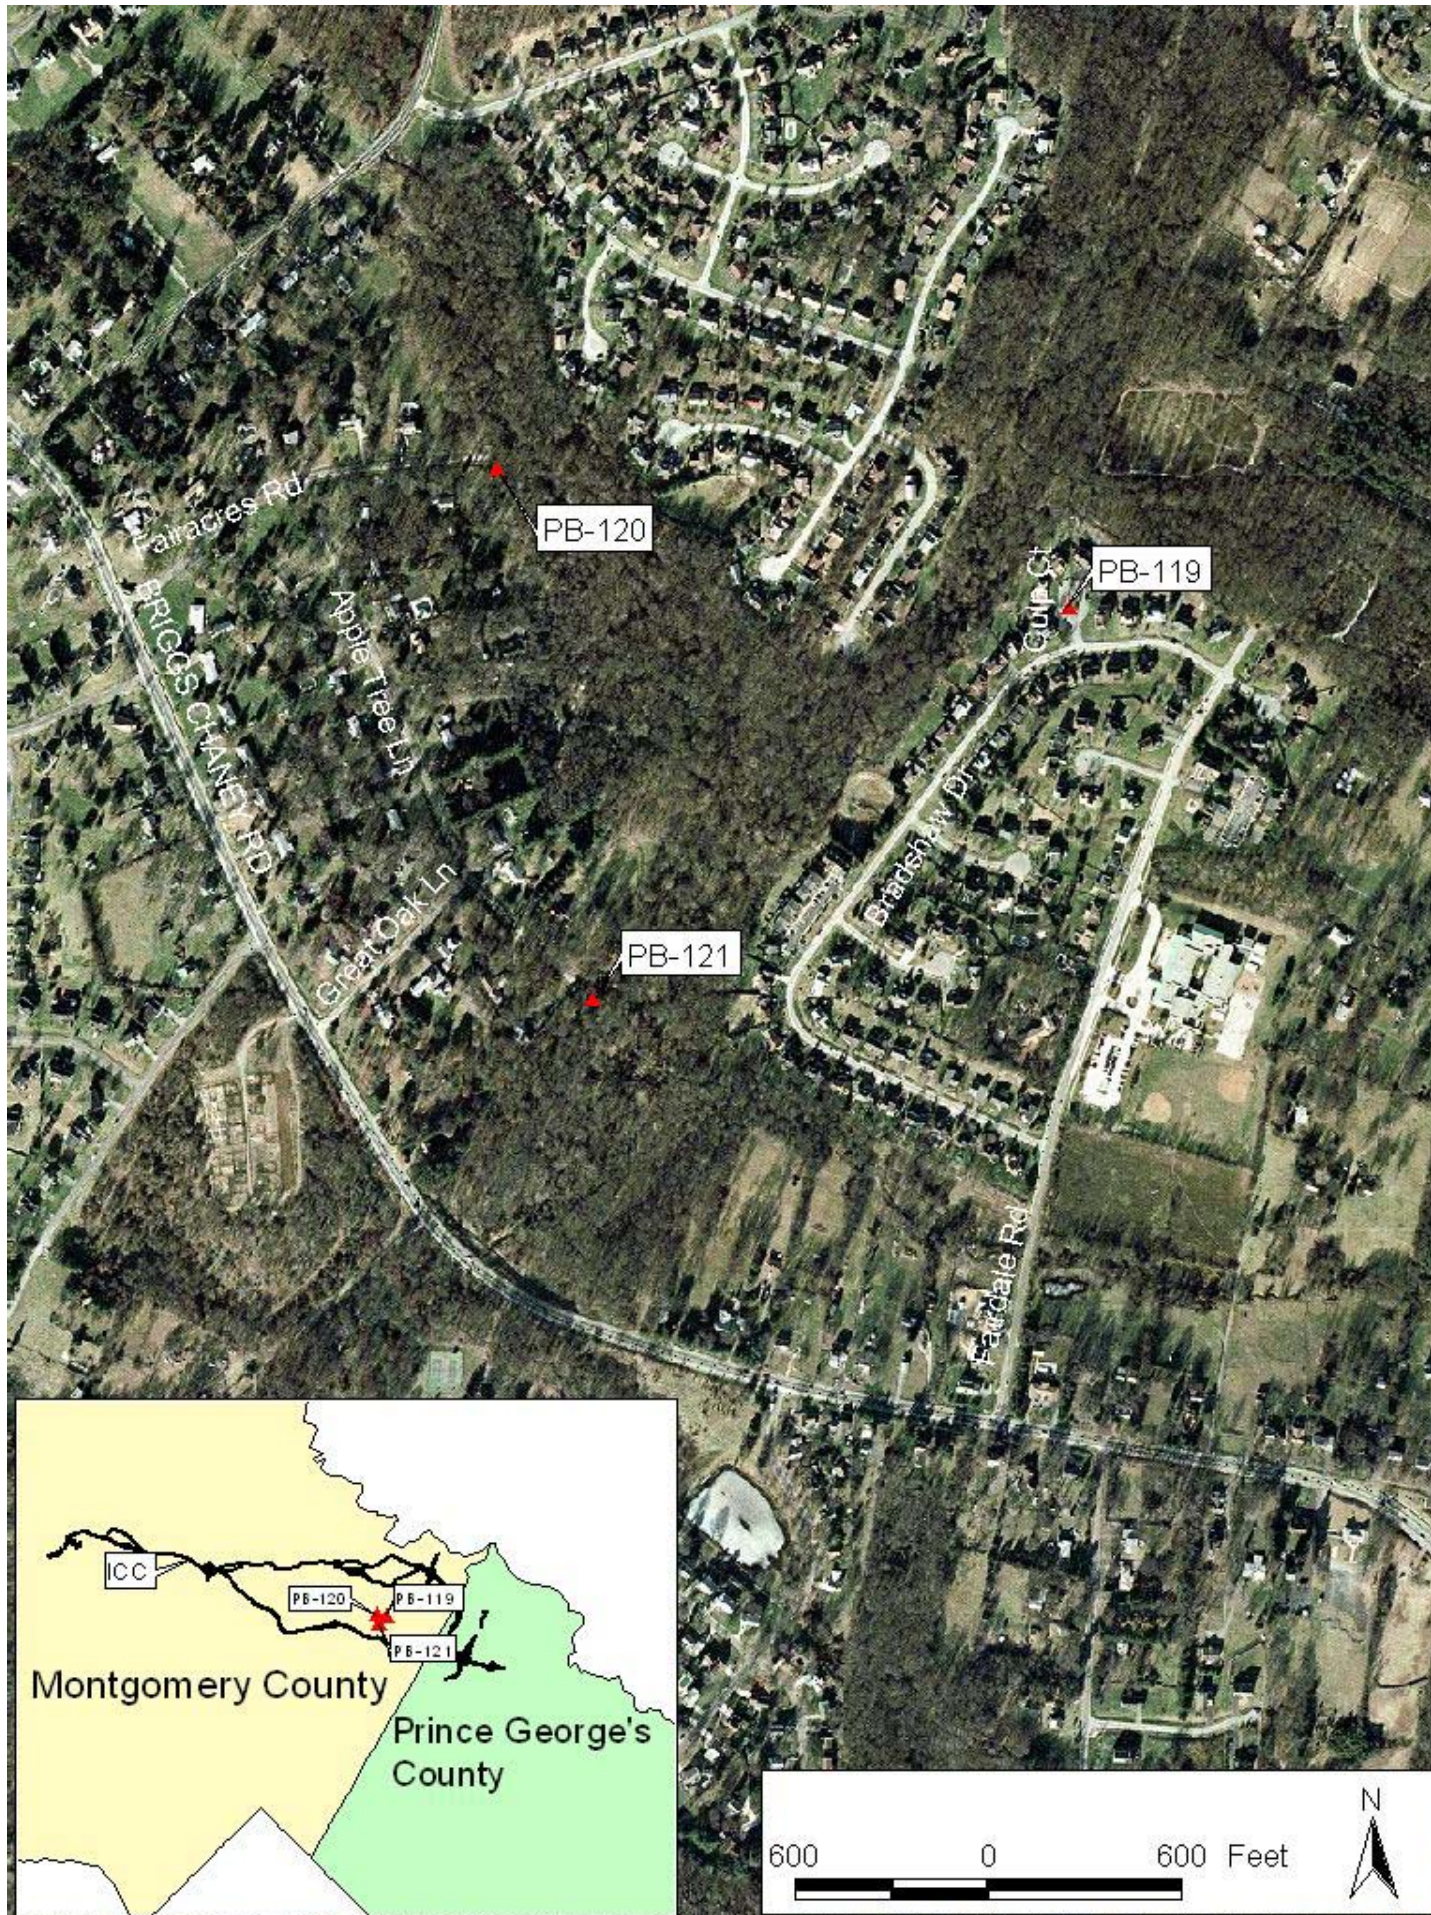
CONCEPT PLAN
Special Protection Area Best Management Practice Site PB-120 and PB-121

The existing street gradient is fairly steep; therefore, the best opportunity for BMP treatment may be an under-street/bioretenion storage combination at the end of Fairacres Road.

Scale: 1" = 200'
Topography: 5-foot contours

Restoration Area: 14.4 acres
Potential Impact: 0 acres
Cost: \$43,200

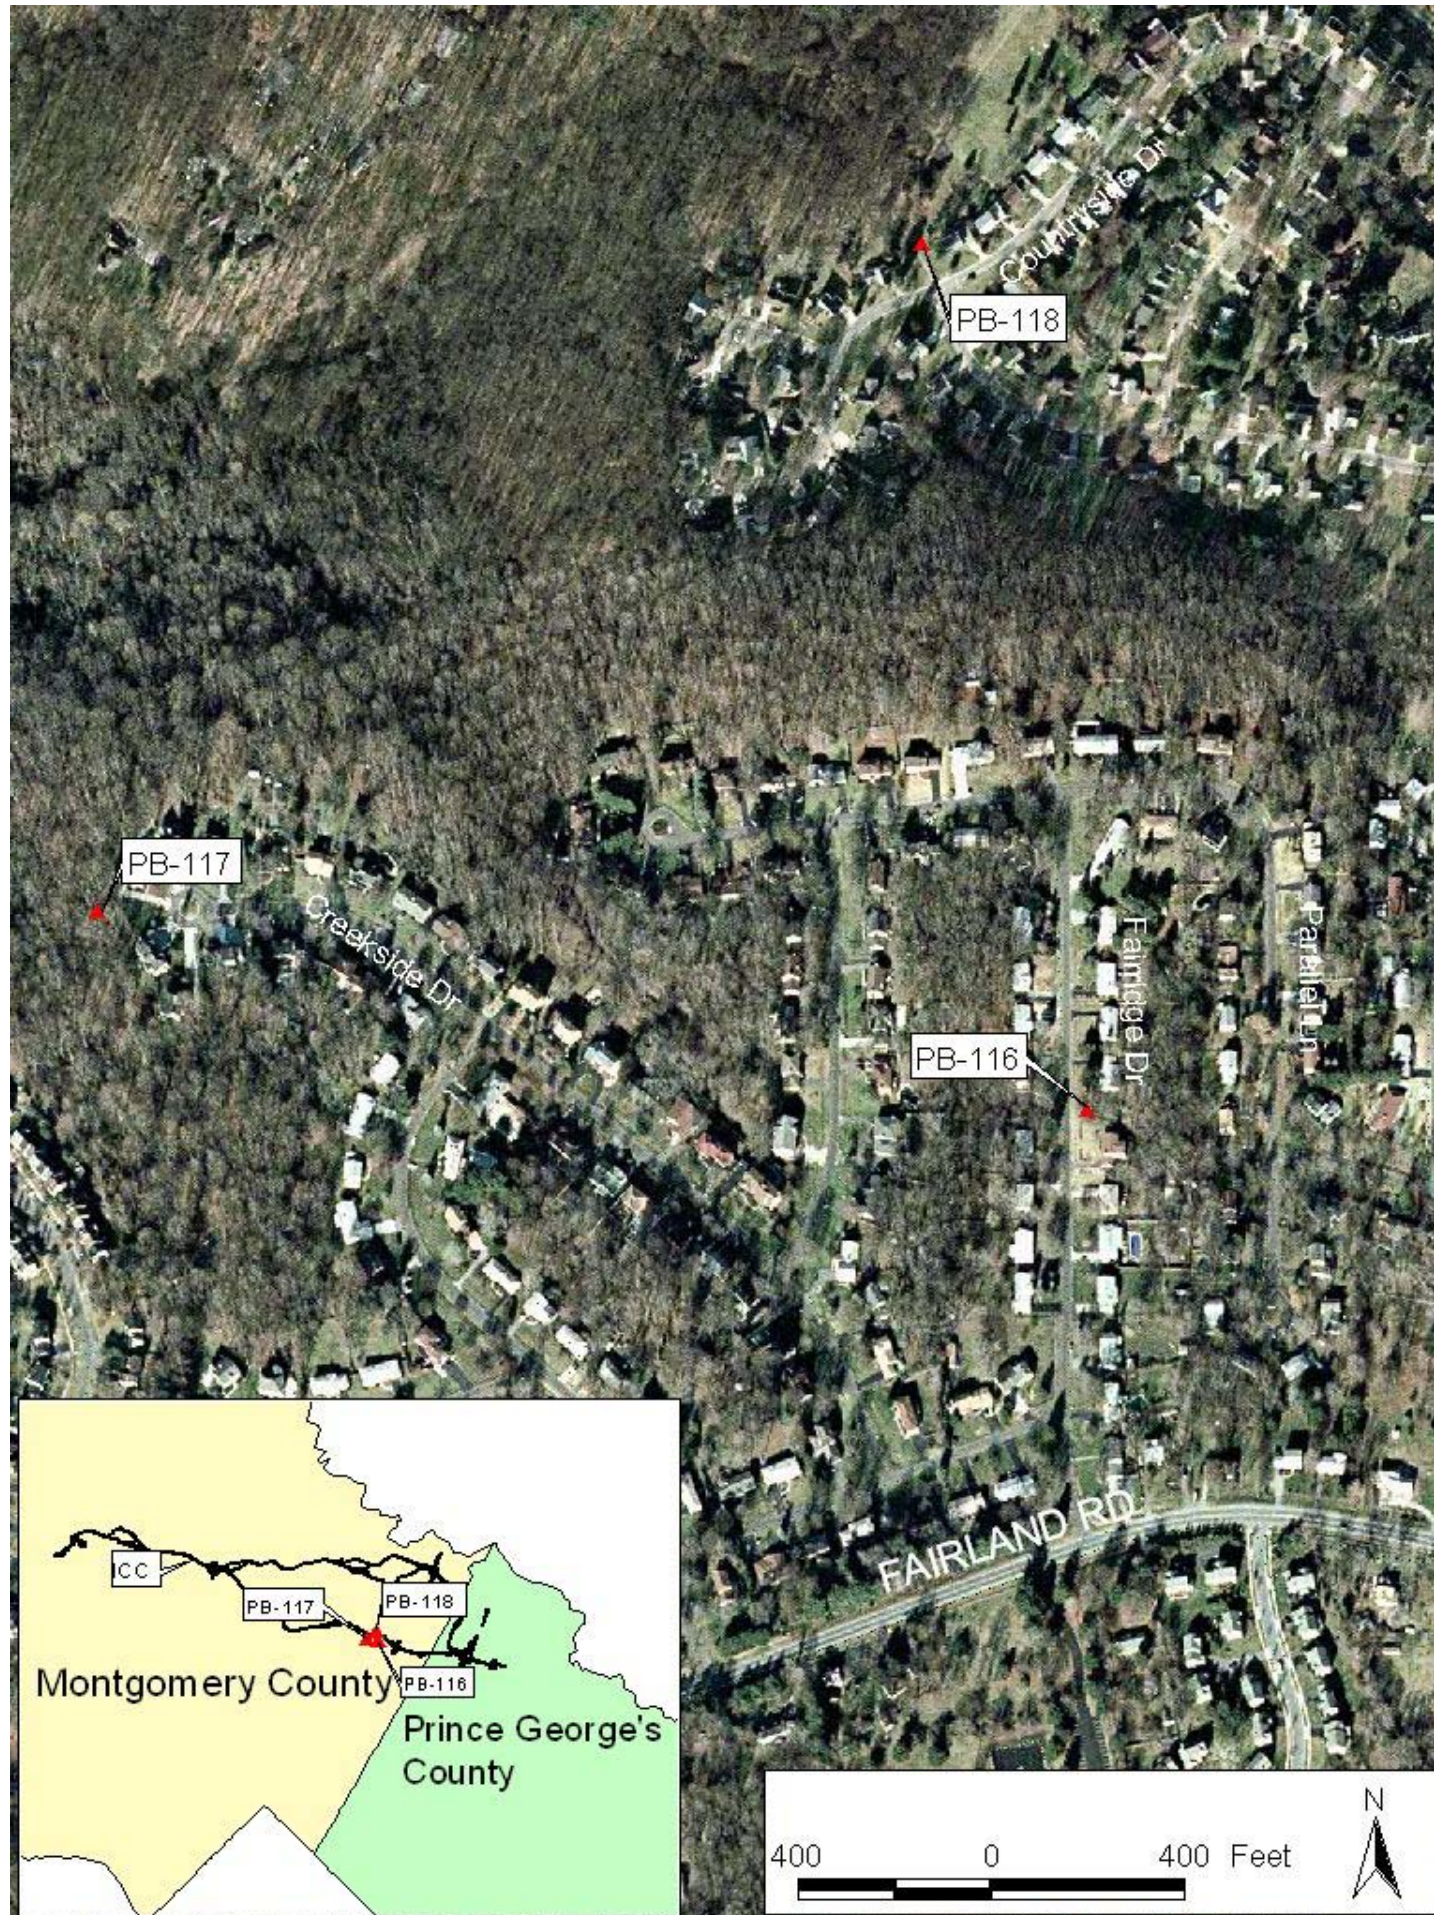
The project concept is to construct a bioretention area between Ness Lane and the existing outfall and extending the treatment area into the park to accommodate the roughly 106,000 ft³ of volume to treat the first flush.
