Appendix – Q
Environmental Stewardship Design Plates

**PB-133: Environmental Stewardship
Special Protection Area Best Management Practice Site
Corridor 1 and Corridor 2**

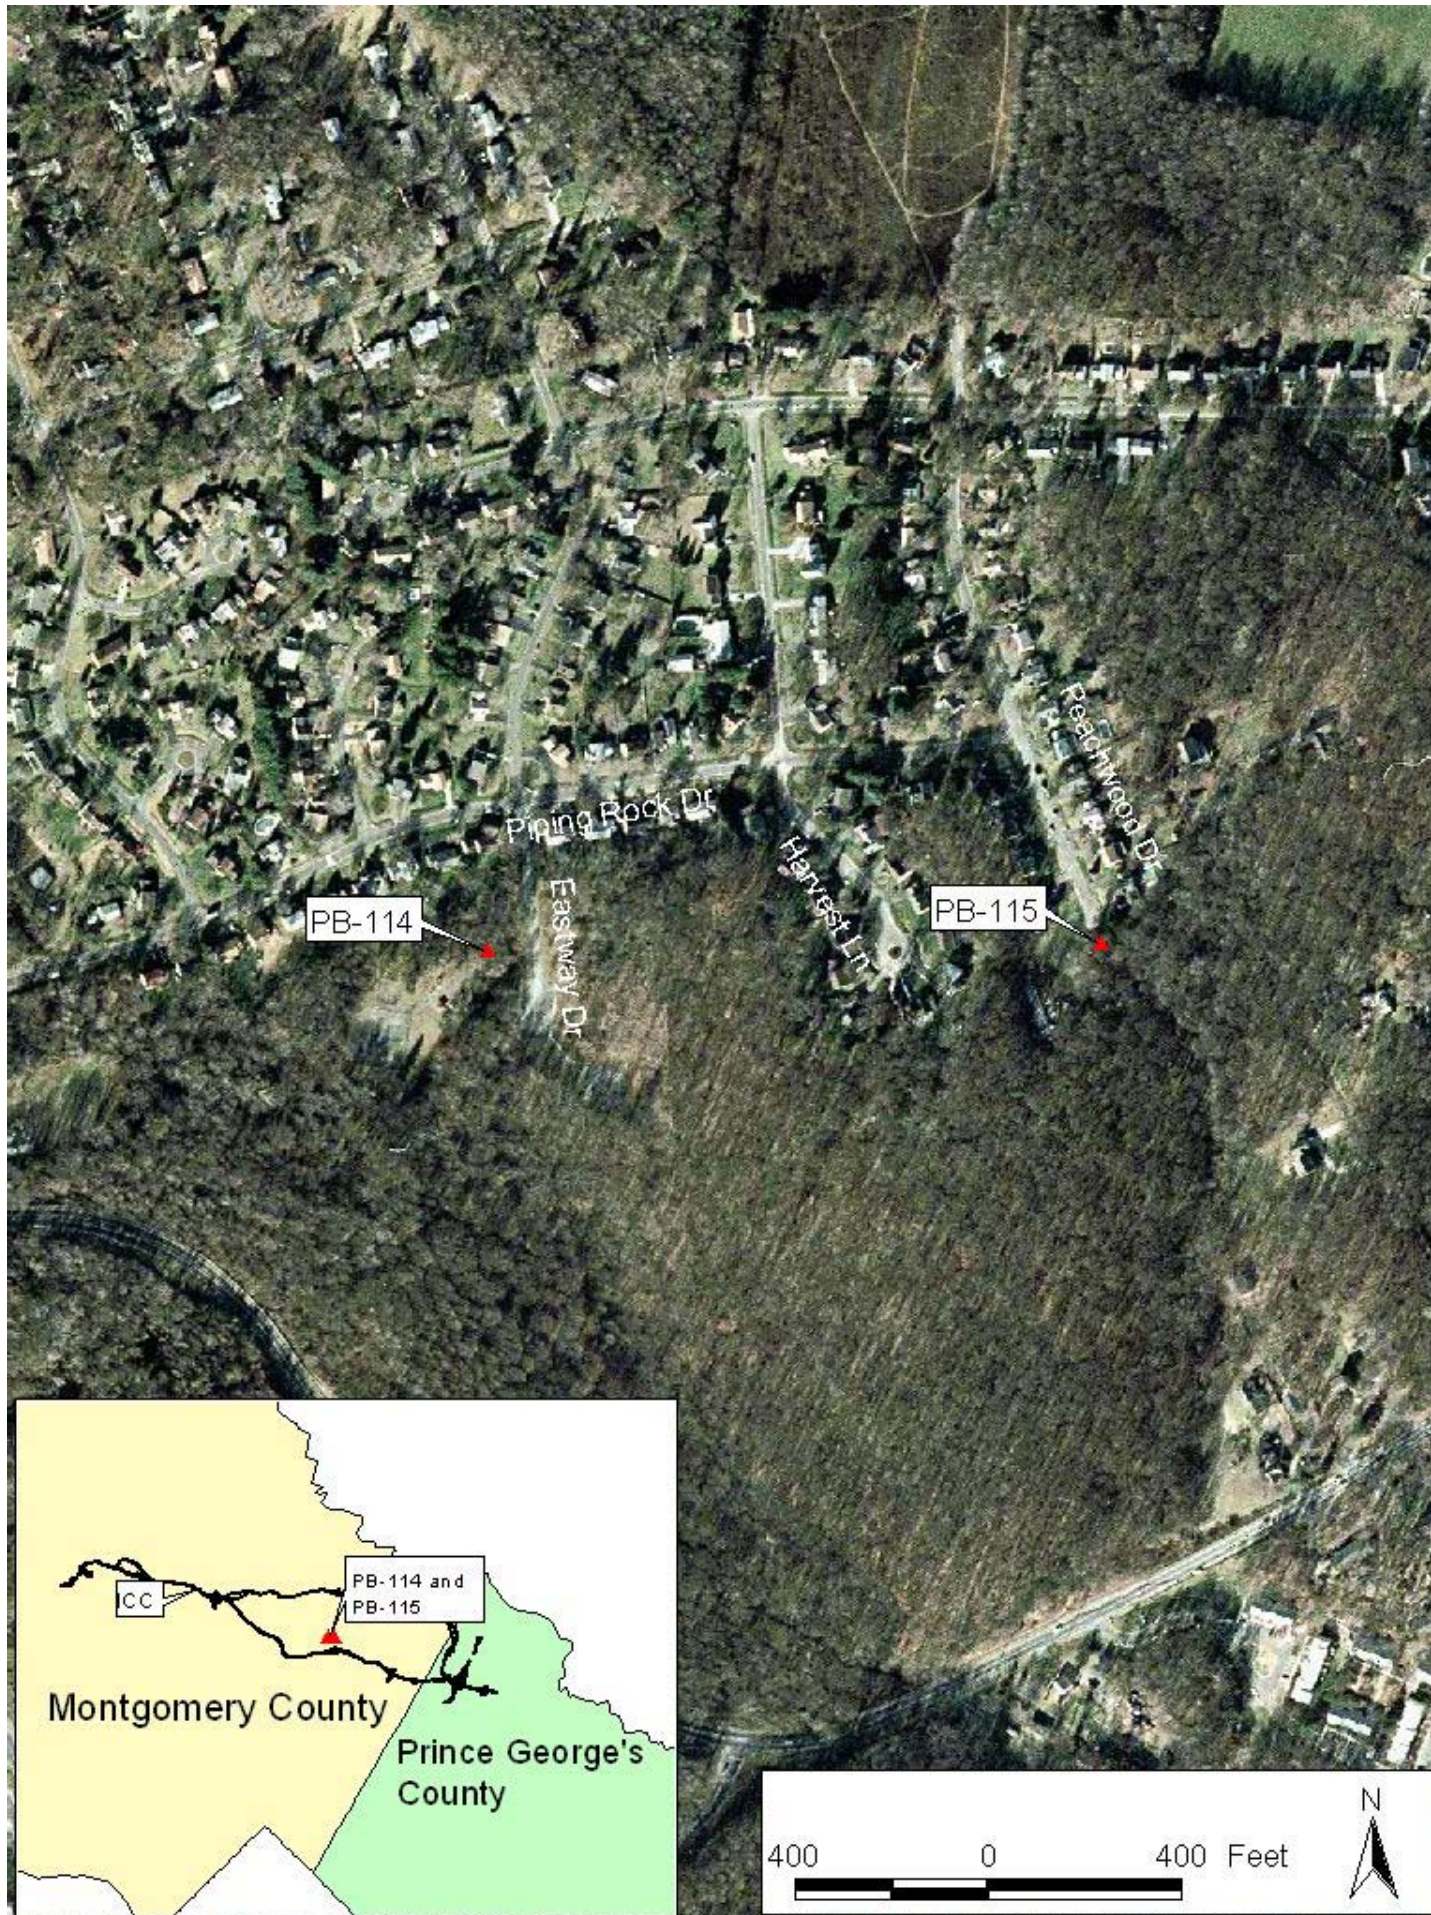
Projects within the development consist of reconstructing existing grassy swales to provide bioretention areas. The project concept also includes the construction of a bioretention area within Peachwood Park, at the end of Eastway Drive.

It is anticipated that the construction of PB-114 and PB-115 would not impact streams. Restoration of PB-114 and PB-115 would cost approximately \$100,000.

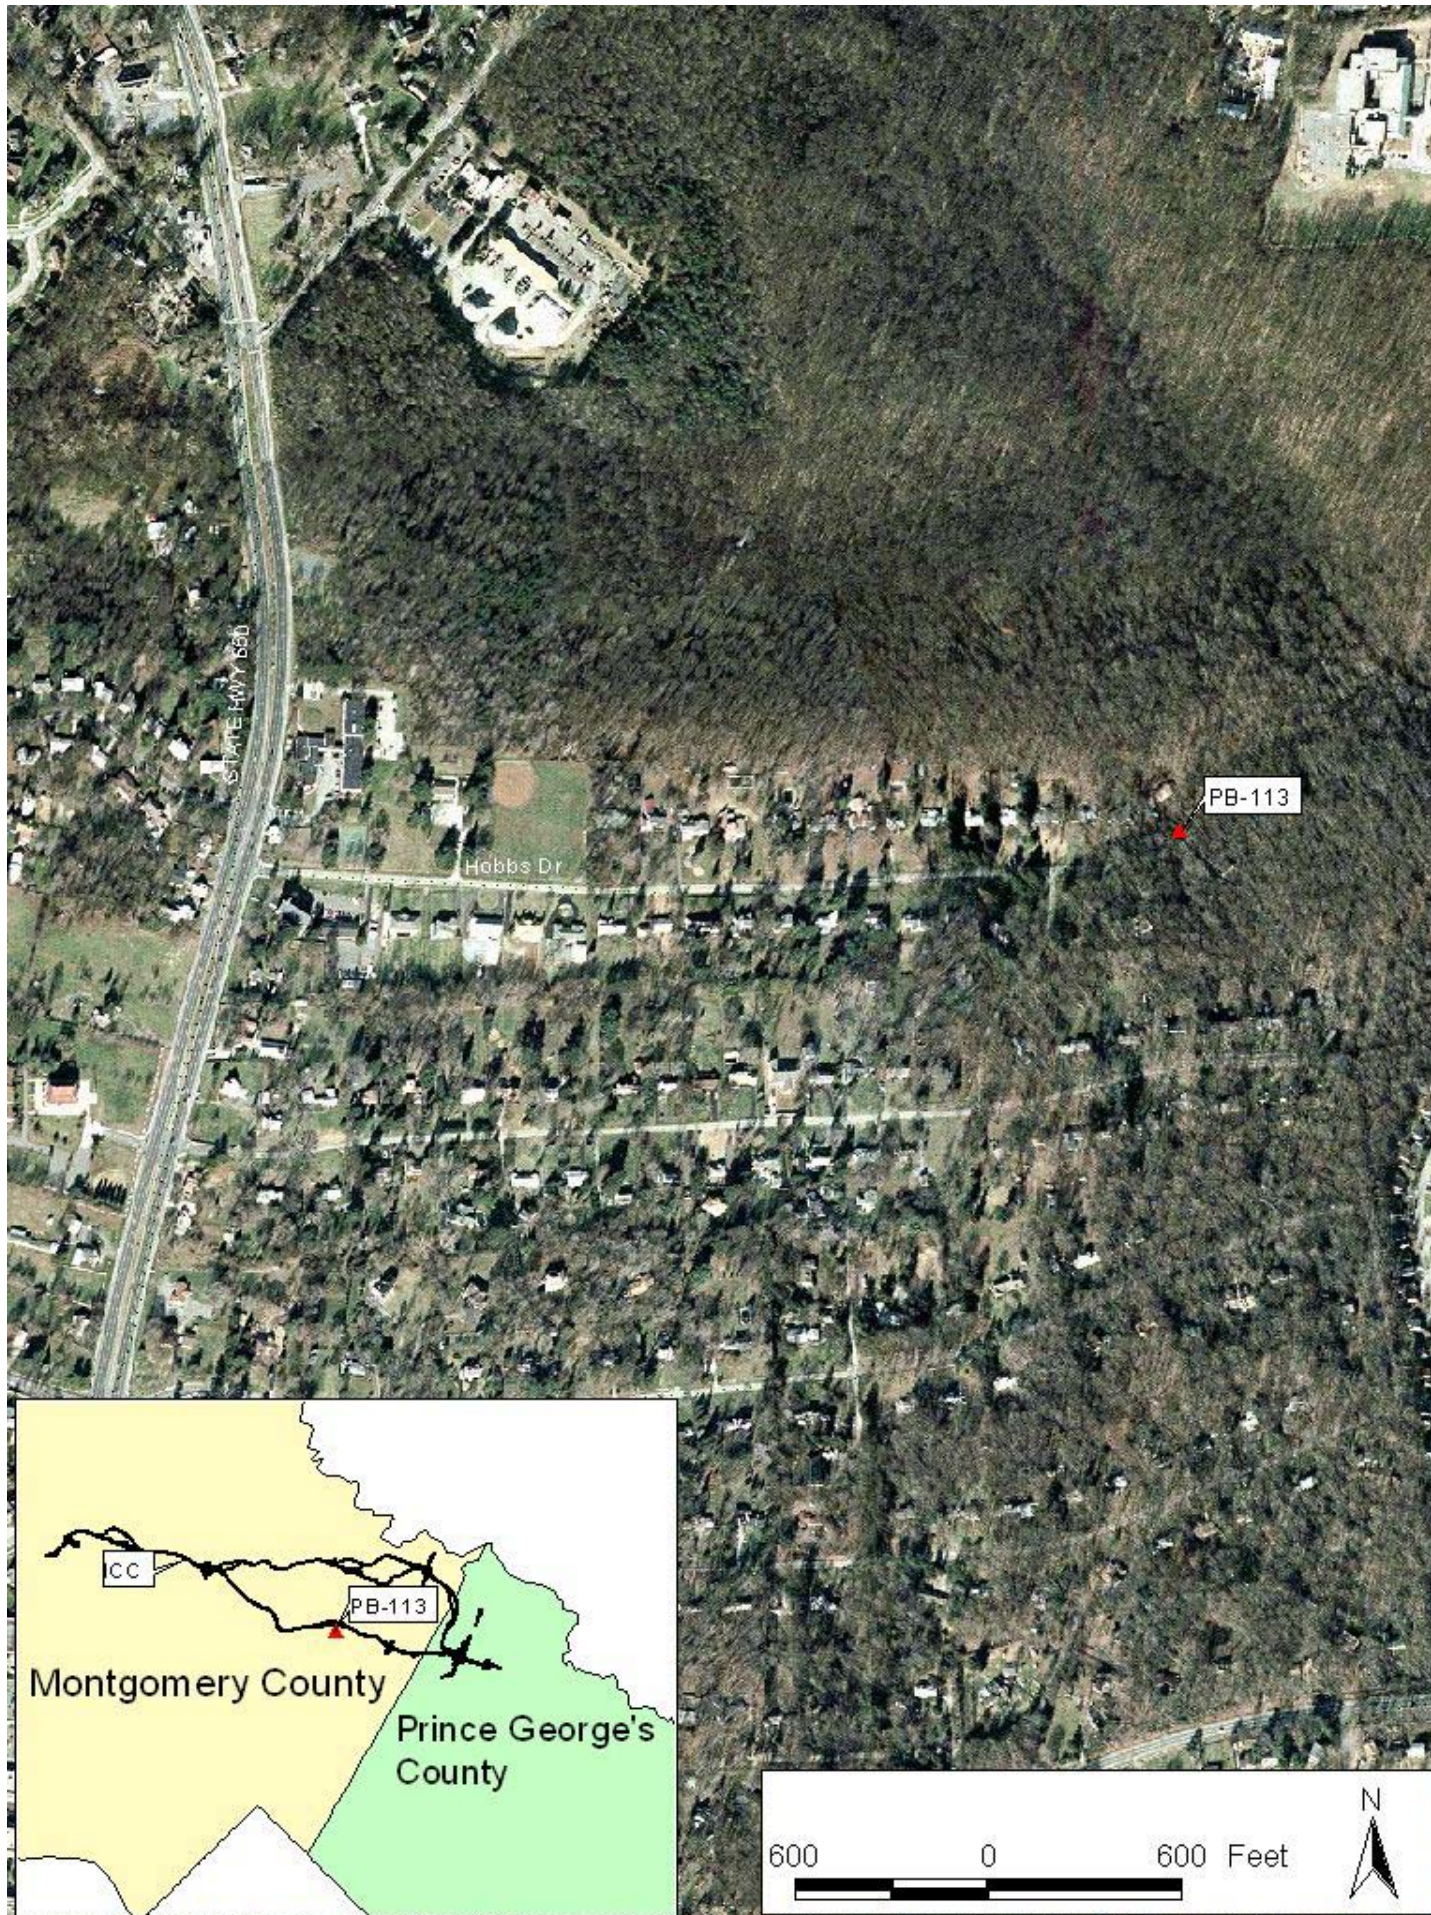
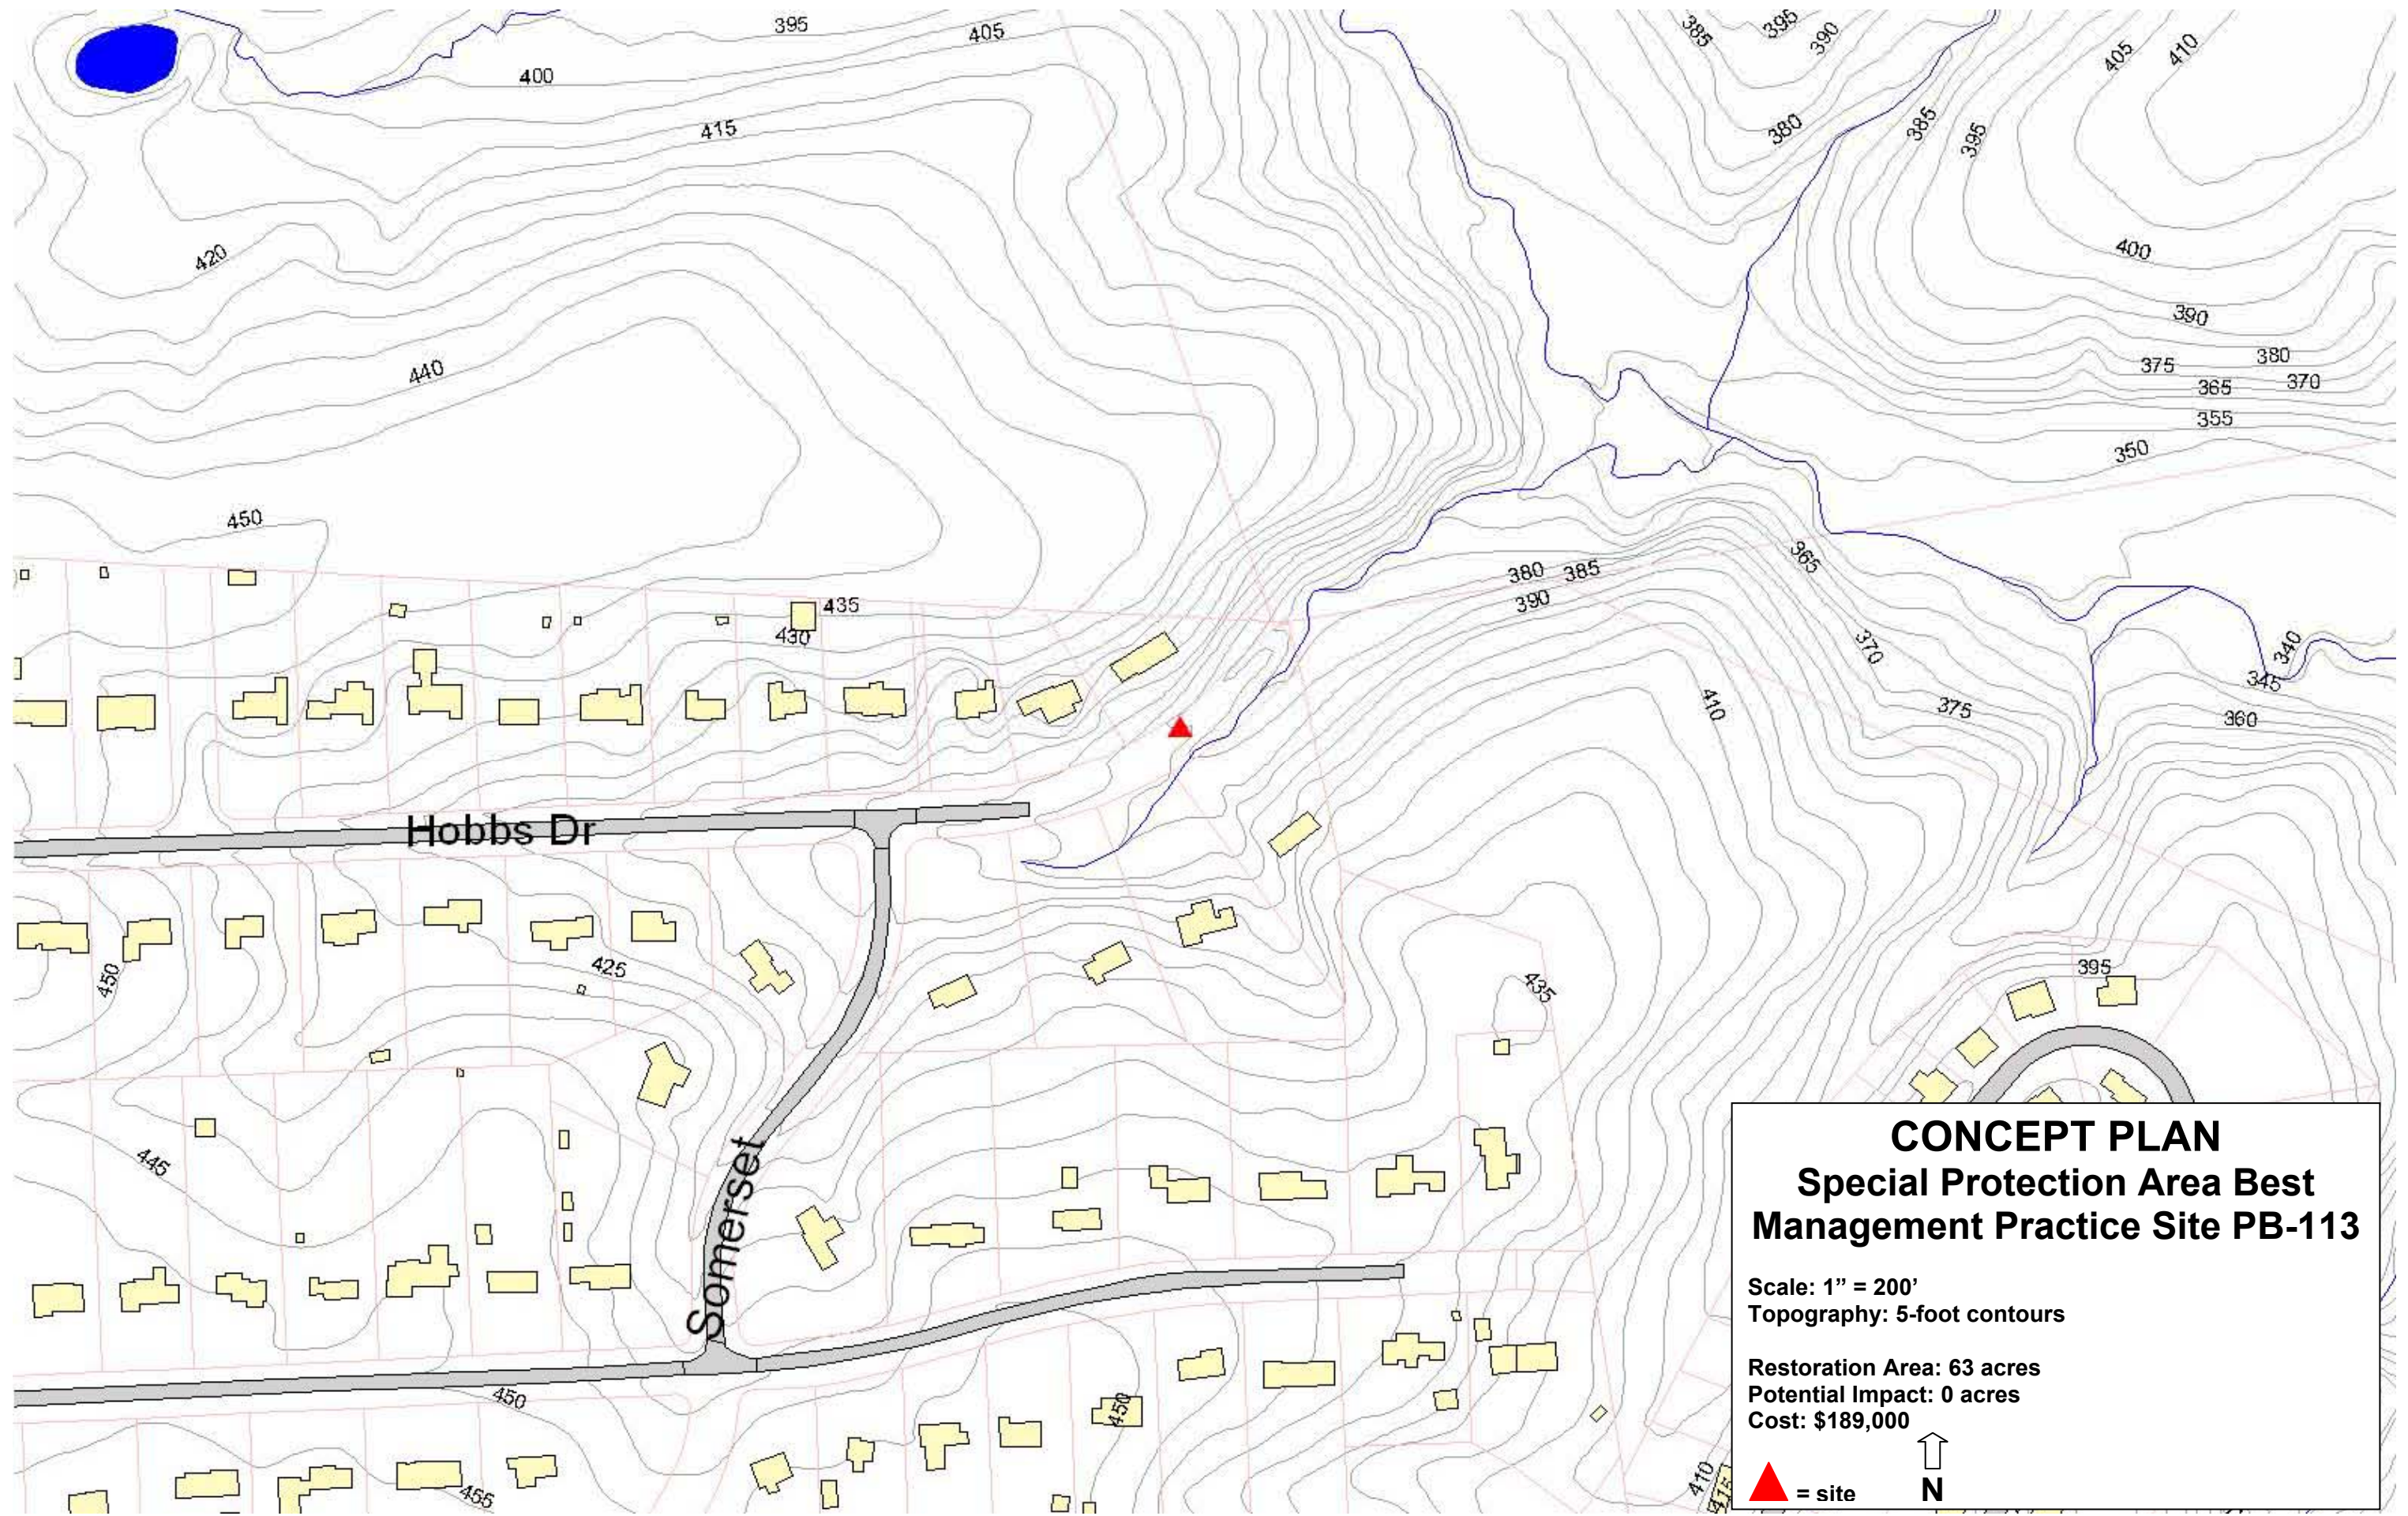
For example, 53 single-family residences exist within the Hobbs Drive drainage area. The average lot size is approximately 1 acre. The area of the paved road is approximately 0.1 acre. Therefore, an overall impervious surface cover of 25% of 1.1 acre or approximately 0.28 acres exists in the drainage area. Using the criteria in the Maryland Department of the Environment's *2000 Maryland Stormwater Design Manual, Volumes I & II*, the treatment volume calculates to be approximately 955 ft³ per parcel. Using the Prince George's County 5% bioretention criteria, the bioretention area would be approximately 988 ft² by approximately 1 foot deep.
