Maryland Historical Trust Maryland Inventory of Historic Properties Form

Inventory No. 31-3-2

other Stubbs Barn (preferred)

street and number 2000 Shorefield Road __ not for publication

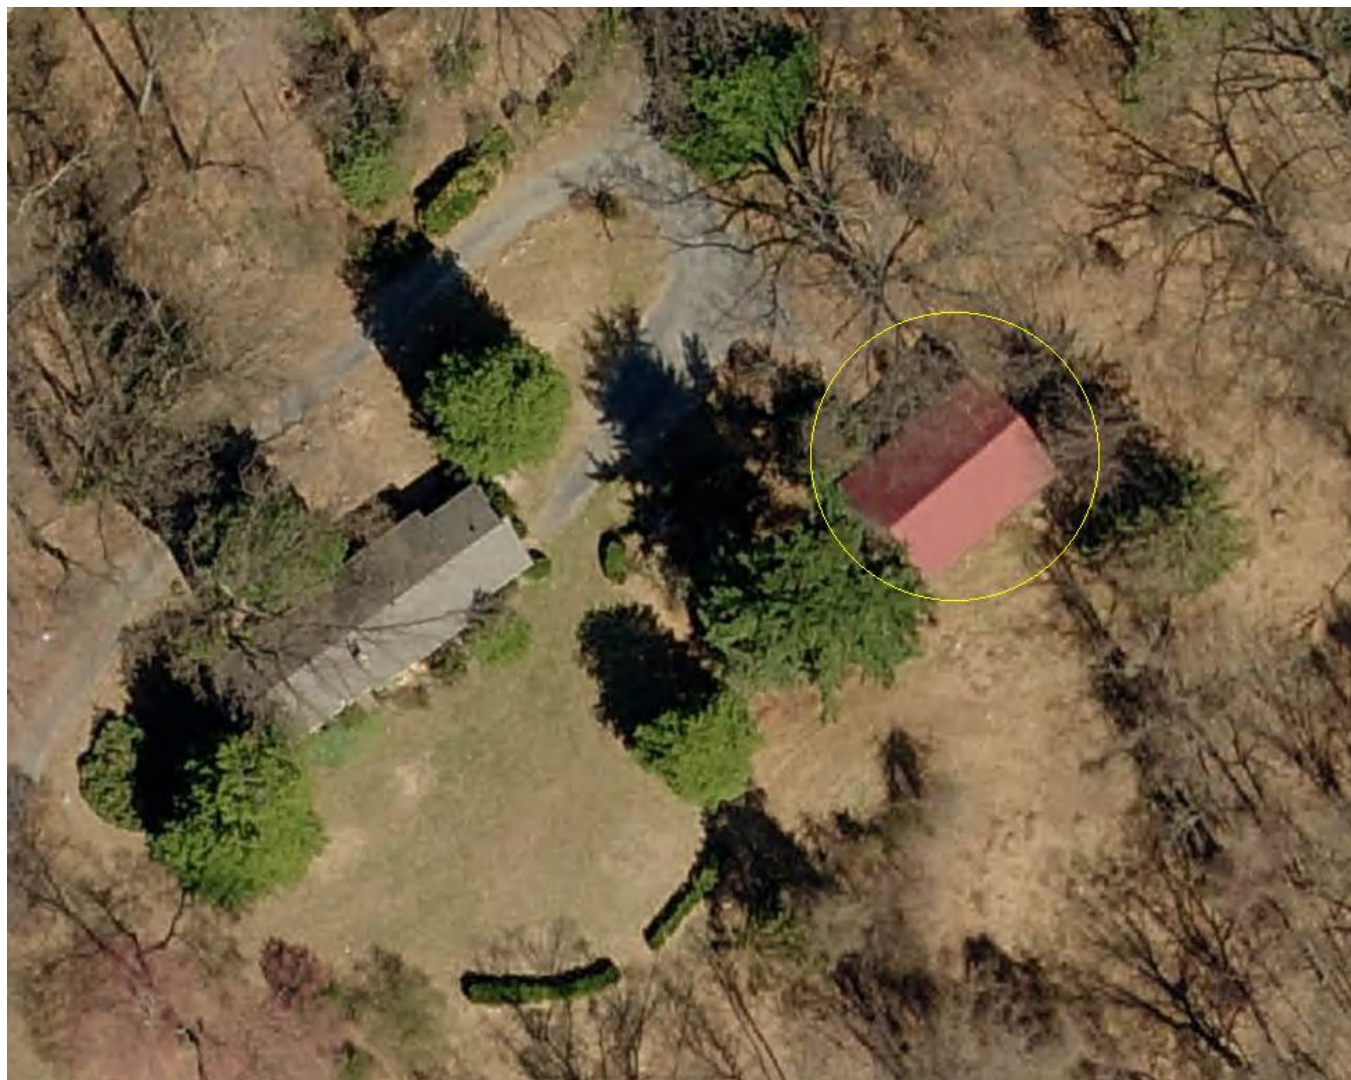
Figure 4. Aerial View of the Stubbs Barn, Wheaton Regional Park, Wheaton, Maryland. (2008). Courtesy: M-NCPPC

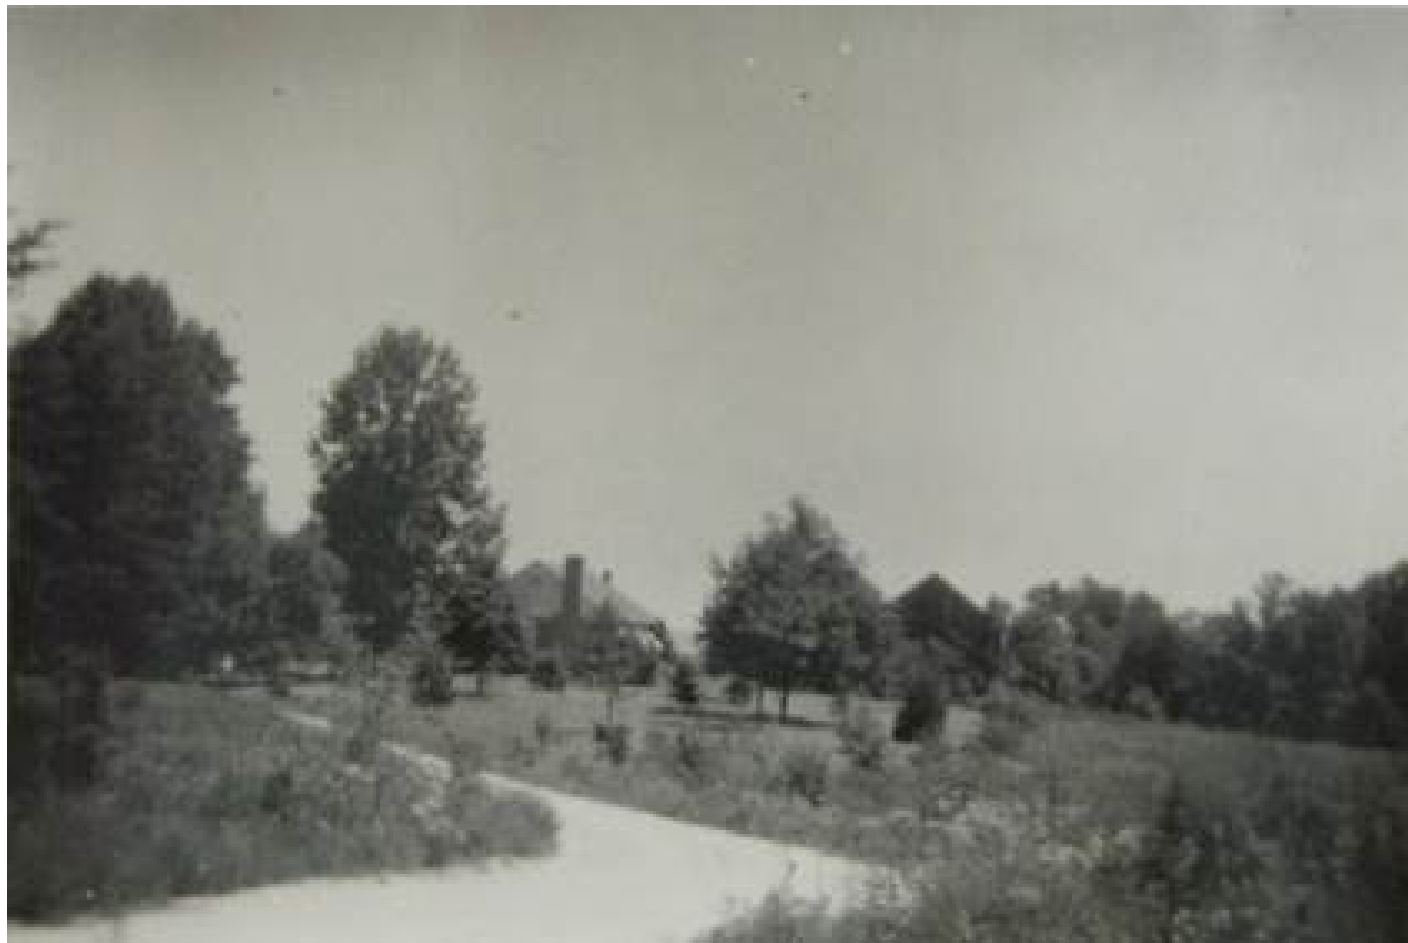
Figure 5. Mid-20th Century view of the Armstrong property with the Stubbs Barn in the background. Courtesy: M-NCPPC

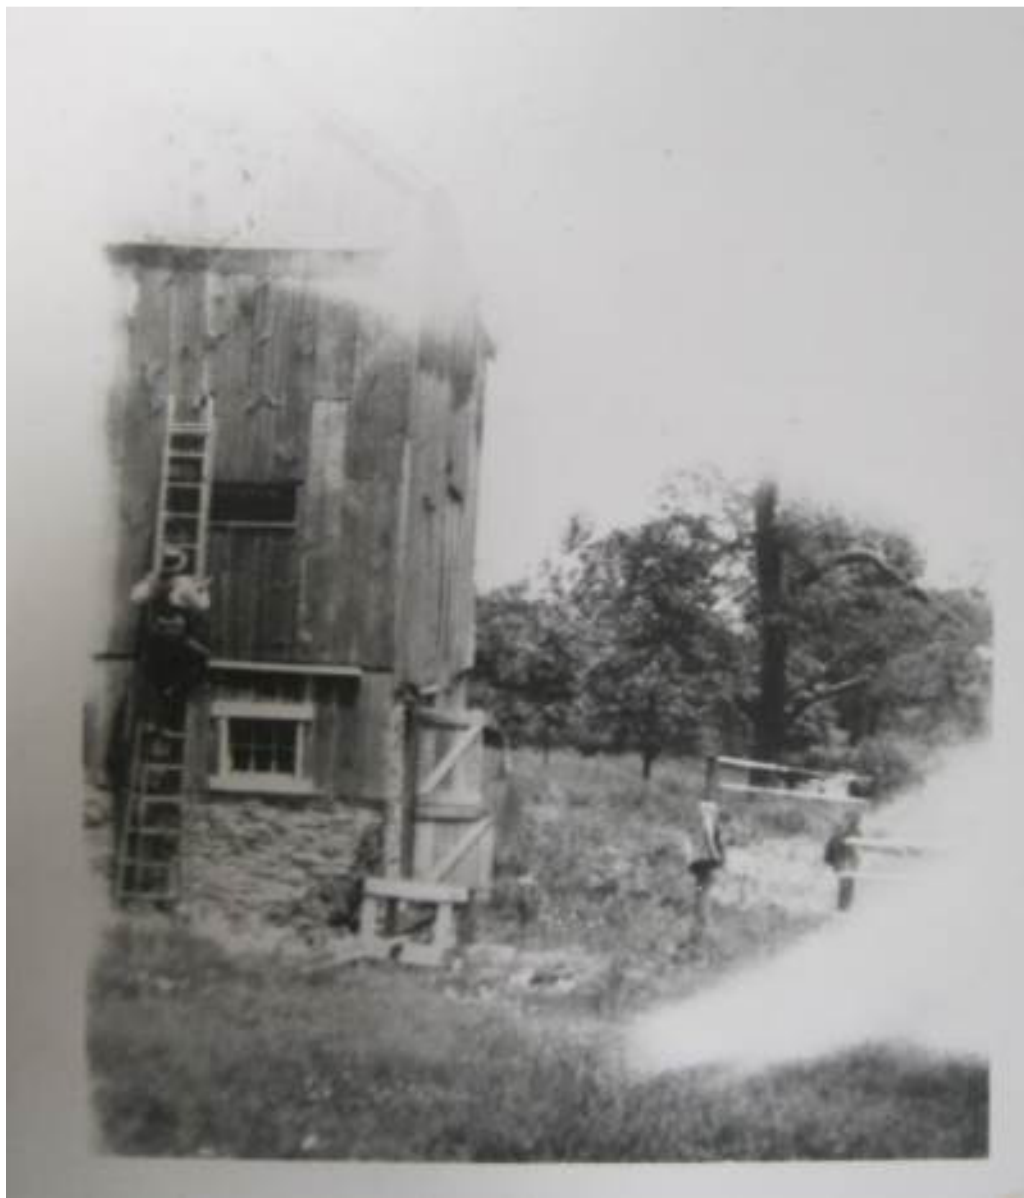
Figure 6. Mid-20th century close-up of the Stubbs Barn. Courtesy: M-NCPPC

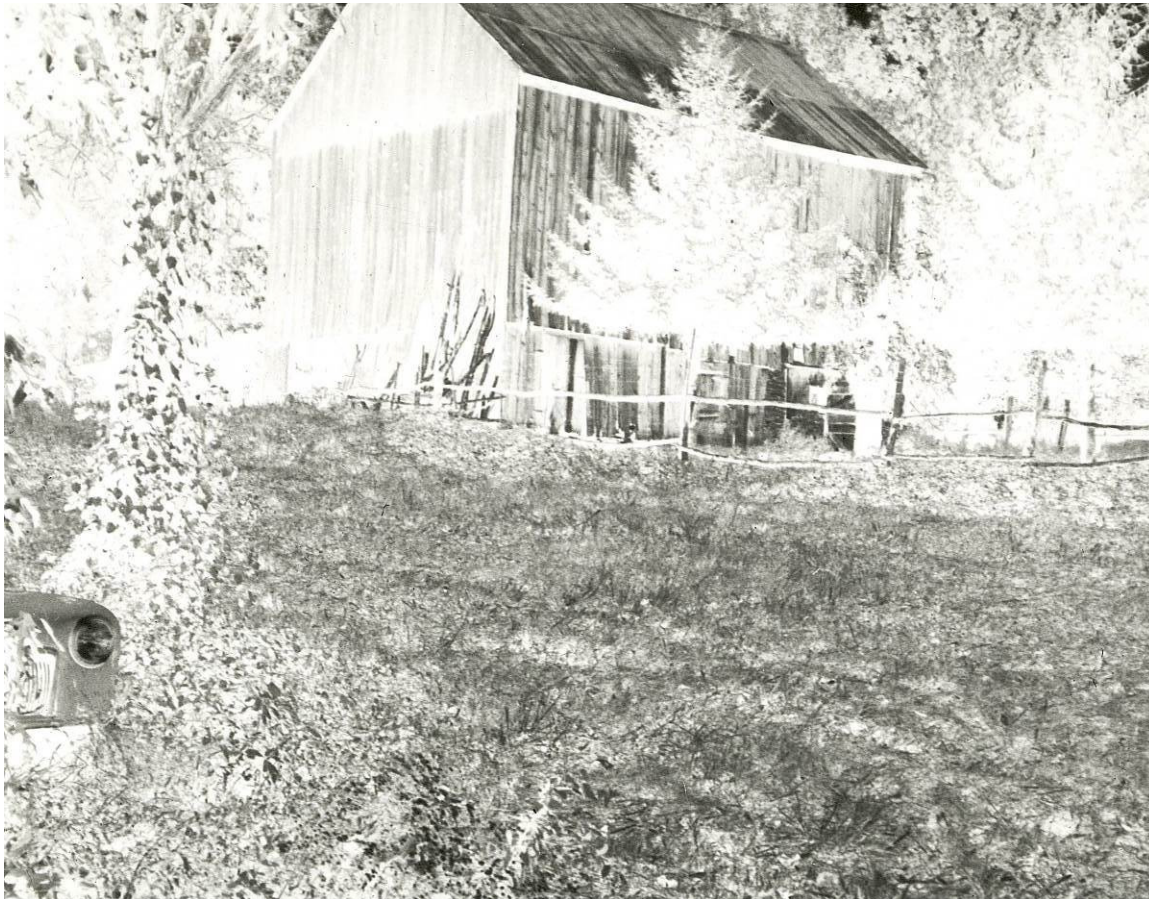
Figure 7. Mid-20th century Negative of the Stubbs Barn, rear elevation. Courtesy: M-NCPPC

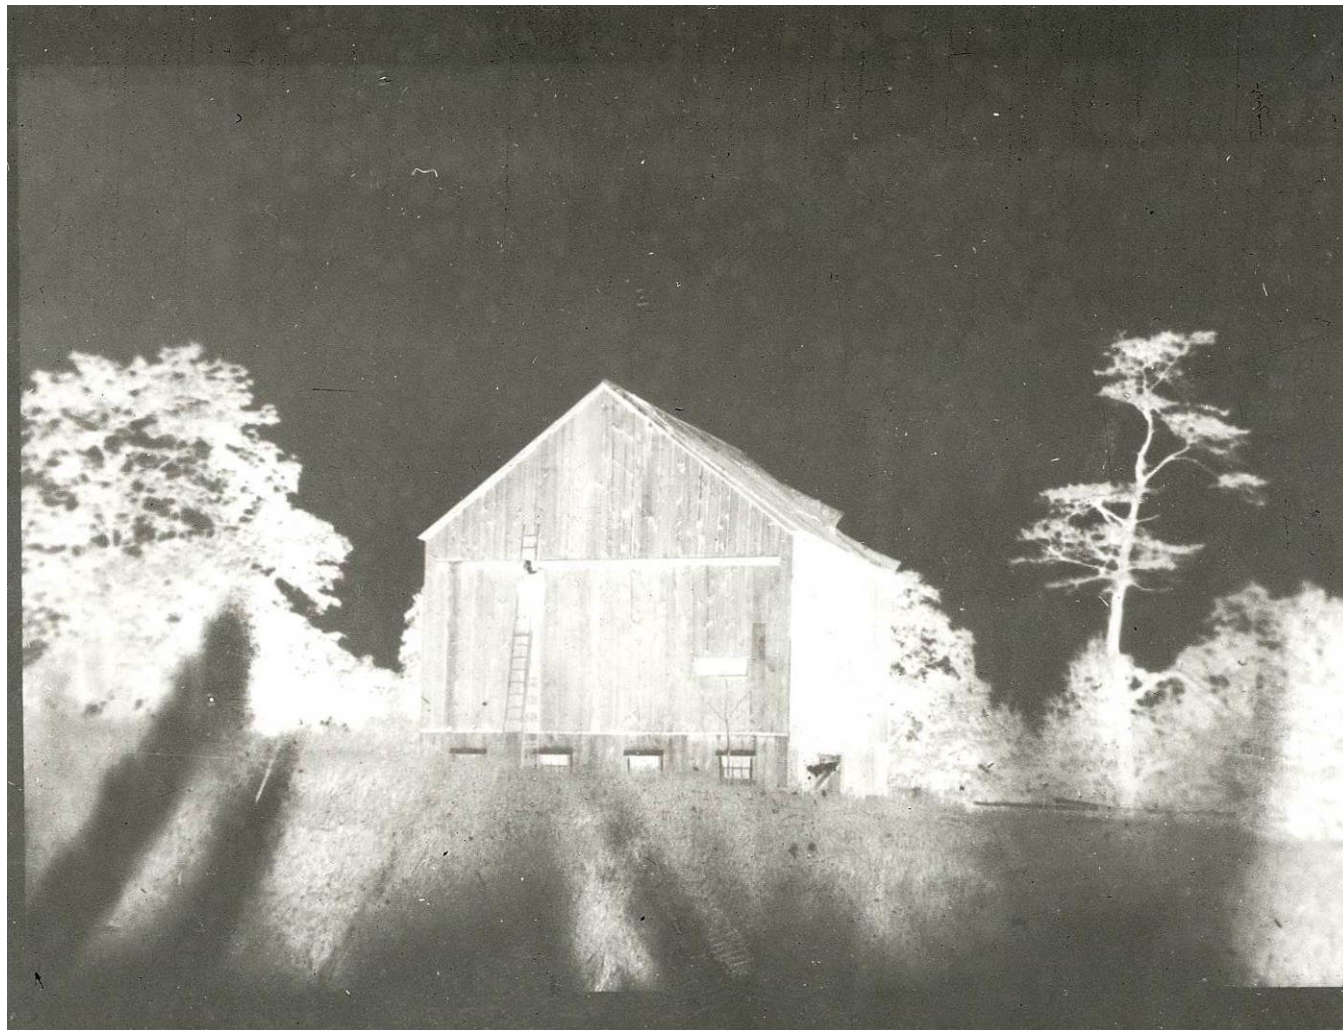
Figure 8. Mid-20th century Negative view of Southwest elevation. Courtesy: M-NCPPC

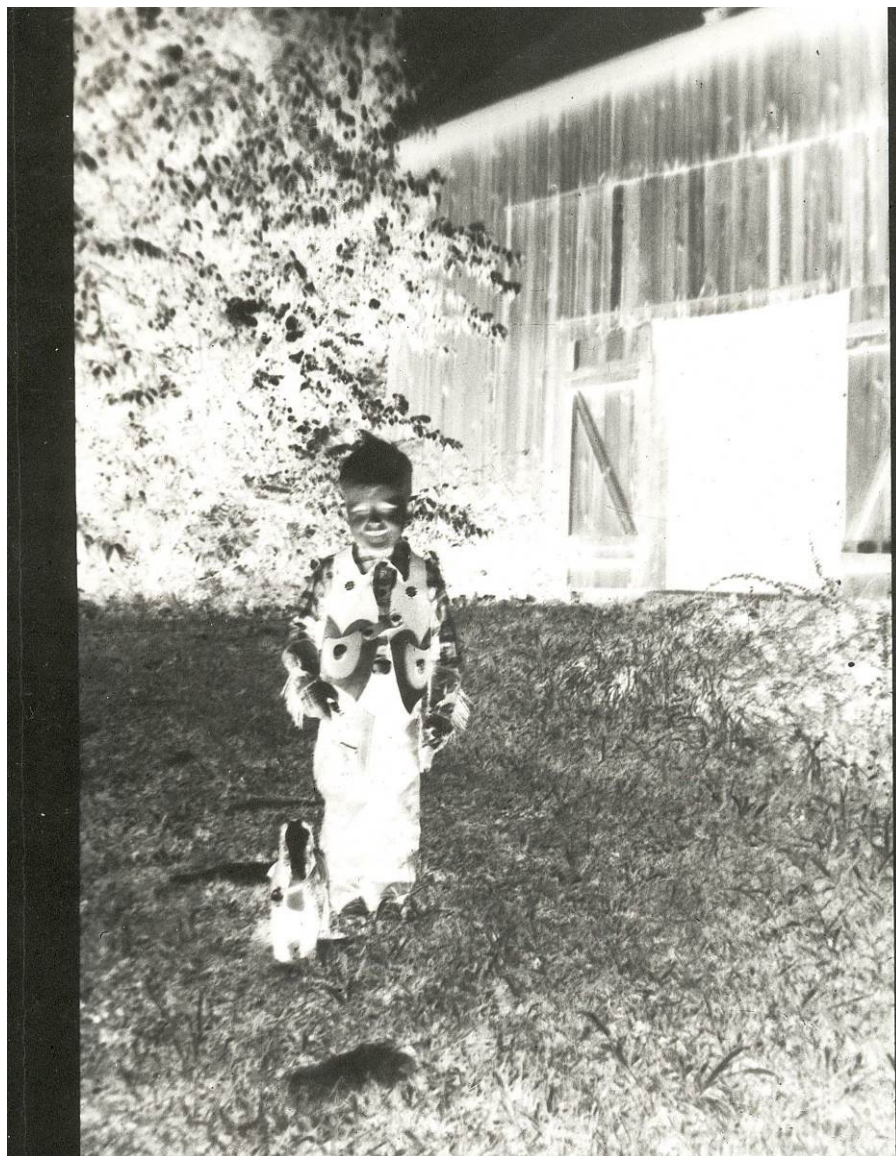
Figure 9. Mid-20th century Negative view of little boy standing outside the front elevation of the Stubbs Barn.
Courtesy: M-NCPPC

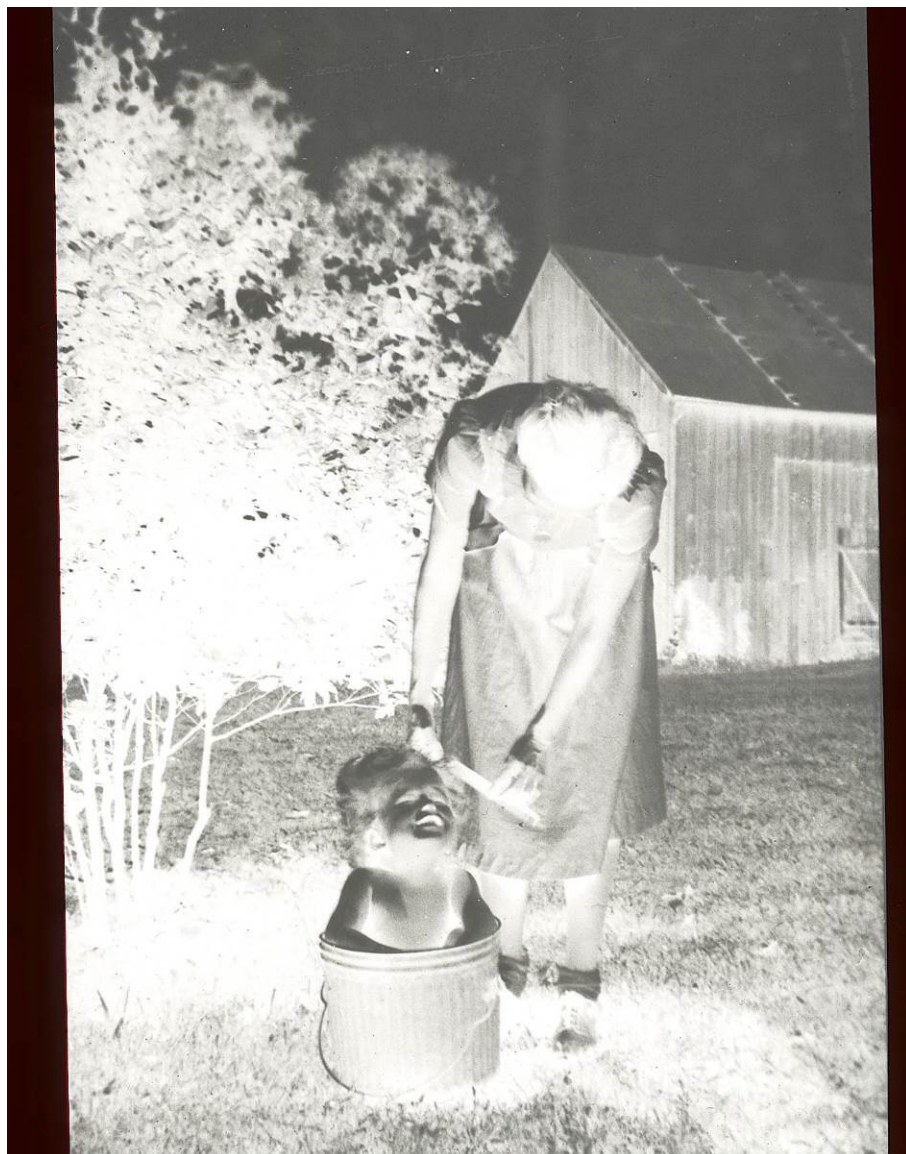
Figure 10. Mid-20th century Negative view of mother and child outside front elevation of the Stubbs Barn.
Courtesy: M-NCPPC

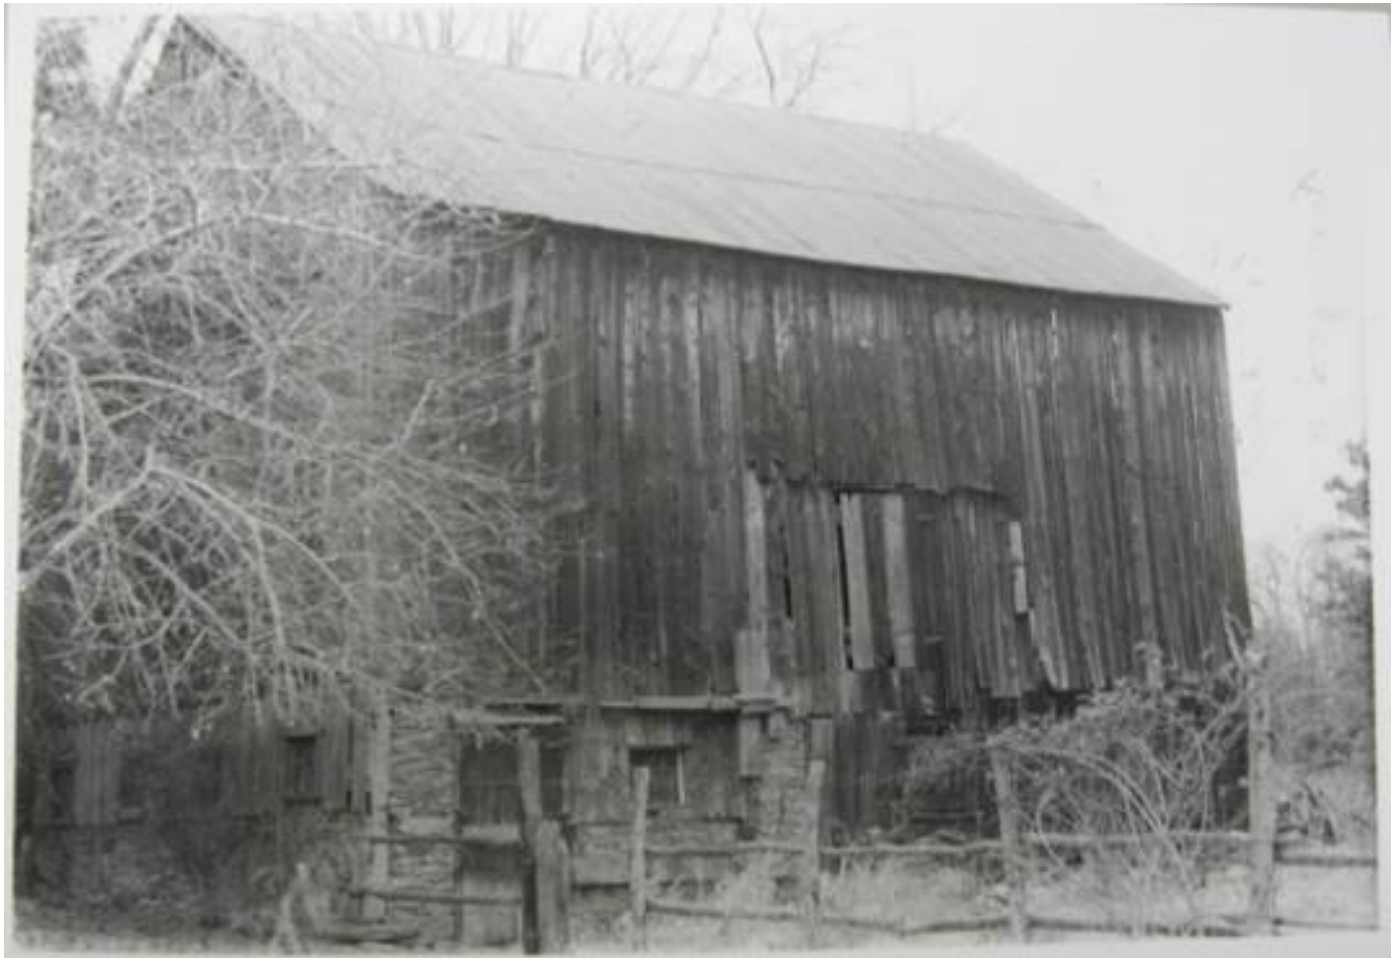
Figure 11. Stubbs Barn prior to renovations in the late 1980s. A note on the back of this photo, believed to have been written by John Armstrong, states: "Barn siding was always loose fitting. Tobacco barns were built that way. I was always told that the farm had originally been a tobacco [farm] long ago." Although tobacco was originally grown at "Shawfield," by 1850 the Stubbs family had switched to grain and corn cultivation, and this barn likely served those purposes. Courtesy: M-NCPPC

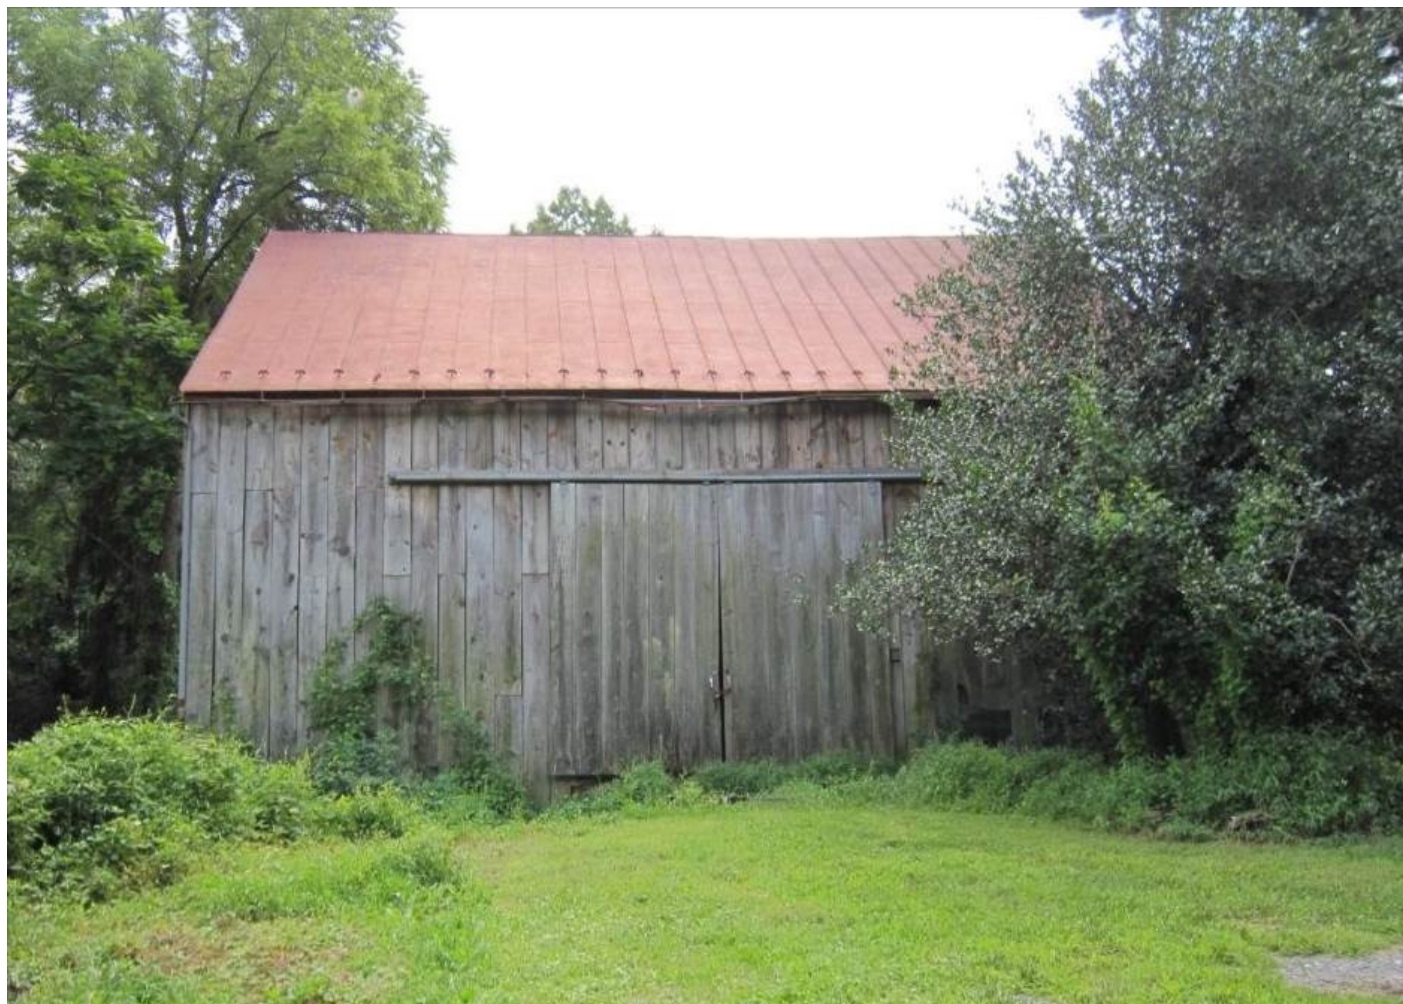
Figure 13. Current view of Northwest front façade.

The main northwest, uphill façade features a local fieldstone stone foundation and vertically planked walls, many sash-sawn, which means they may be contemporaneous with the barn's construction. Other planks are clearly appended to the frame with 20th century nails. All planks are now completely devoid of their former red paint and some of them have their wood worn away on the façade to the point that the building has been temporarily fixed with steel mesh to preclude nuisance animals and vandalism. A large-scale double, sliding door on the banked, threshing-floor level is the barn's sole feature, and the door is still operable. It opens into the tall, large interior.

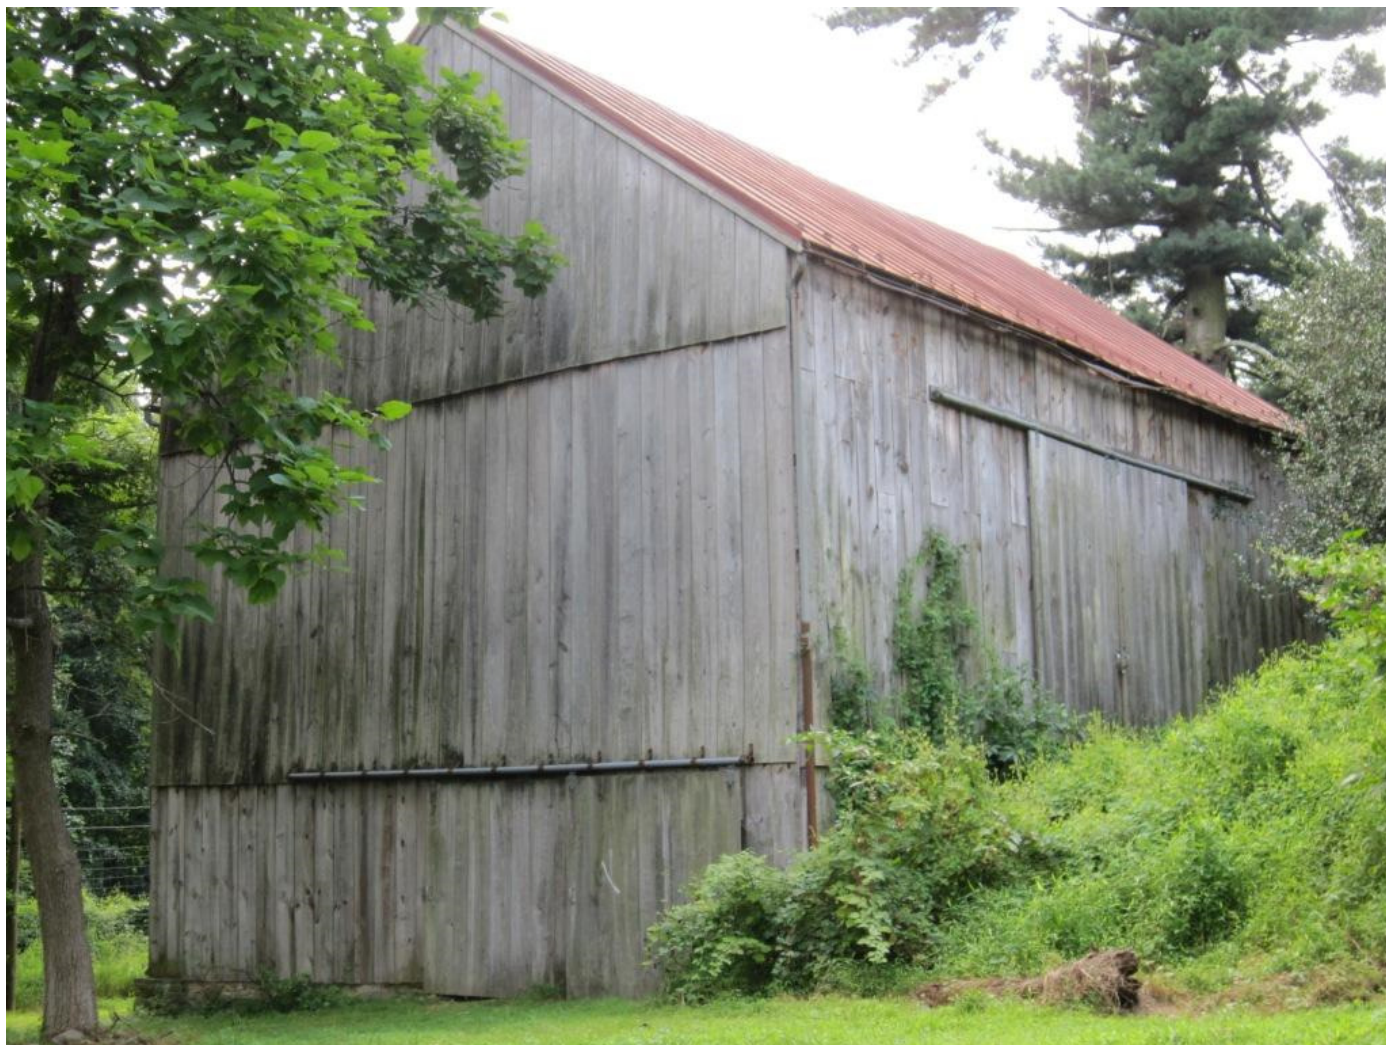
Figure 14. Northwest (front façade) at right, with Northeast gable end.

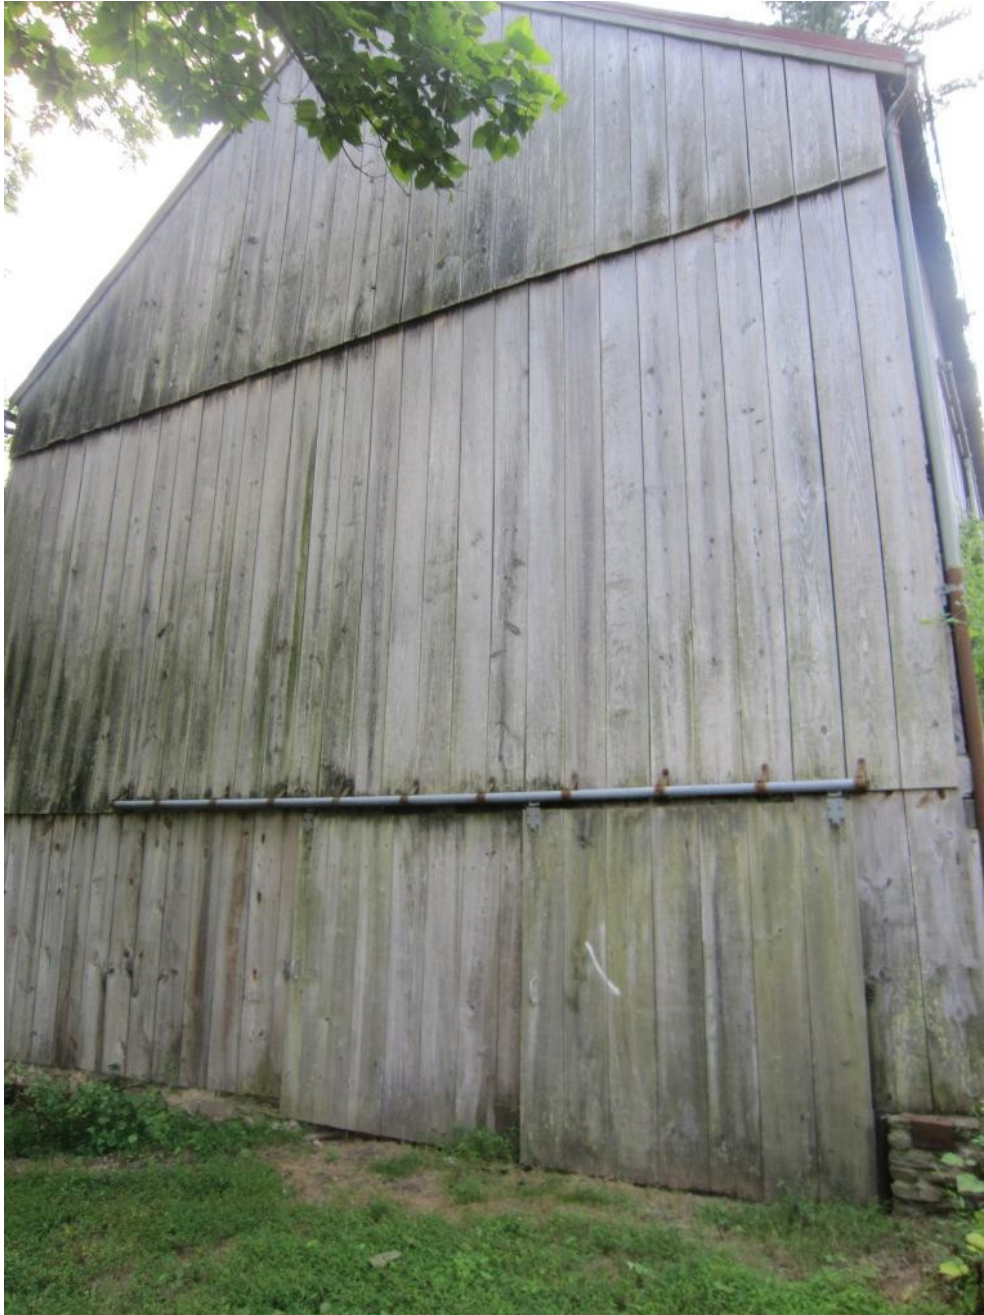
Figure 15. View of the Northeast face.

The northeast face features a sliding door on the lower level that gives way into the former livestock area. This door may have been added after original construction as sliding doors on the stable level of bank barns are not common.

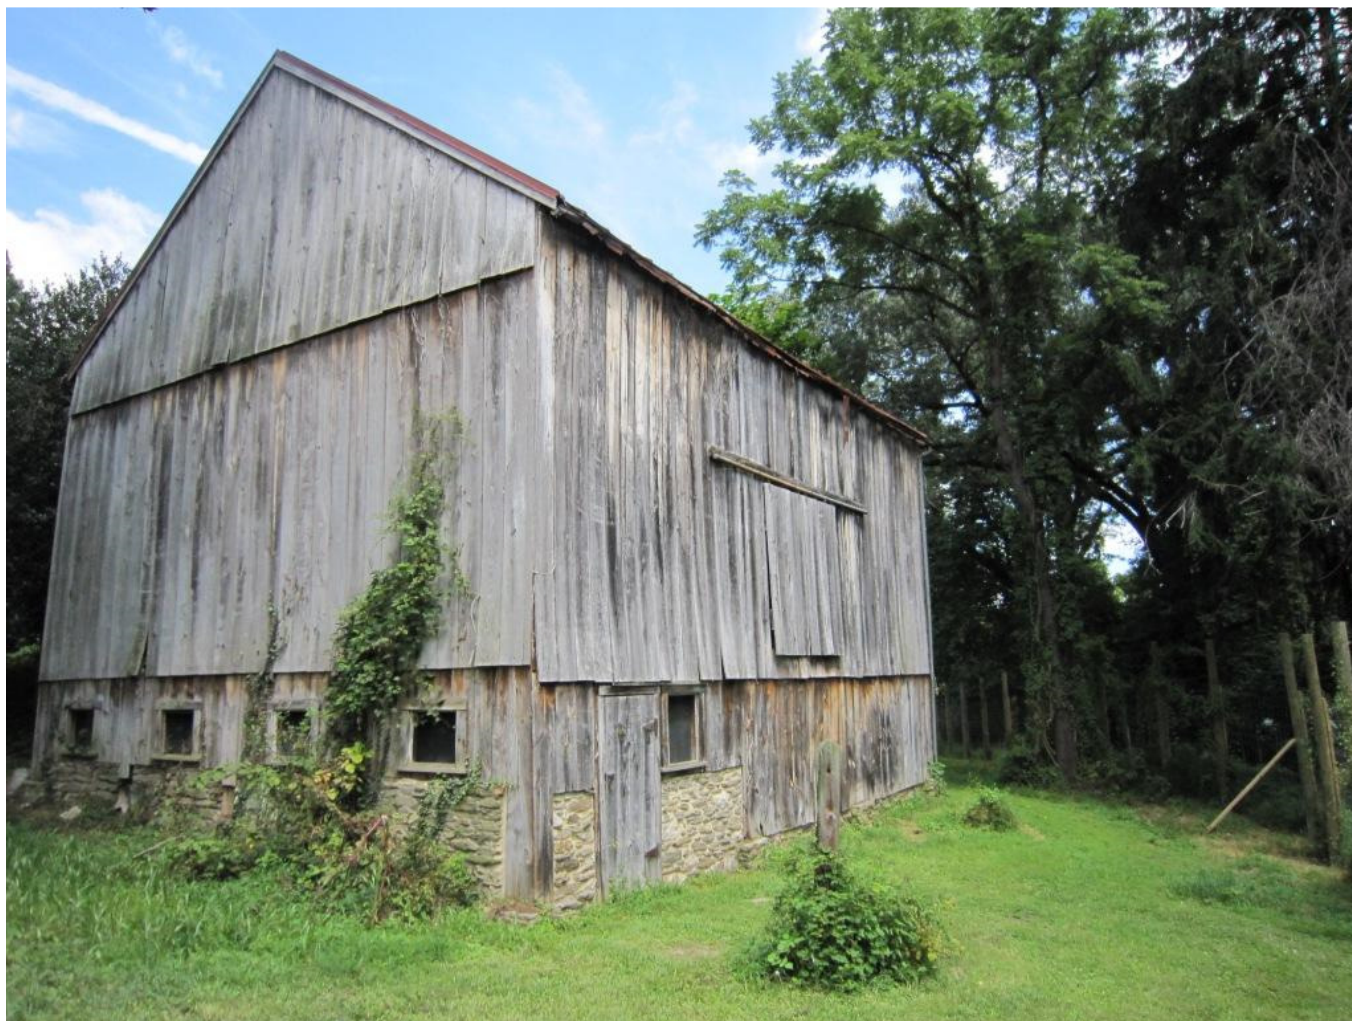
Figure 16. South corner, with Southeast (rear) at right.

The southeast, stable-side face shows alteration to the corner it shares with the southwest face. This rear façade features only one stable door near the corner (it appears in an older photo as a "dutch door" with interior, diagonal Z-bracing) and is adjacent to a window that once held a nine-pane sash. This door probably once gave way to the horse stall area, but now opens onto a 20th century, small converted dairy milking aisle. The paired, door-window opening is set within a rubblestone wall with mortar. The upper level of this rear face features a sliding door for pitching hay down into the former stable area. Again, unlike Pennsylvania-type bank barns, this

one does not feature a cantilevered forebay that would shelter part of the stable level. The plane of the rear wall is flush from roof to ground.

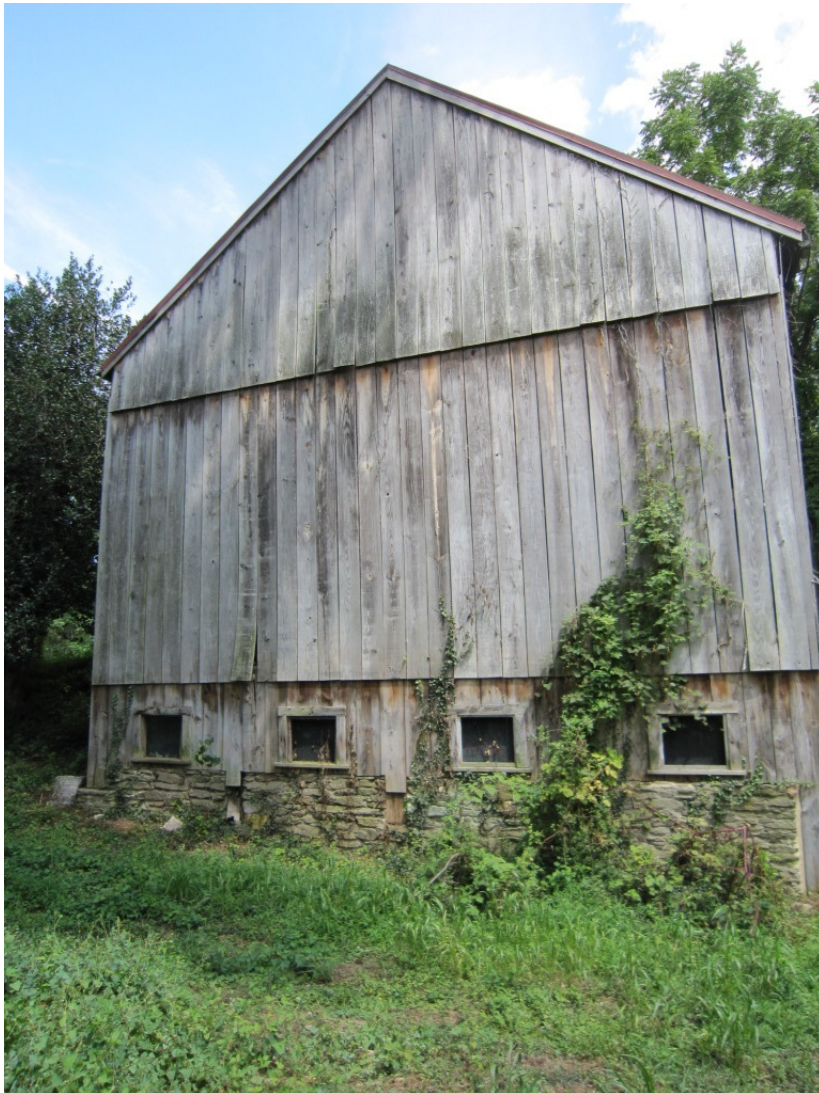
Figure 17. View of Southwest gable end.

The southwest face, again possibly altered from its original appearance, has a rubblestone and mortared wall that is approximately four feet high. Above it are four, square window openings that used to be filled with multi-pane glazing in a three-over-three pattern.

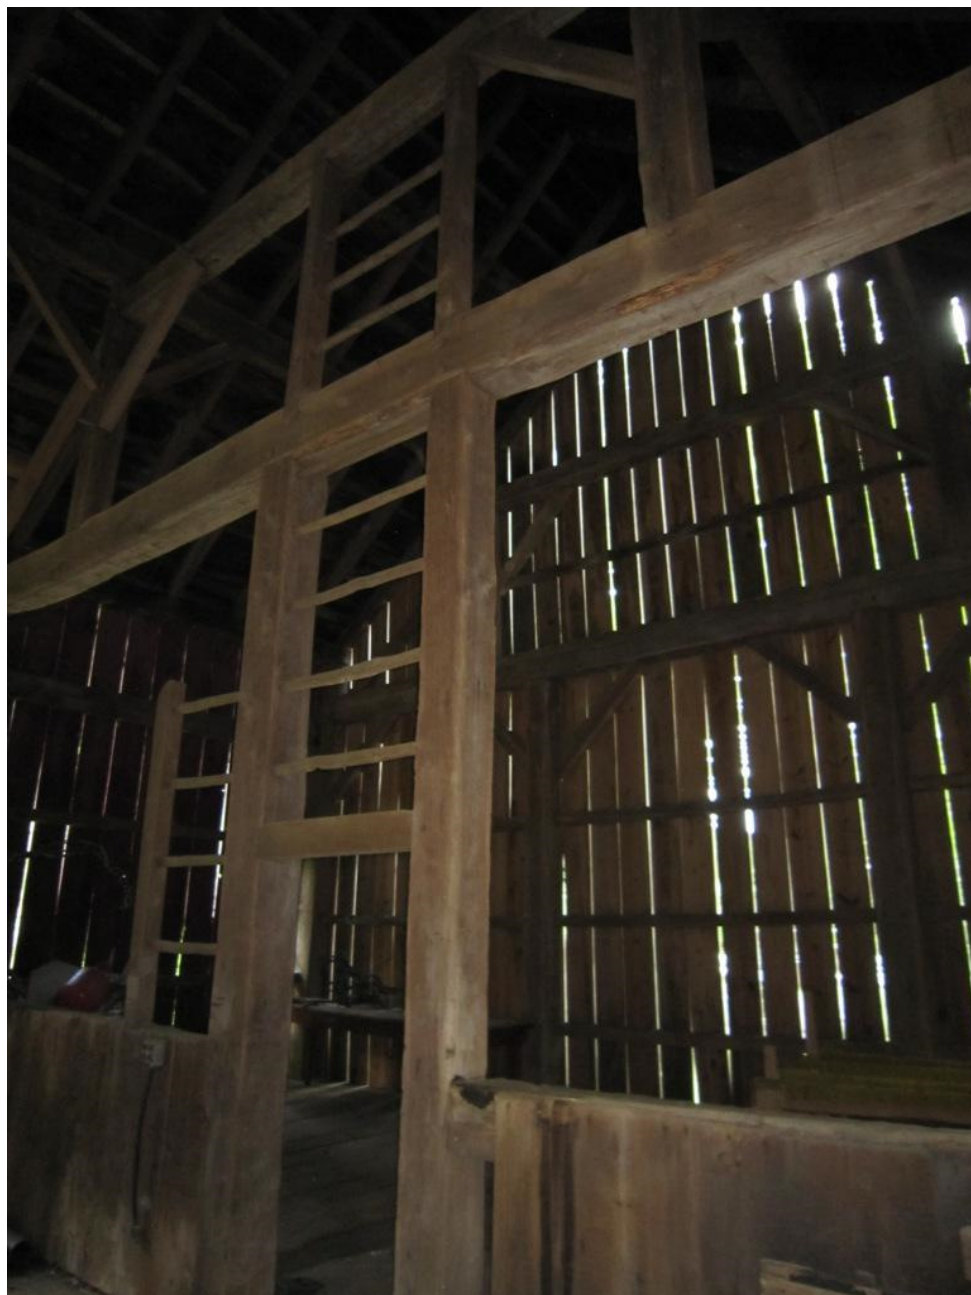
Figure 18. Interior Ladders, Hay Mow Short Walls, Double Tie Beams, and Wall Construction.

The tall interior space manifests the double-tie beam framing system with its upward posts and diagonal bracing that support the top plates. The common rafter and purlin roof has a 30 degree slope and features a center ridge board. The barn's walls are framed in a series of pegged posts and beams, including a mid-level girt, and pegged diagonal braces. The exterior planks are nailed to smaller dimension “nailers” and from the interior, an abundance of daylight shines through their slats.

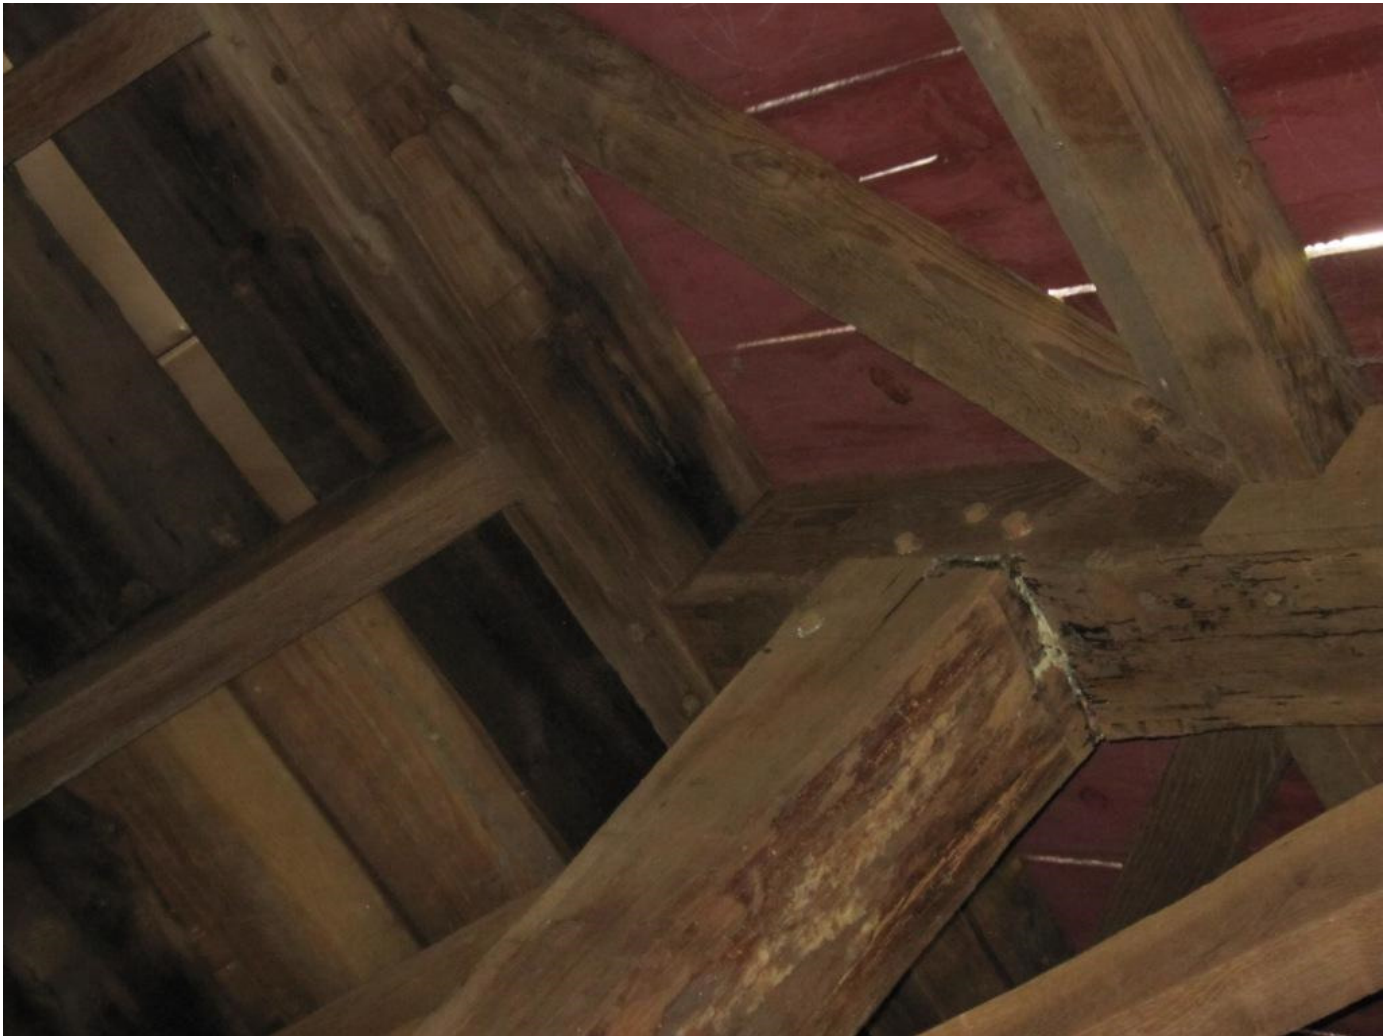
Figure 19. Framing system shows pegs and diagonal braces.

The interior of the upper, two-level height hay threshing and storage area is particularly impressive for the size of the framing timbers and the integrity of the barn's construction to 1843. The thickness of the oak tie beams reveals both a construction methodology that was meant to last for generations and an old-growth forest whereupon the owners could fell giant trees. The barn is framed in some of the largest hewn members seen in the county. The bents contain two parallel, hewn tie beams and all vertical and horizontal framing members are pegged together. The largest tie beam – the “swing beam,” the lower of the two – on the west side features a major split and is missing its three pegs where its mortise connects into the door post. (This beam needs repair.) While the north and south face posts are one piece, full height, from foundation to eaves level, all other posts are discontinuous at ground floor level with bearing connections.

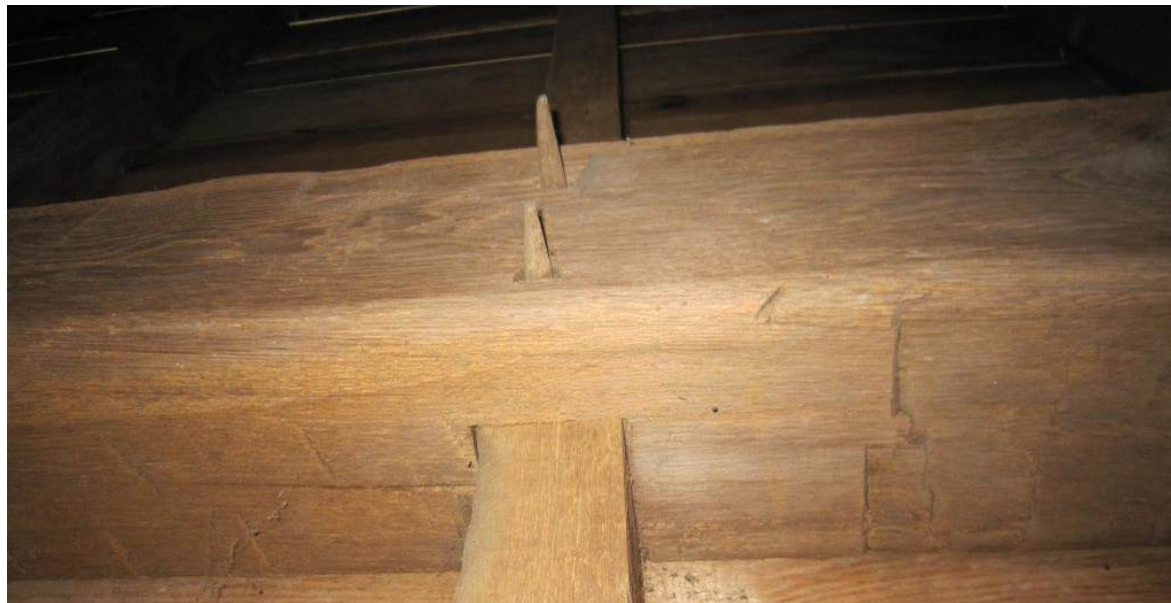
Figure 20. Pointed Pegs between Post and Tie Beam.

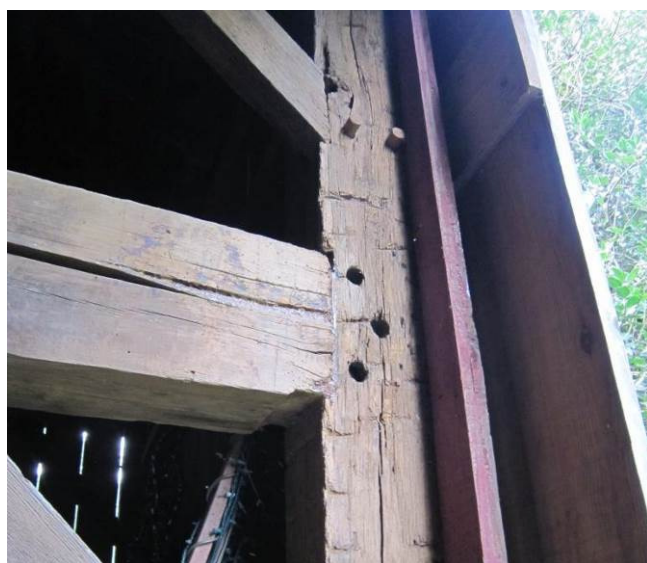
Figure 21. Hewn Interior Post showing missing pegs at Tie Beam.

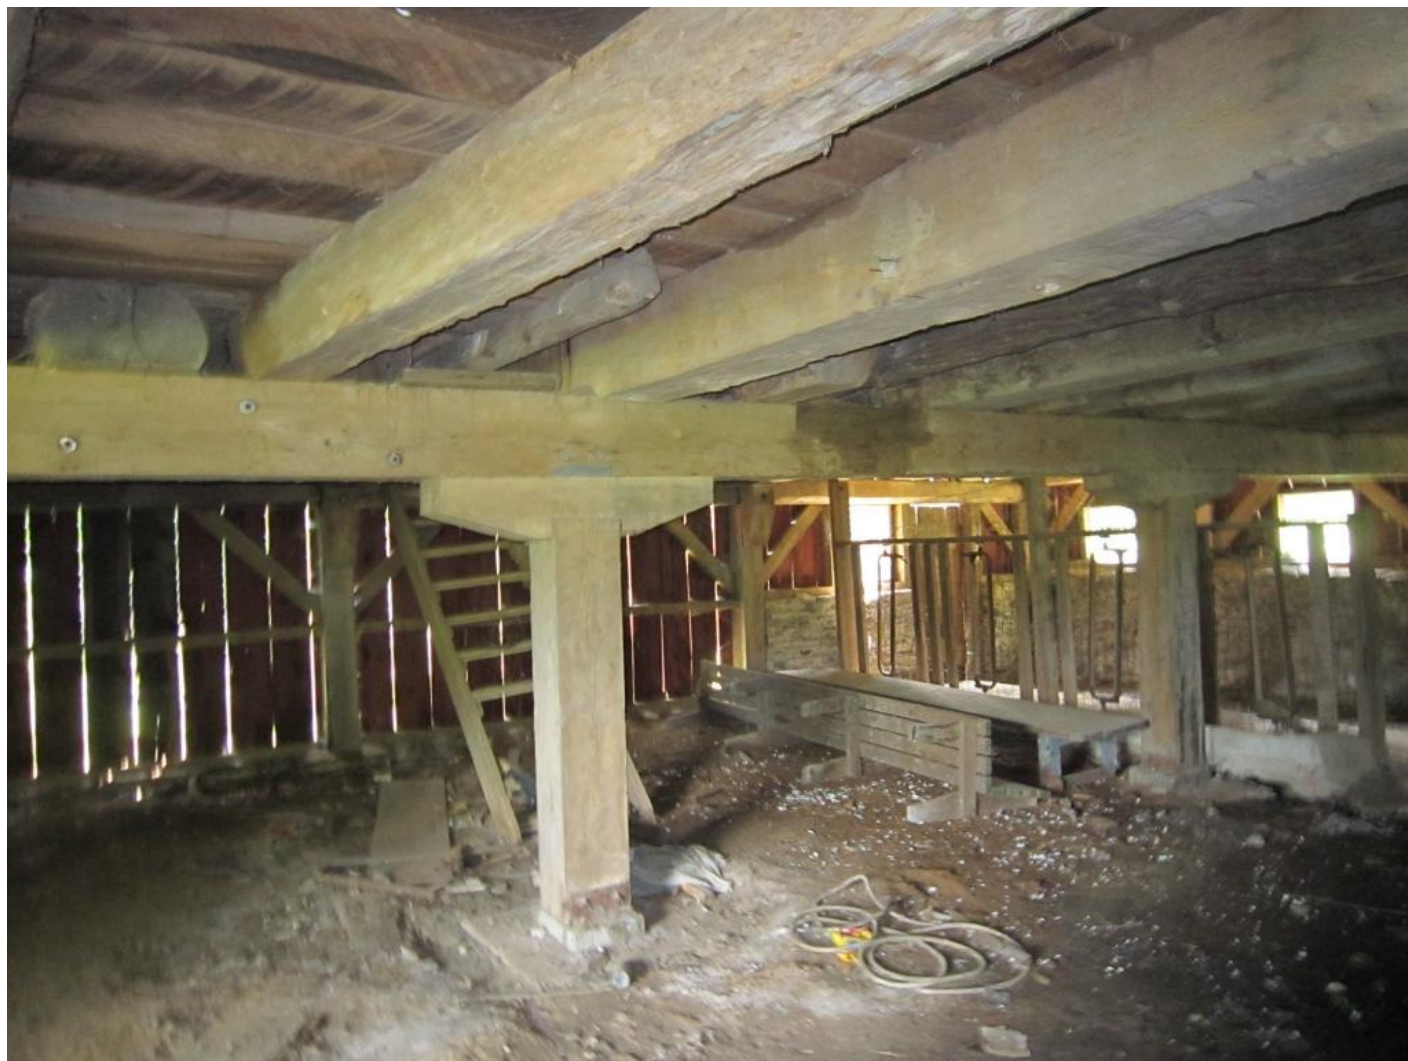
Figure 22. Interior of lower stable level, looking southeast. Ladder to upper level in center background, and 20th century milking stanchions in right background.

Originally, this interior space held wooden livestock stalls, feeding aisles, and mangers for cows and horses, and perhaps mules or sheep. The Armstrongs, owners from the Depression era, used the barn for horses and goats. Today, the livestock level features only some 20th century milking stanchions and an added concrete trough on the floor for the dairy operation, probably located where the former horse stalls stood.

A single wooden plank ladder provides a former connection up to the threshing level by means of a hatch in the floor that is no longer apparent.
