Maryland Historical Trust Maryland Inventory of Historic Properties Form

Inventory No. 31-3-2

other Stubbs Barn (preferred)

street and number 2000 Shorefield Road __ not for publication

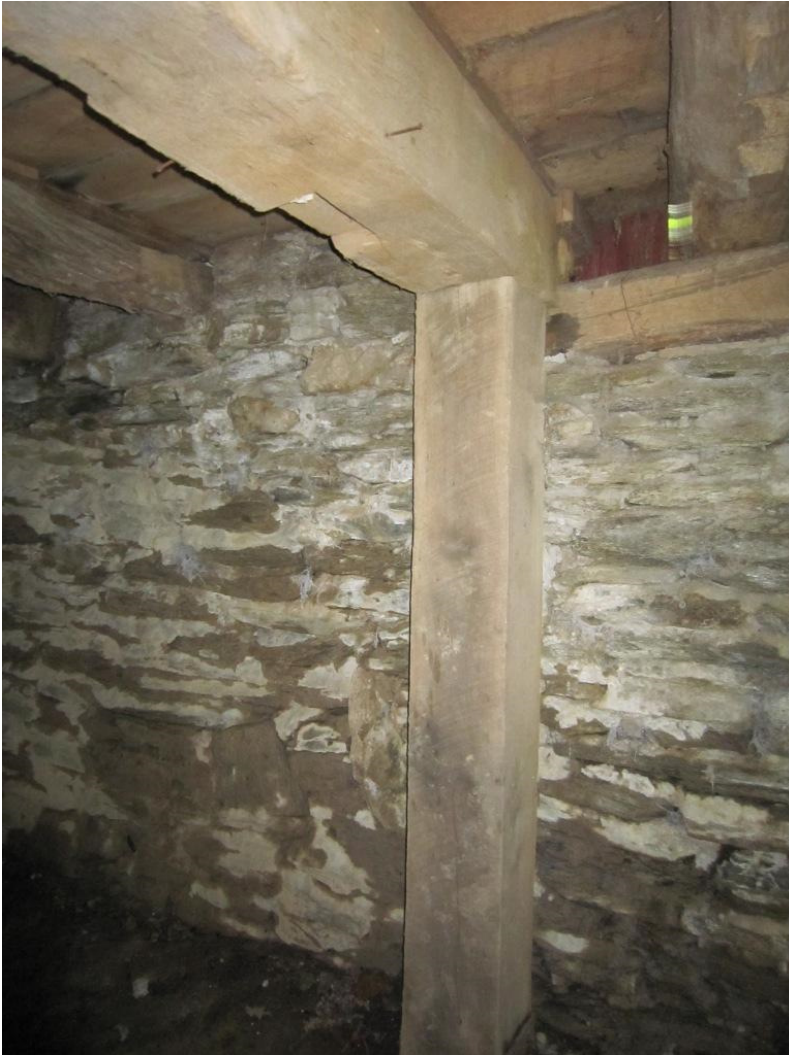
Figure 23. Interior detail, stable level: whitewashed walls and joist framing.

The lower, livestock stable interior reveals a dirt floor and (now) open floor plan within stone masonry walls of 8 ½ feet height showing remnant whitewash. Above the wall are wood plates and or pockets within the stone (at different wall heights distinguishing the main bay and side aisles) into which the joists are framed or set

respectively. One can look up to the rhythmic thirteen joists, their flattened undersides circular sawn or hewn, and their sides, still left with the bark on, and comprehend the framing of the 40-foot width. Some of the joist's bark is splintering off rather wildly due to age. The summer beam that provides most floor support is a replacement wood member, now supported on posts with concrete footings. Additional support members extend from this summer beam to the edge of the building's southeast wall.

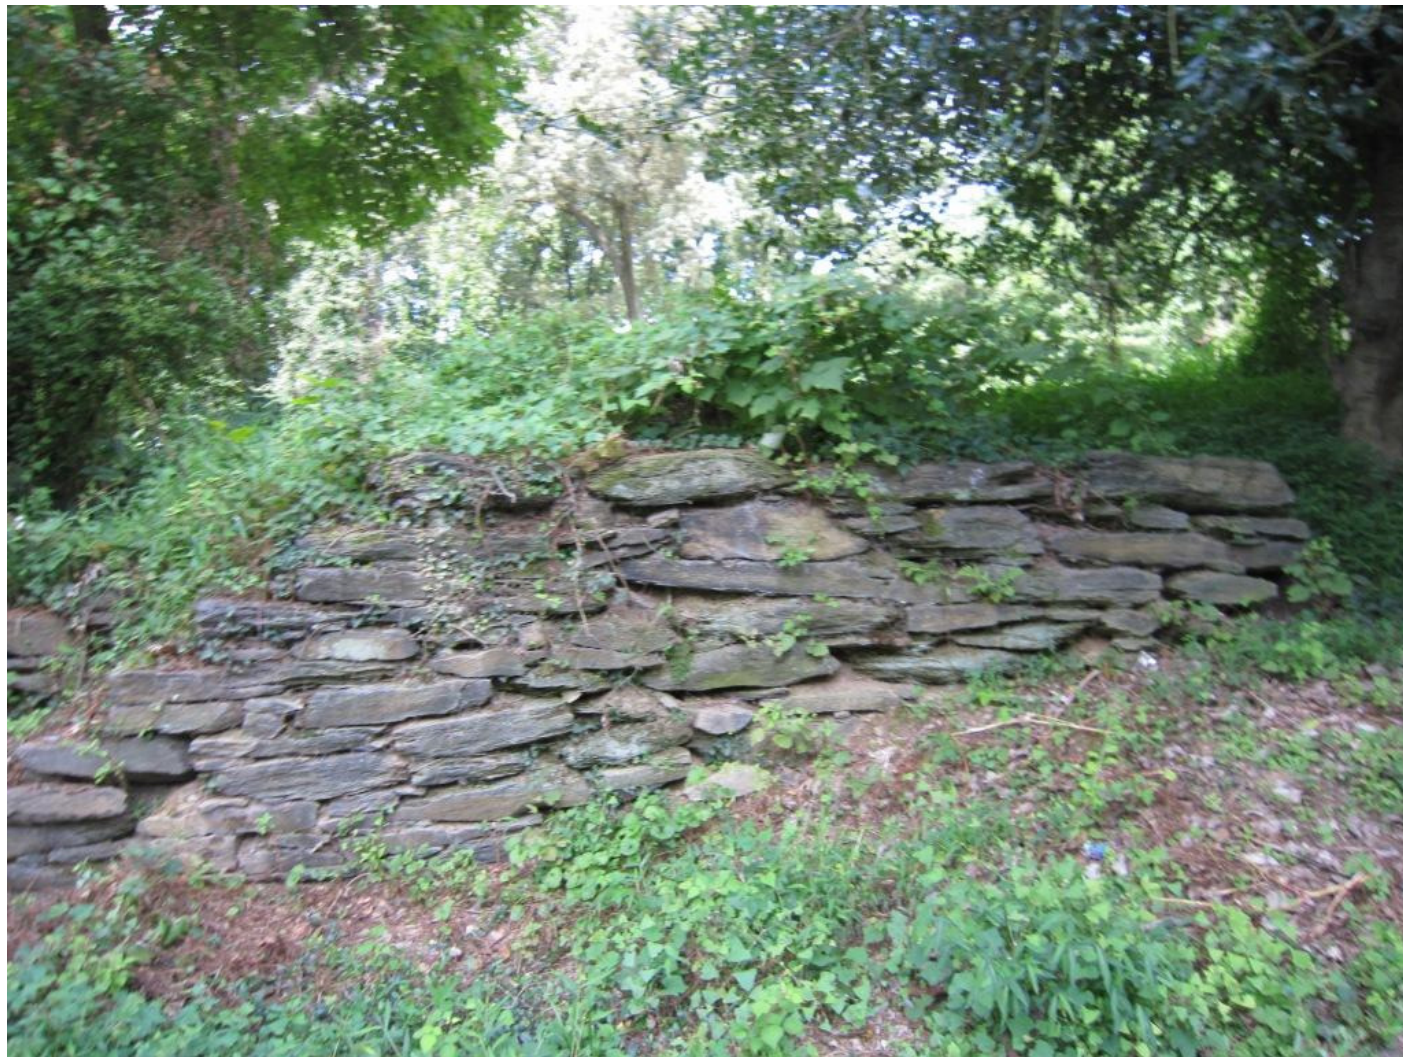
Figure 24. Dry stack stone retaining wall for banking earth.

landscape elements, only one of the banked-earth, dry-stack stone walls is still apparent, a semicircular stone wall on the west side of the barn that holds back the earth and creates the bank so that a wagon can be driven into the upper level. This wall may date to the Depression era, according to an oral history taken in June 2008 with John Armstrong, who grew up on the farm. The other stone wall—or remnants of it—that holds back the earth for the bank likely exists under a lot of vegetation. Although historic photographs indicate a former, fenced-in stable yard to the rear, no evidence of that stable yard remains.
