WATER RESOURCES TECHNICAL REPORT

AUGUST 2013

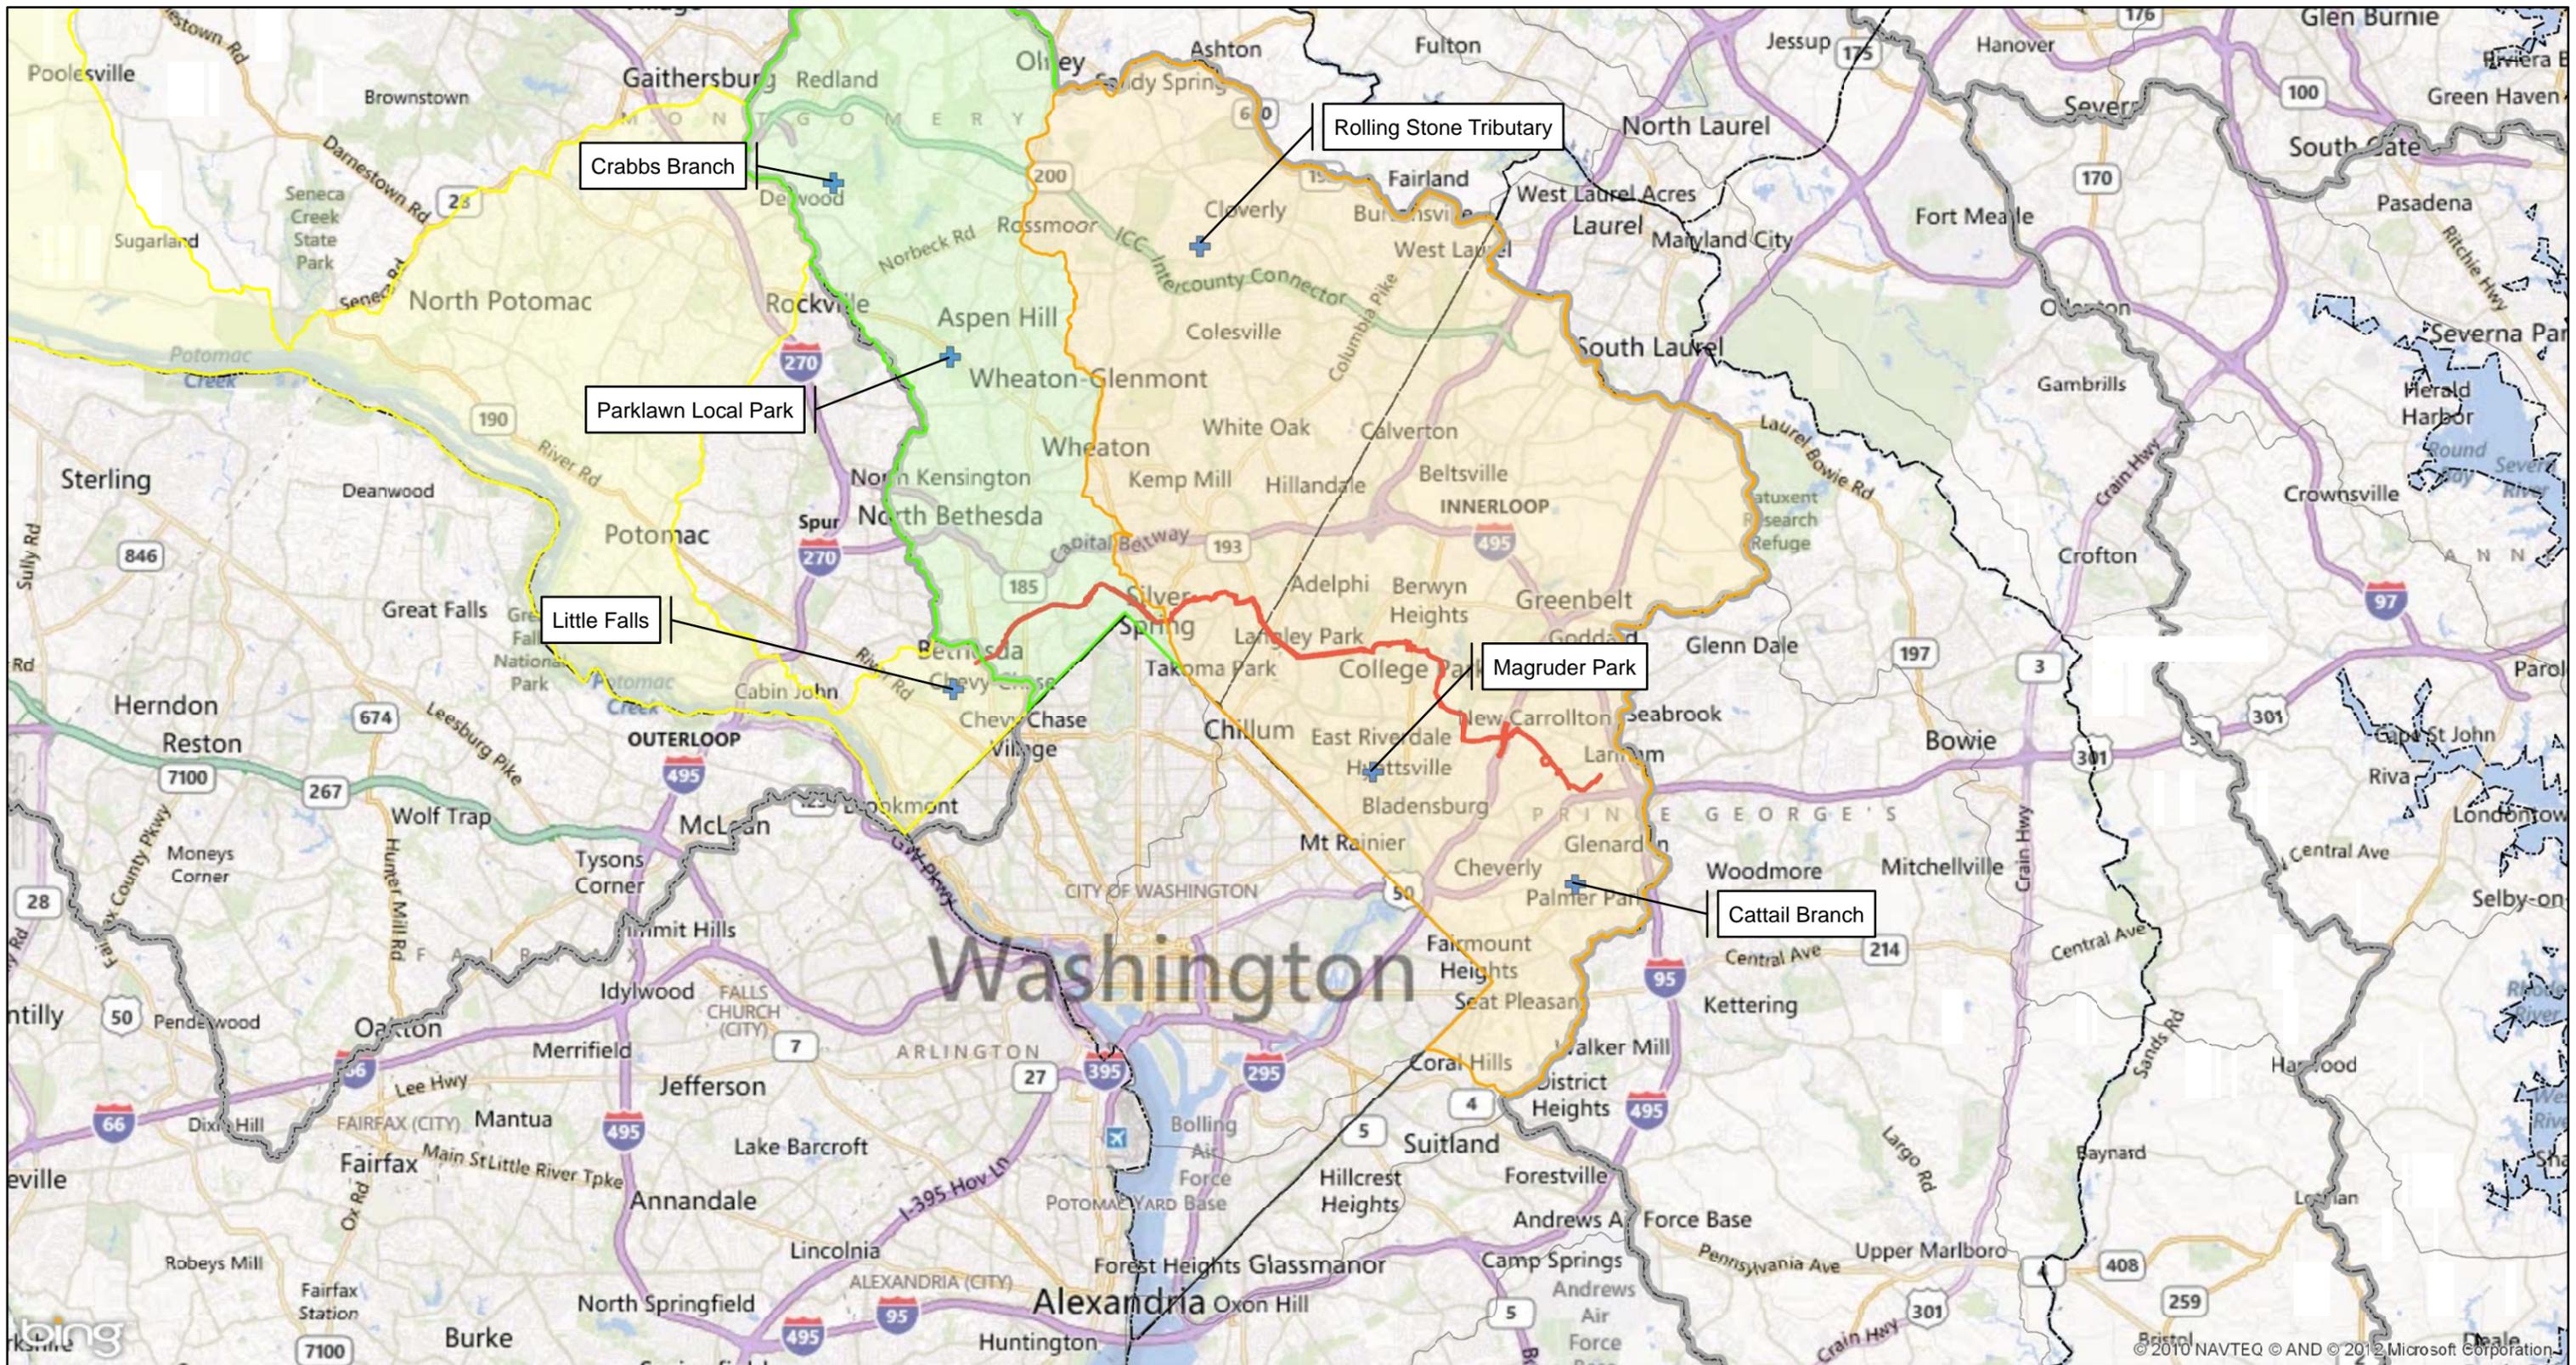
Potential Wetland and Stream Mitigation Sites

Site Name	Site ID	Type of Mitigation	Site size (acres and/or L.F.)	Location	Watershed	Property Ownership
Cattail Branch	AR-2 AR-3 AR-4 AR-8 AR-9	Stream	4,500 L.F.	Landover	Beaverdam Creek	Public
	AR-8	Wetland	0.70 Acres			
Magruder Park	AR-21	Stream	950 L.F.	Hyattsville	Northwest Branch	Public
	AR-21	Wetland	0.95 Acres			
Little Falls Branch	PR-1	Stream	850 L.F.	Bethesda	Potomac River	Public
Parklawn Local Park	RC-9	Wetland	4.37 Acres	Rockville	Rock Creek	Public
Crabbs Branch	RC-74	Stream	5,360 L.F.	Derwood	Rock Creek	Public
	RC-74	Wetland	3.22 Acres			
Rolling Stone Tributary	NW-49 NW-50	Stream	2,700 L.F.	Colesville	Northwest Branch	Public

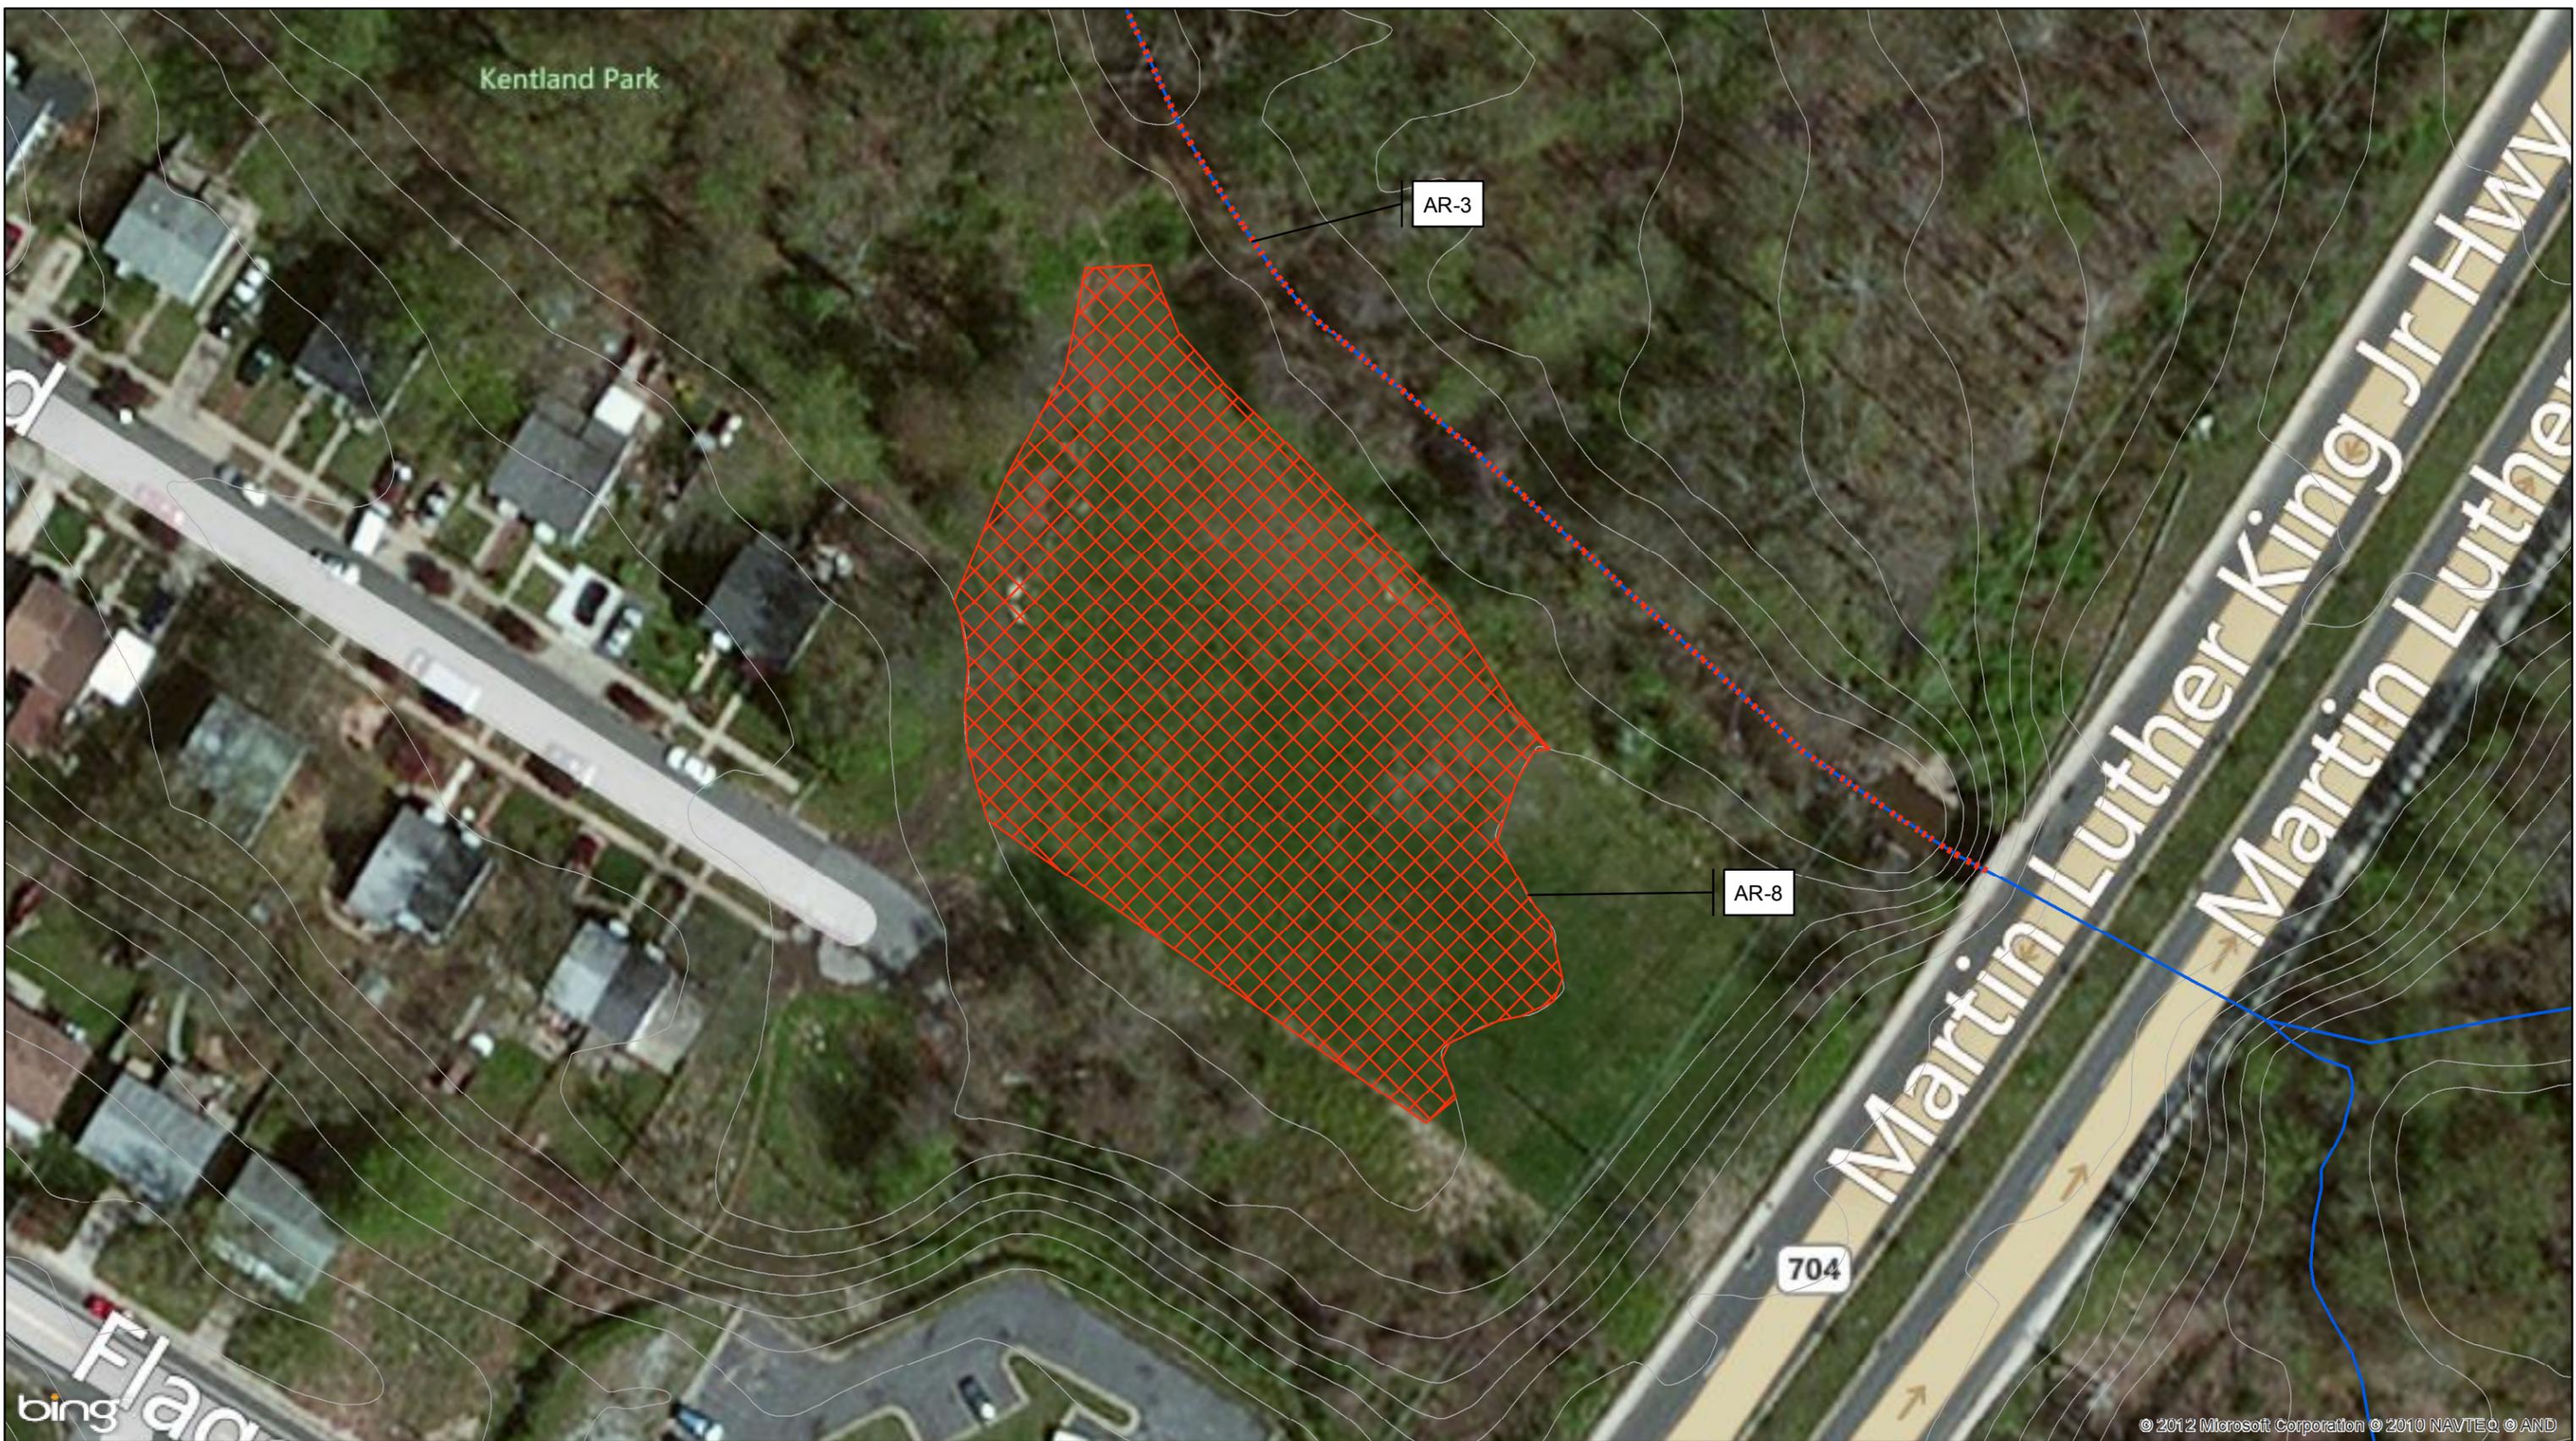
Purple Line Potential Mitigation Sites
Cattail Branch
October 2012

ASSOCIATED SITE ID:
AR-2 AR-8
AR-3 AR-9
AR-4

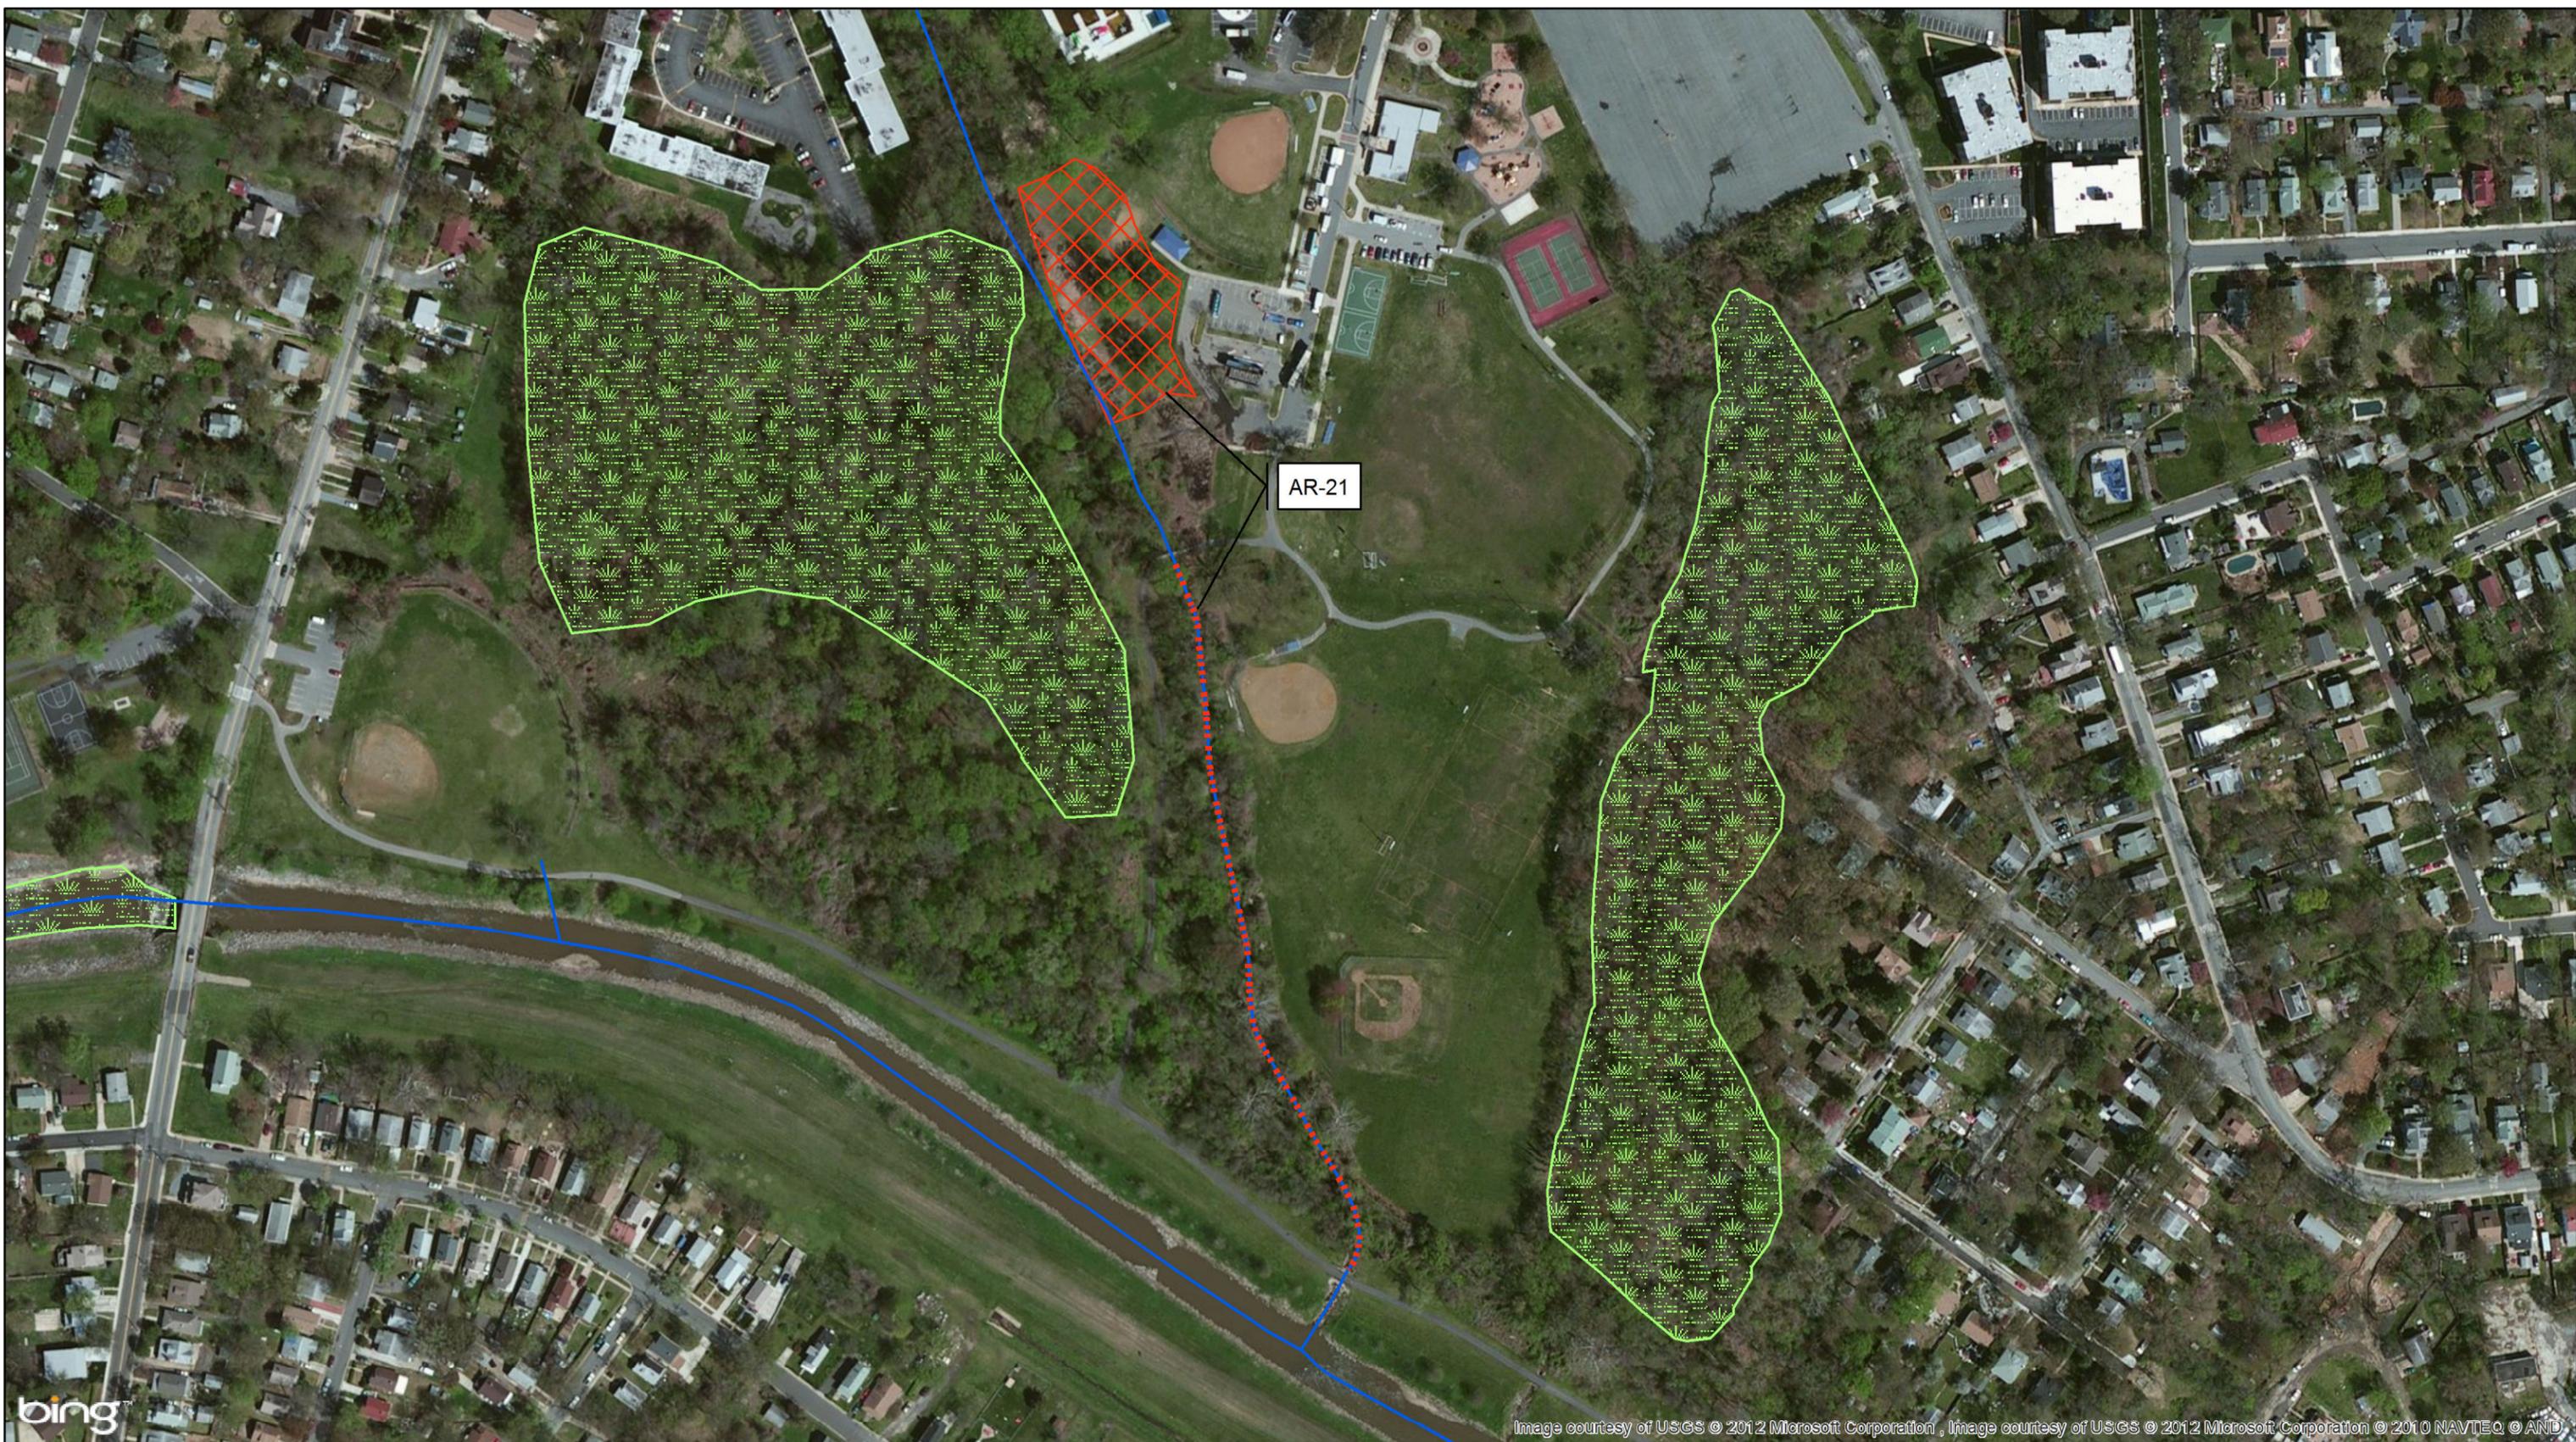
- Minimal grading to north of bioretention area to create wetlands
- Planform adjustment to return the channel to a meandering stream
- Bank grading to improve floodplain connectivity and reduce sediment loading
- Installation of in-stream structures to improve channel stability, protect existing utilities, and improve in-stream habitat

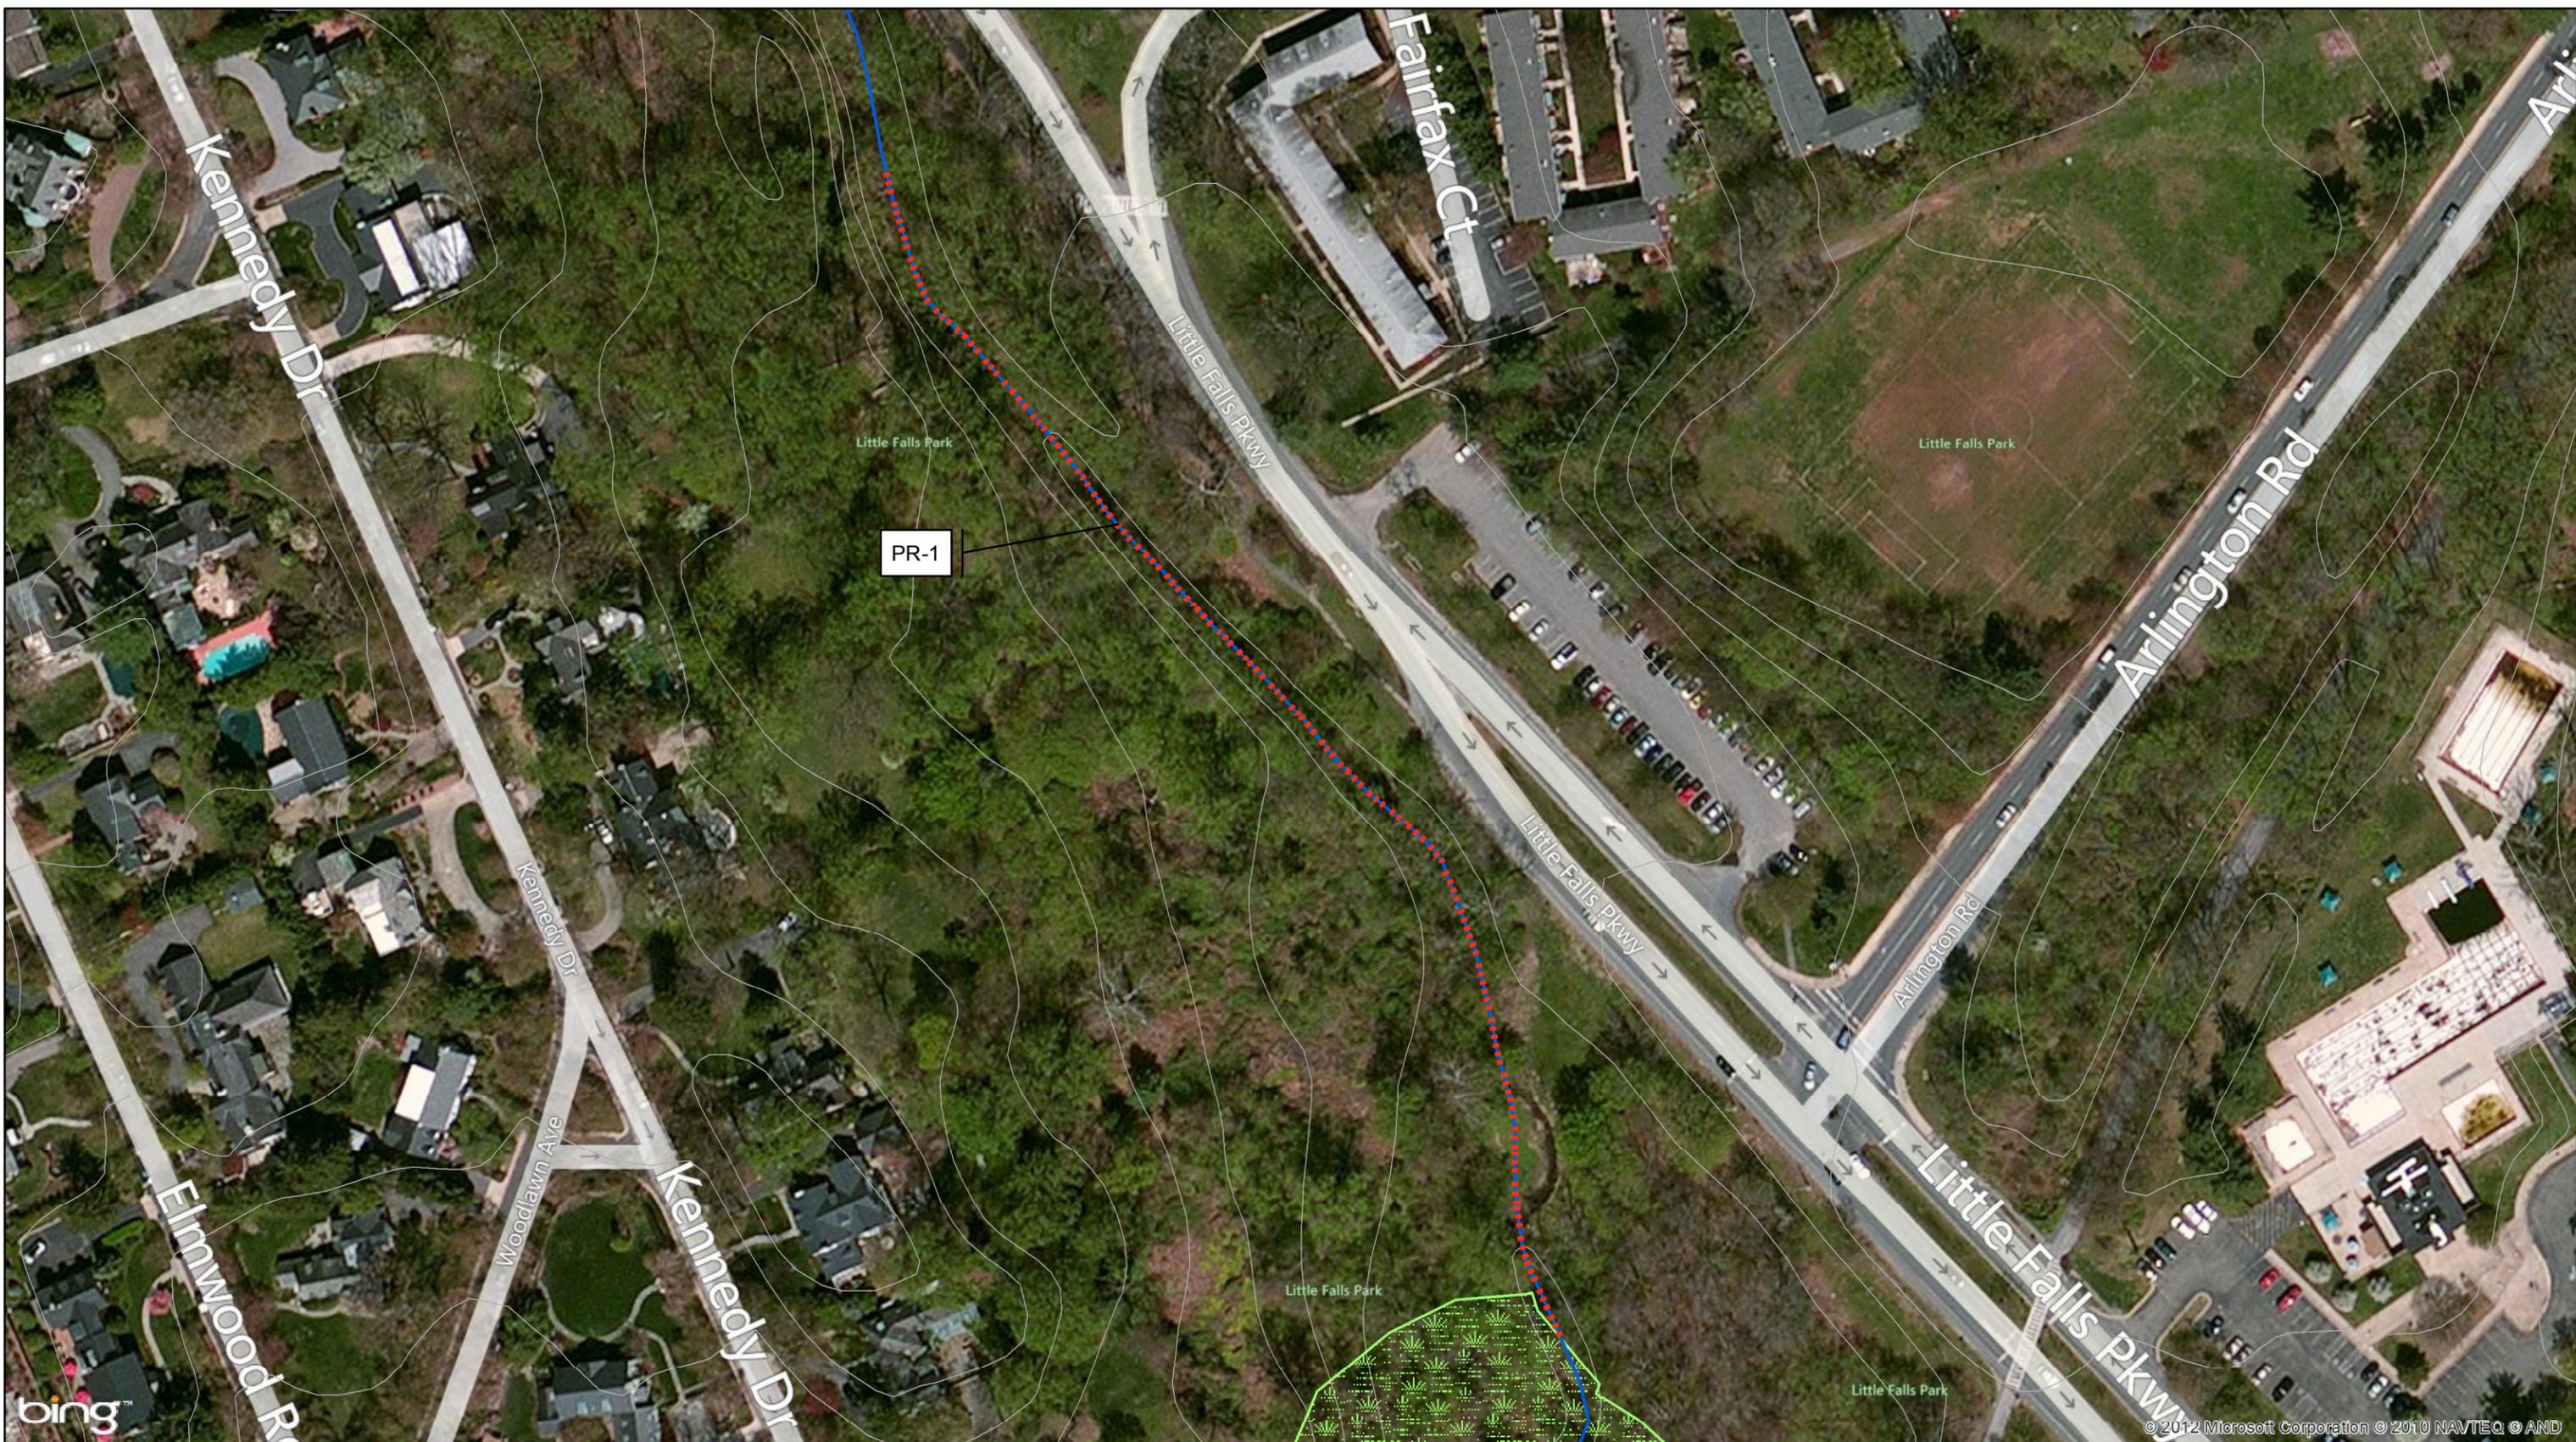
- Installation of in-stream structures and bank grading to improve channel stability, reduce sediment loading, and provide floodplain connection
- Installation of woody debris and other types of in-stream cover and gravel channel material to enhance the benthic and fish habitats and communities

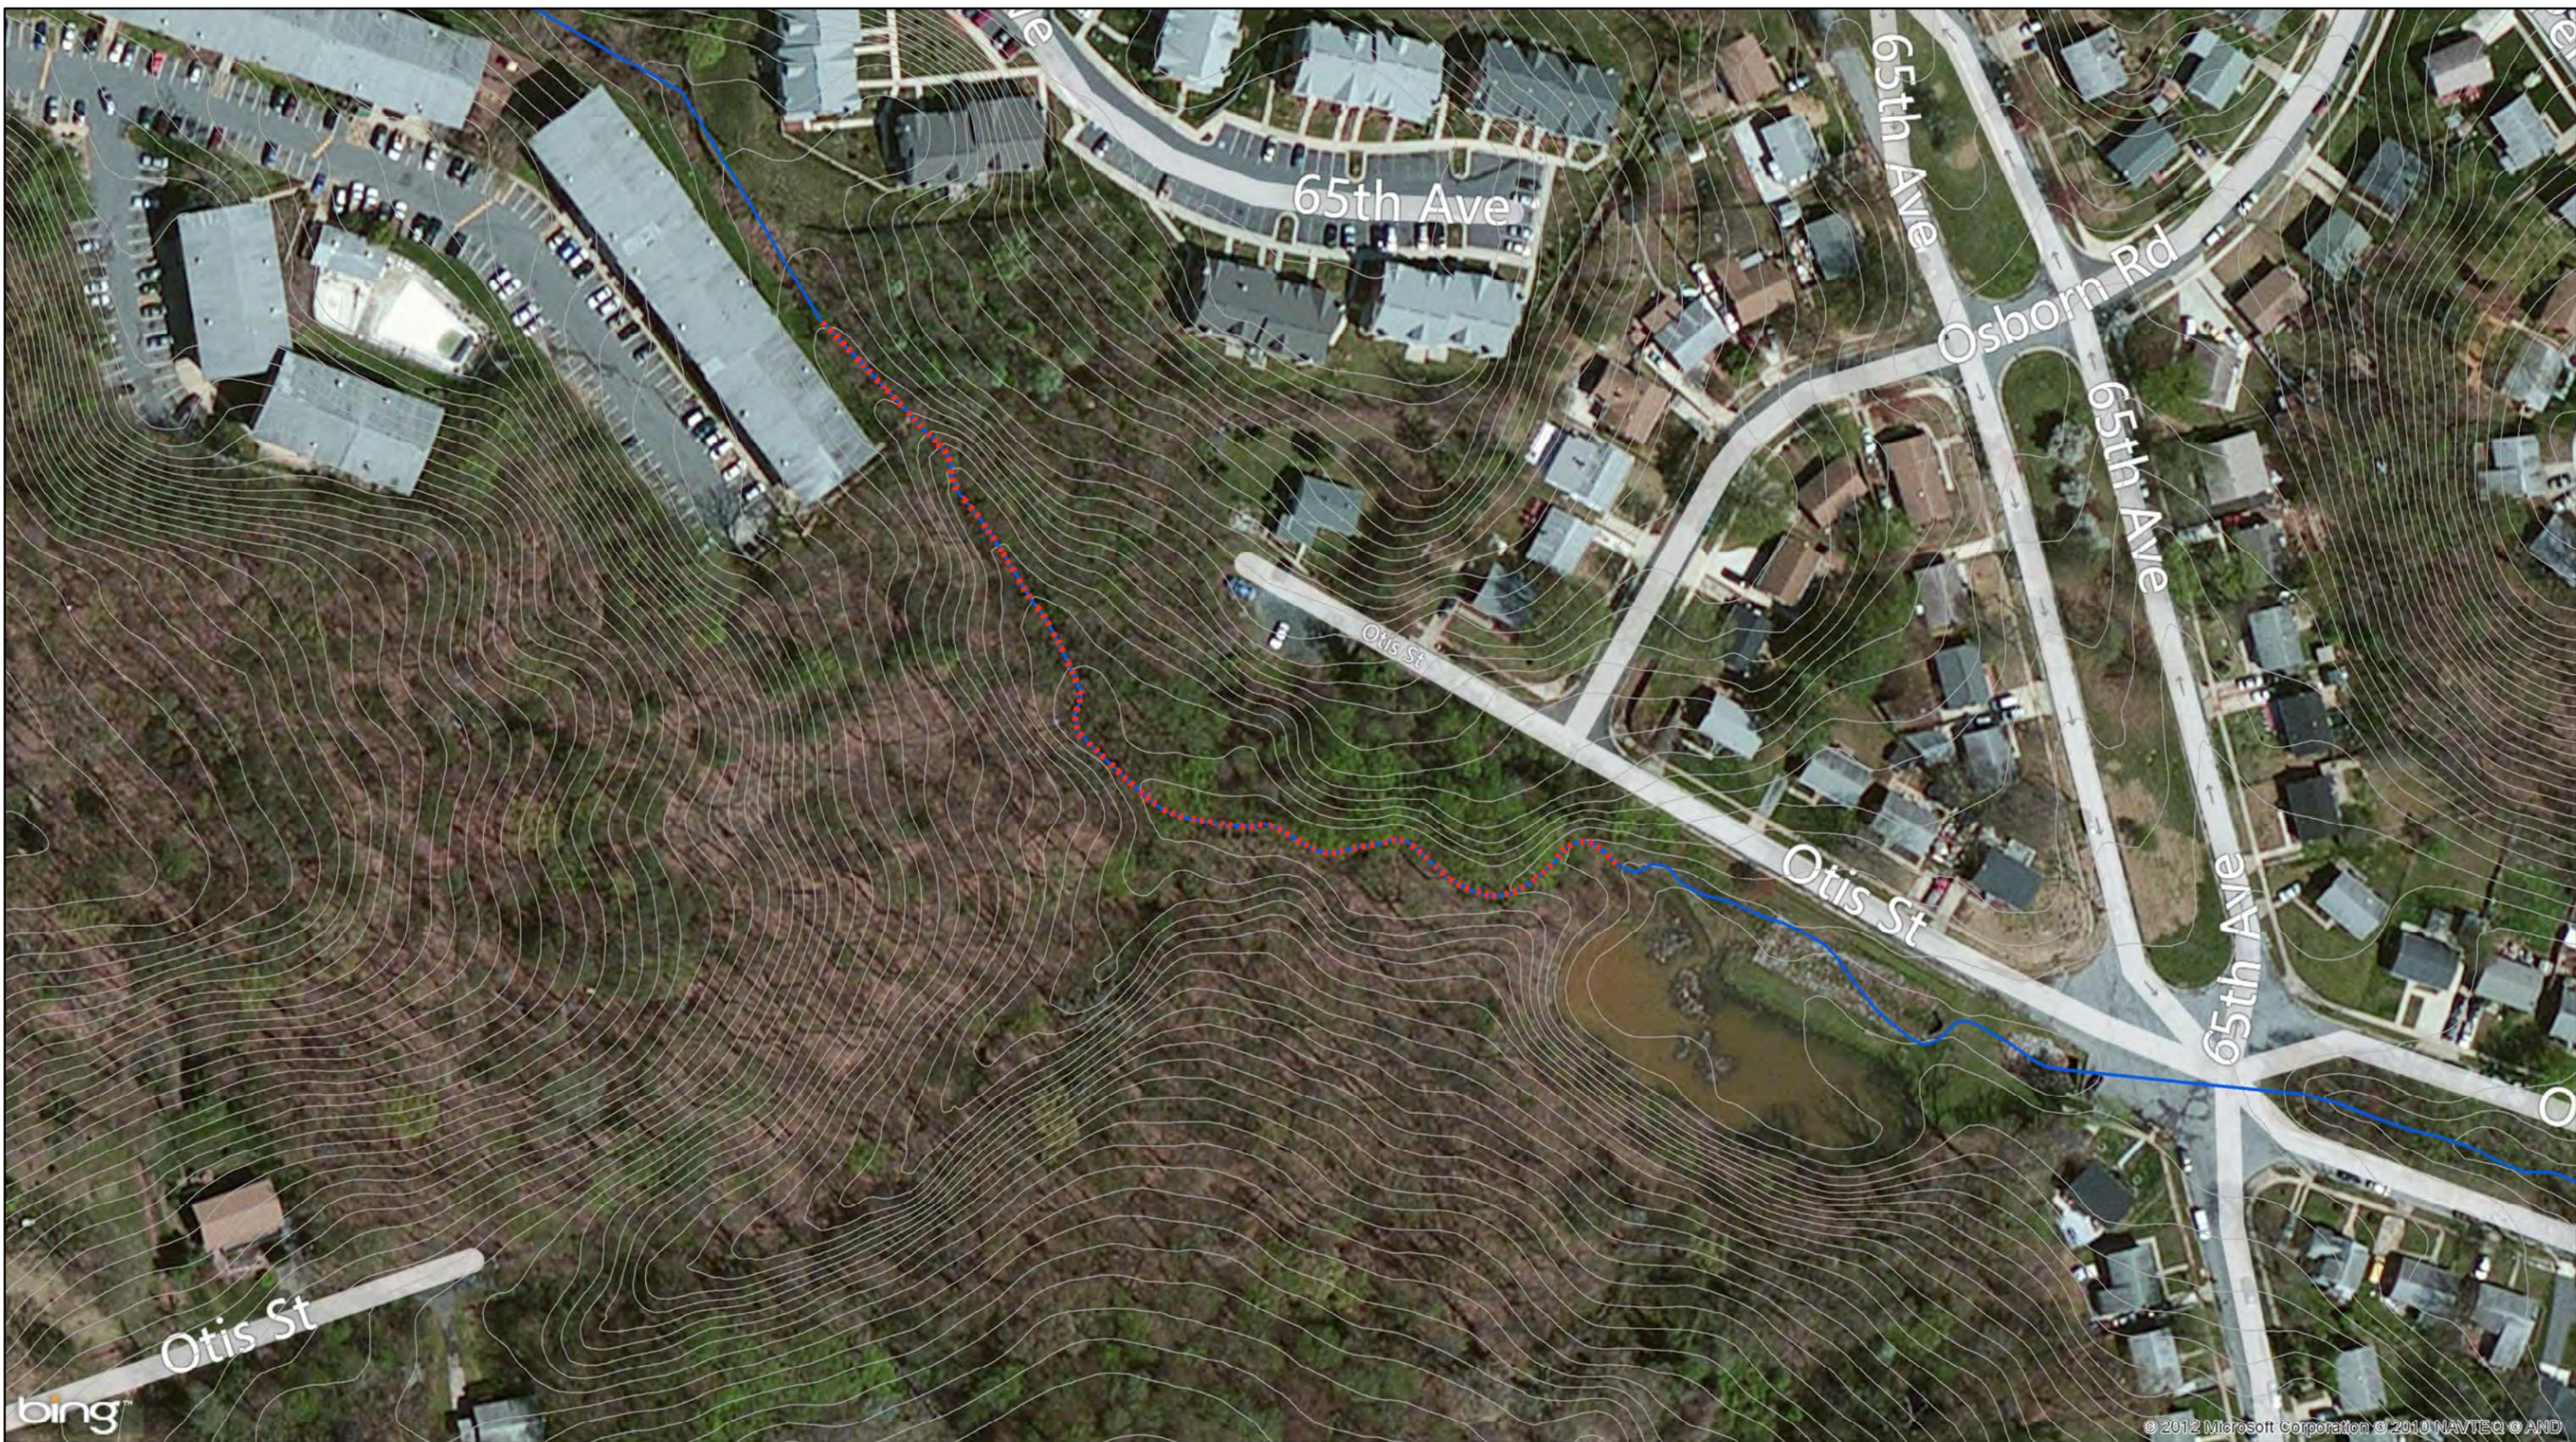
- Installation of in-stream structures and bank grading to improve channel stability, reduce sediment loading, protect existing utilities, and improve in-stream habitat

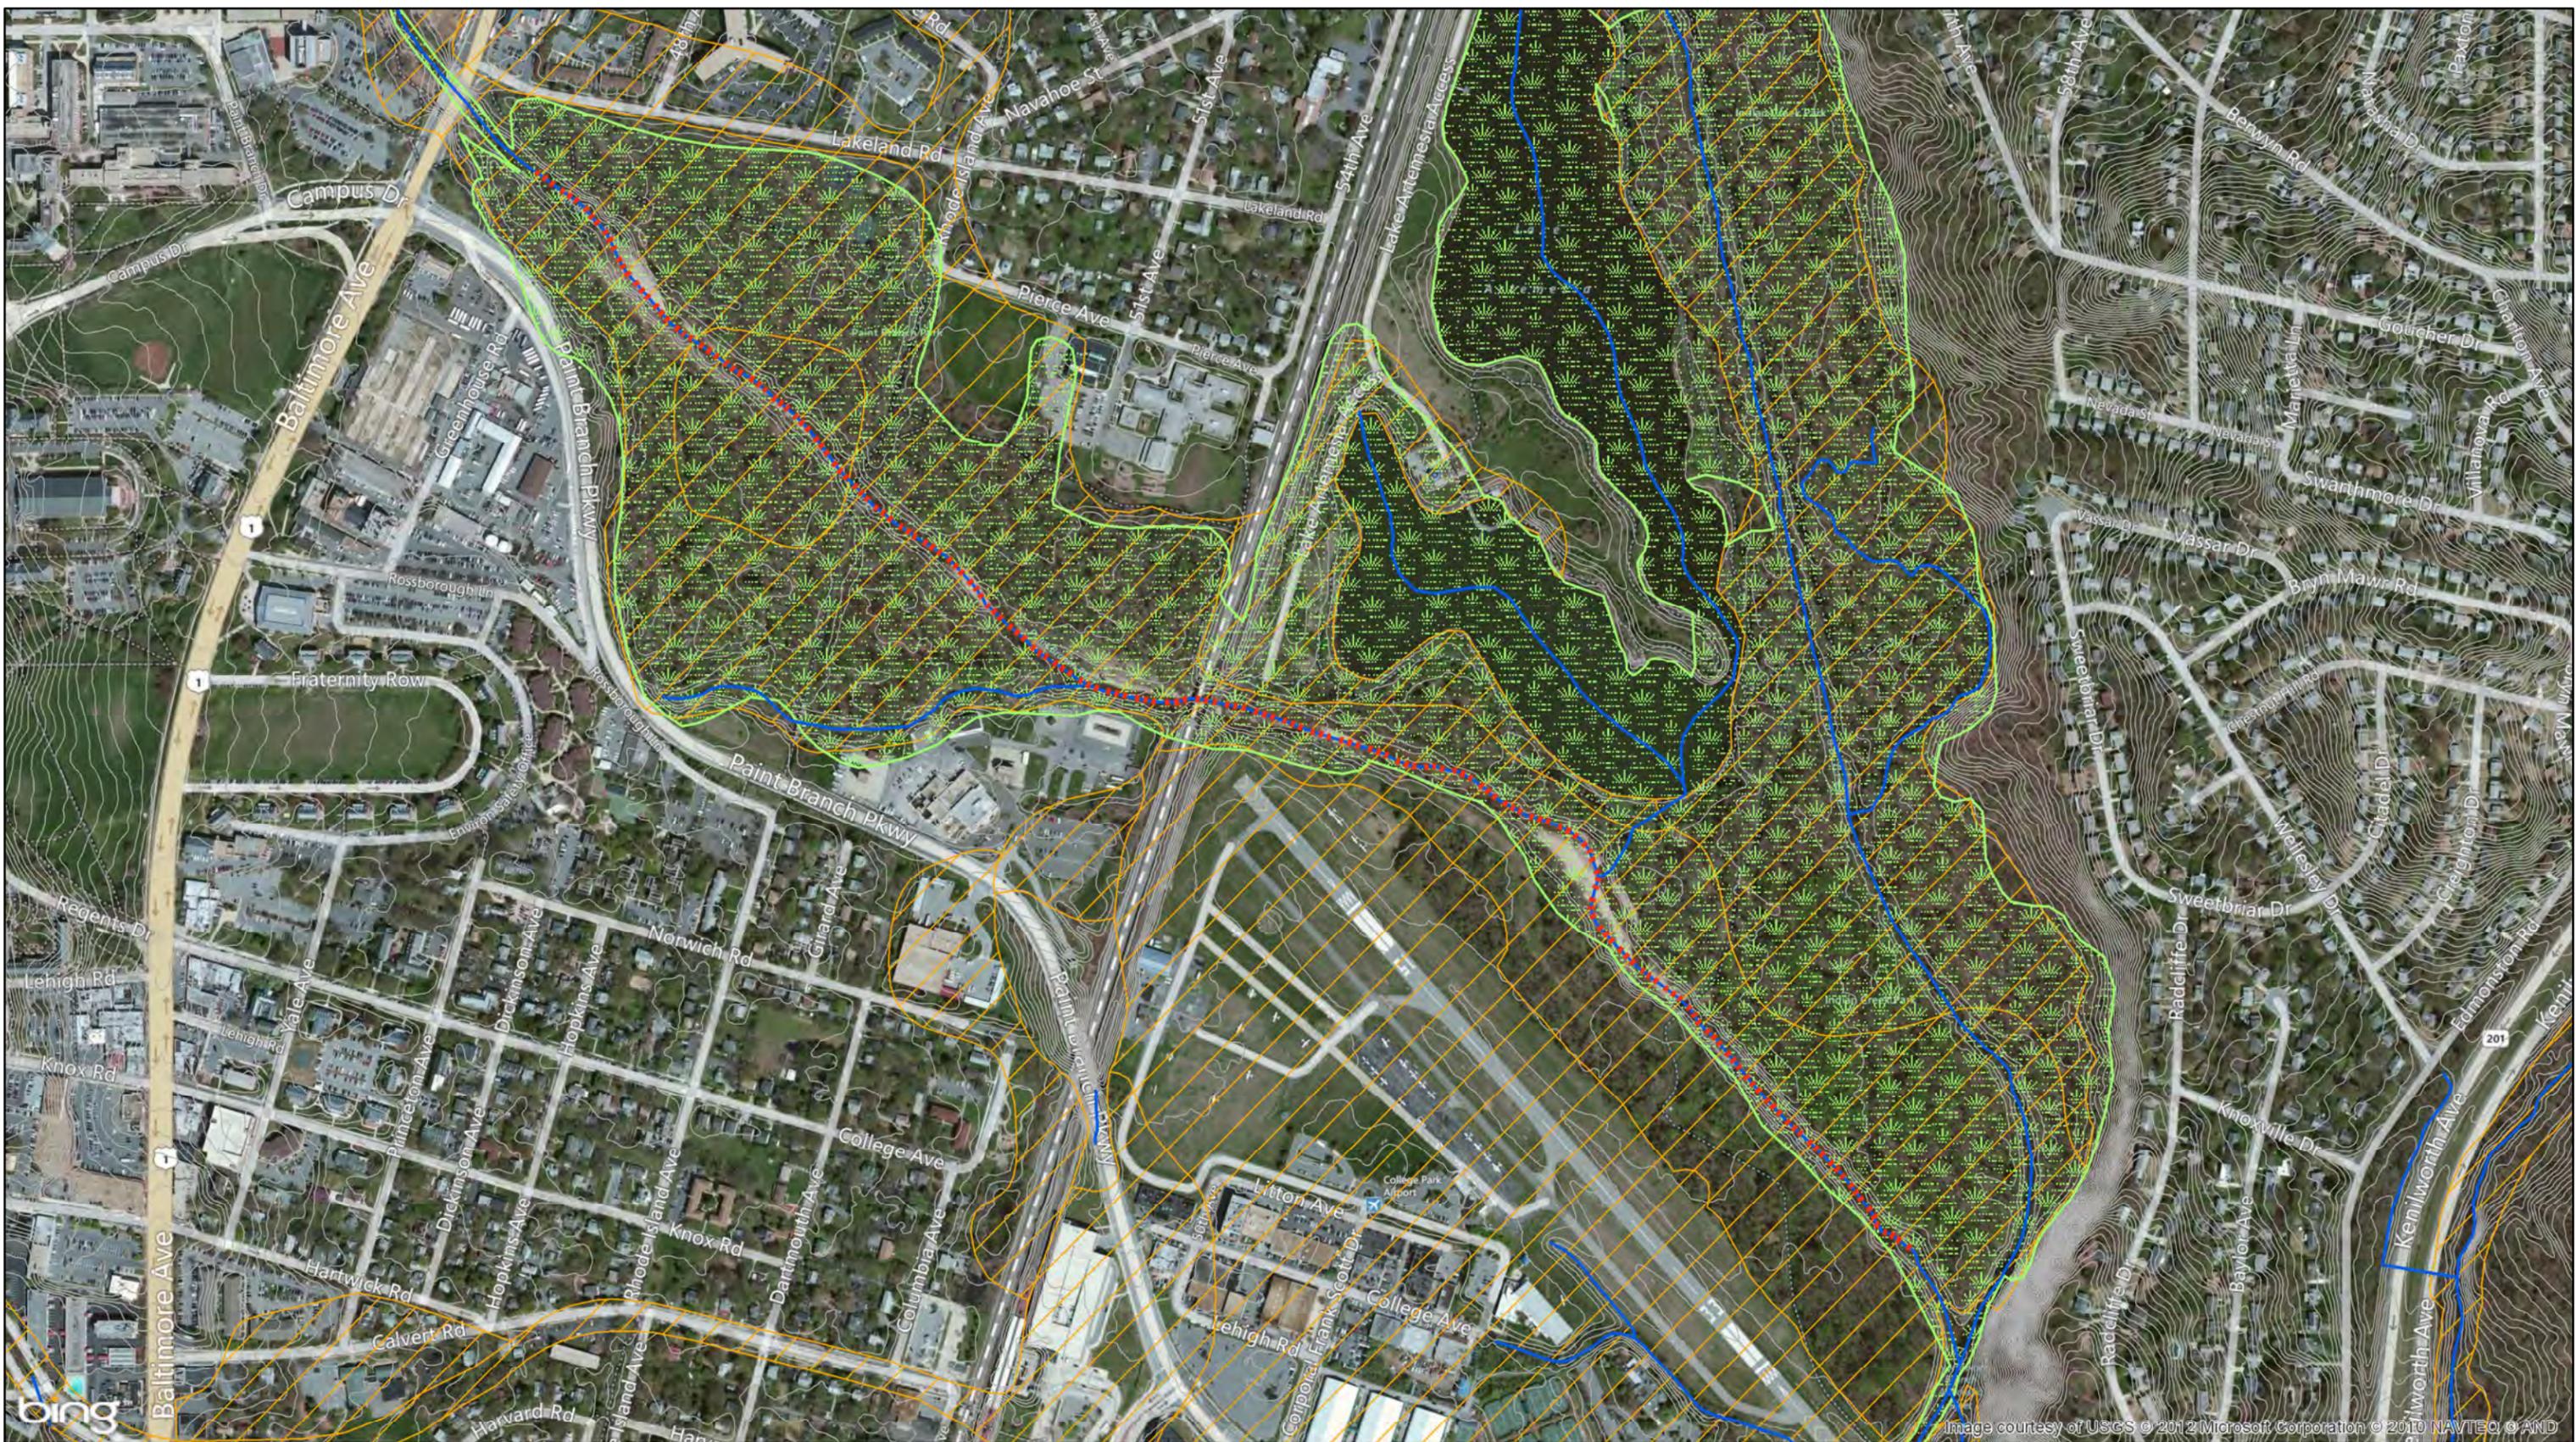
- Installation of in-stream structures and bank grading to improve channel stability, reduce sediment loading, protect existing utilities, and improve in-stream habitat
