WATER RESOURCES TECHNICAL REPORT

AUGUST 2013

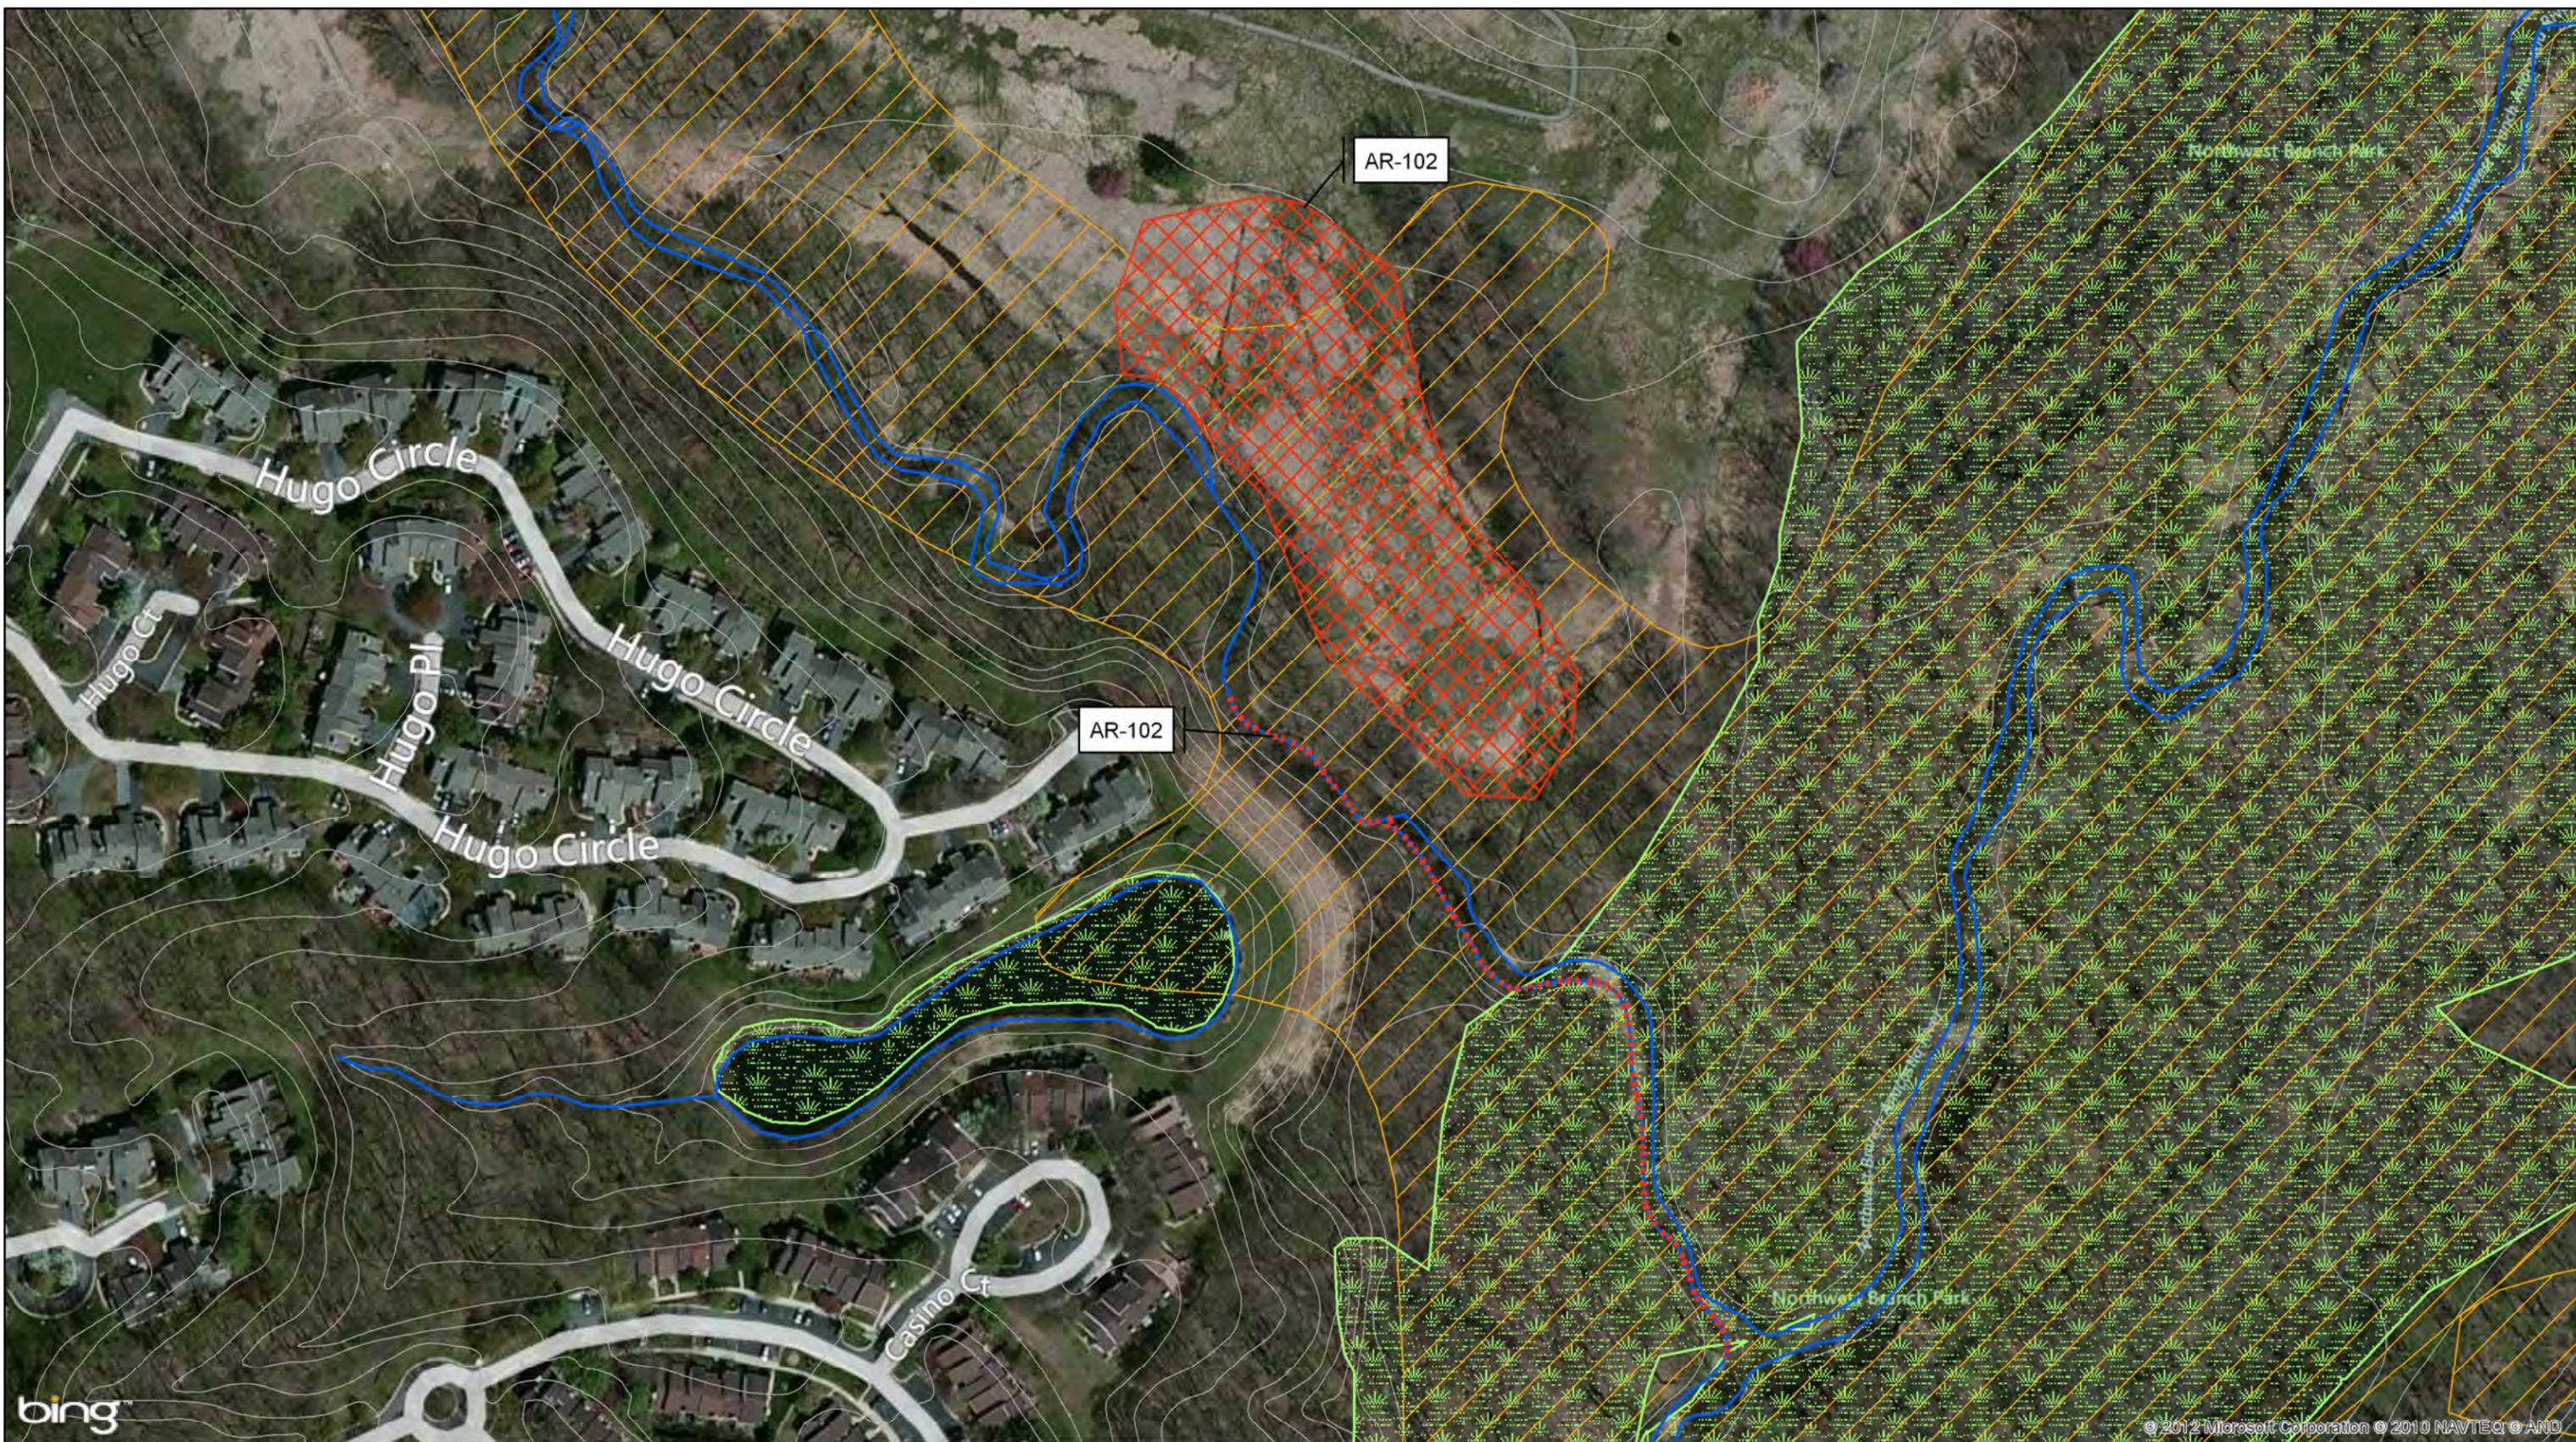
- Minimal grading and the plugging of a ditch on the east side to create a floodplain wetland
- Floodplain creation to provide energy dissipation of erosive flood flows, reduce erosive shear stresses, reduce channel incision, and increase infiltration and groundwater recharge
- Bank stabilization to provide energy dissipation of erosive flood flows, reduce erosive shear stresses, and reduce bank erosion and in-stream sedimentation
- Riparian buffer plantings
- Installation of woody debris and other types of in-stream cover and gravel channel material to enhance the benthic and fish habitats and communities
