# Major Environmental Planning/Resources Management Issues

## Water Quality

### **Water Quality and Habitat Conditions in the Anacostia Tributaries of Eastern Montgomery County**

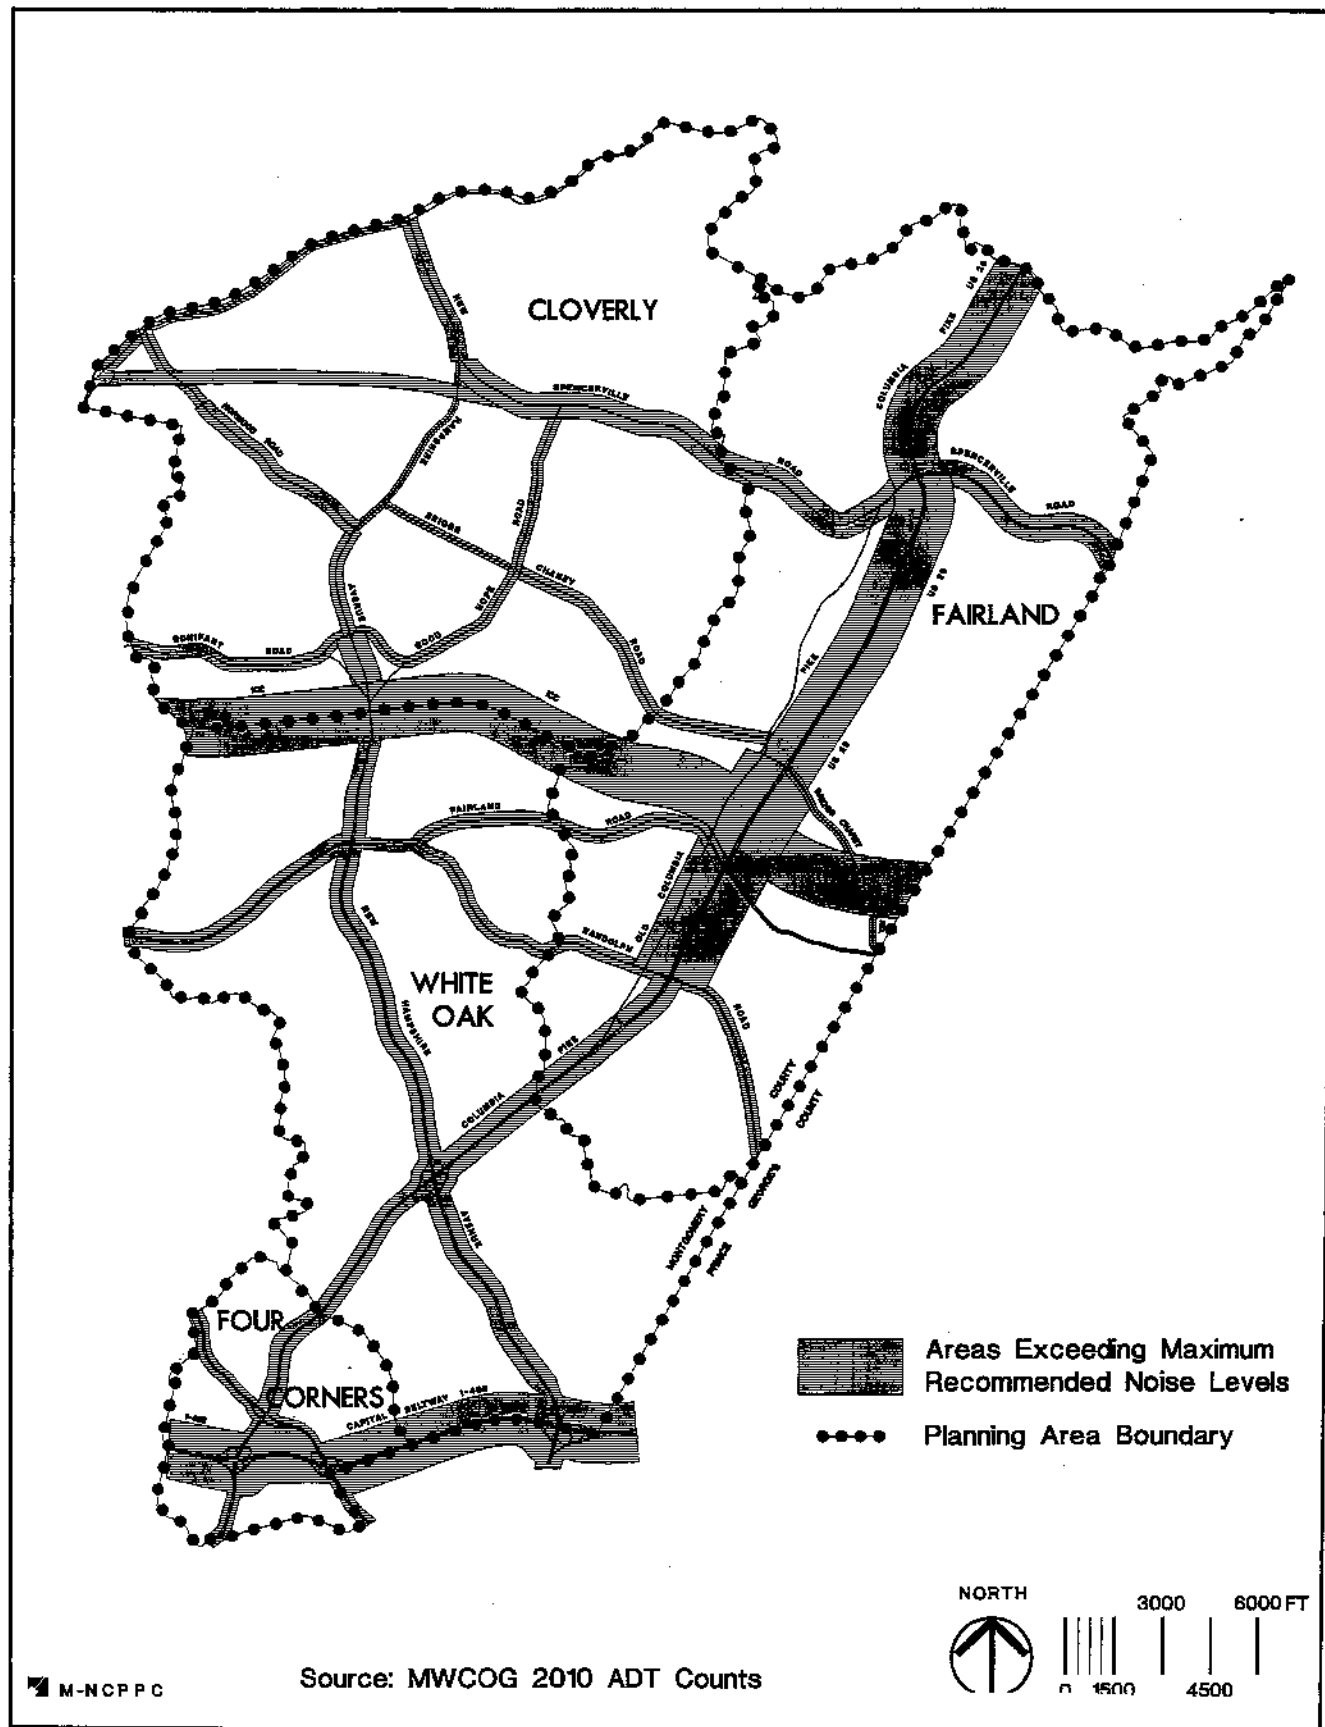
Figure 11

# Projected Traffic Noise Impact Areas
